DUTCH
SAFETY BOARD

Crash following engine failure

The Hague, March 2016

Identification number:	2012096
Classification:	Accident
Date, time ¹ of occurrence:	15 September 2012, around 19.10 hours
Location of occurrence:	Valkenswaard area
Registration:	ES-YLS
Aircraft type:	Aero Vodochody L-39C
Aircraft category:	Single engine jet
Type of flight:	Formation flight
Phase of operation:	Cruise flight
Damage to aircraft:	Destroyed
Flight crew:	One
Passengers:	One
Injuries:	None
Other damage:	Pollution of a field
Light conditions:	Daylight

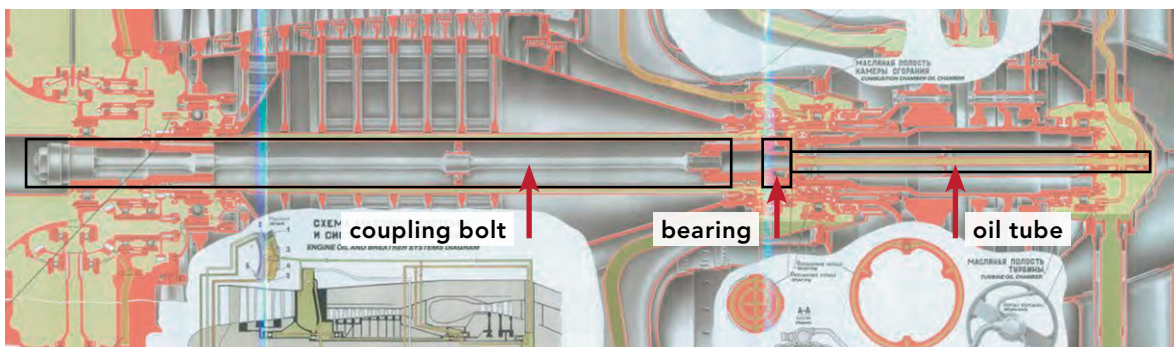
As the Ukraine, state of manufacturer and design of the engine, initially had not responded to participate into the investigation, the engine was torn down at LOM Praha in the Czech Republic on 20, 21 and 22 March 2013. The engine was disassembled in the presence of air safety investigators from Estonia, the Czech Republic and the Netherlands. The investigation showed that the engine low pressure turbine front bearing, an oil tube and a coupling bolt⁴ had failed. The front bearing showed signs of extreme wear, the oil tube was twisted and broken and the coupling bolt was bent and broken into four pieces. These components are located between the engine's low-pressure compressor and low-pressure turbine. Further component examination would be necessary in order to determine the exact nature of their failures.

Figure 3: The engine diagram with the three above-mentioned components. (Photo: Book of Charts and Diagrams AI-25TL)

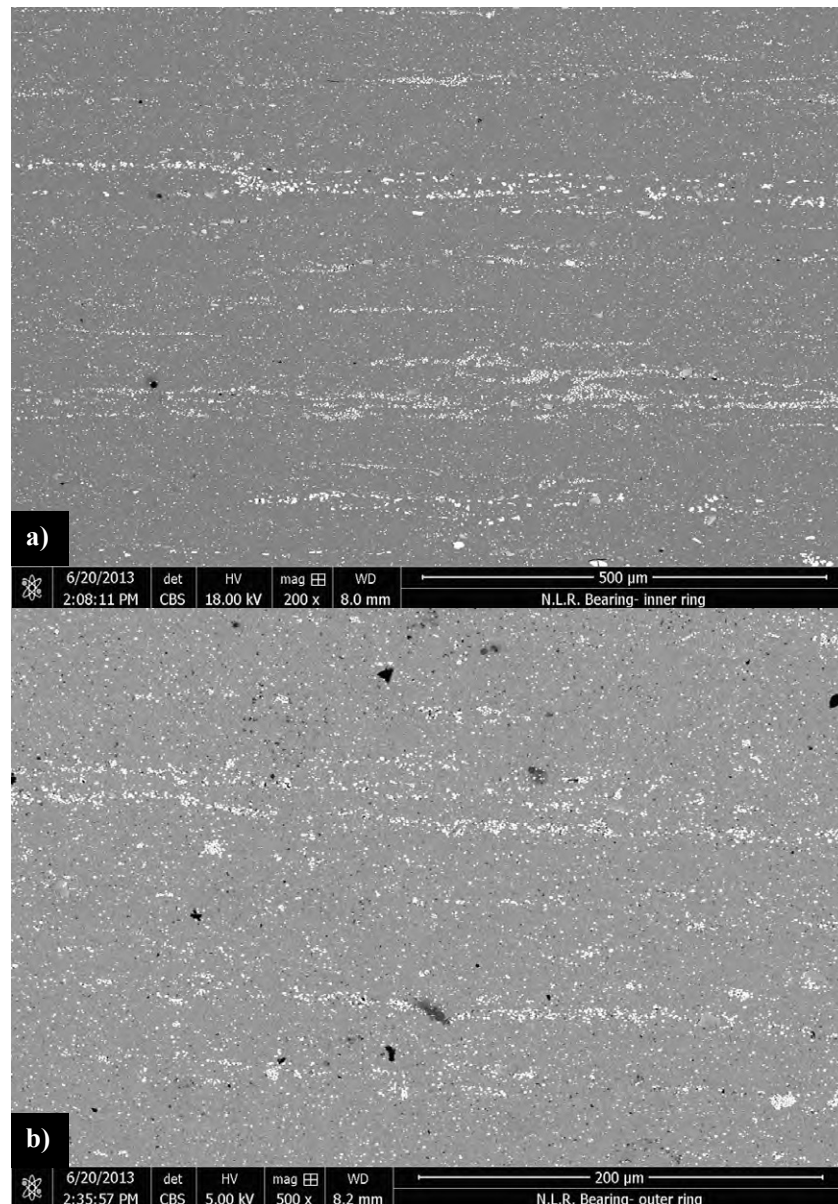
Fig. 3 shows the cross-section of the inner- and outer ring of the bearing. The chemical composition of the bearing components were measured with EDX in the SEM (see Table 1). The chemical composition of the inner ring, outer ring and the rollers is similar and is also similar to the specified material EI 347 Sh, which is similar to 8KH4V9F2-SH [1].

Fig. 3 Microstructure of the a) inner and b) outer ring of the bearing

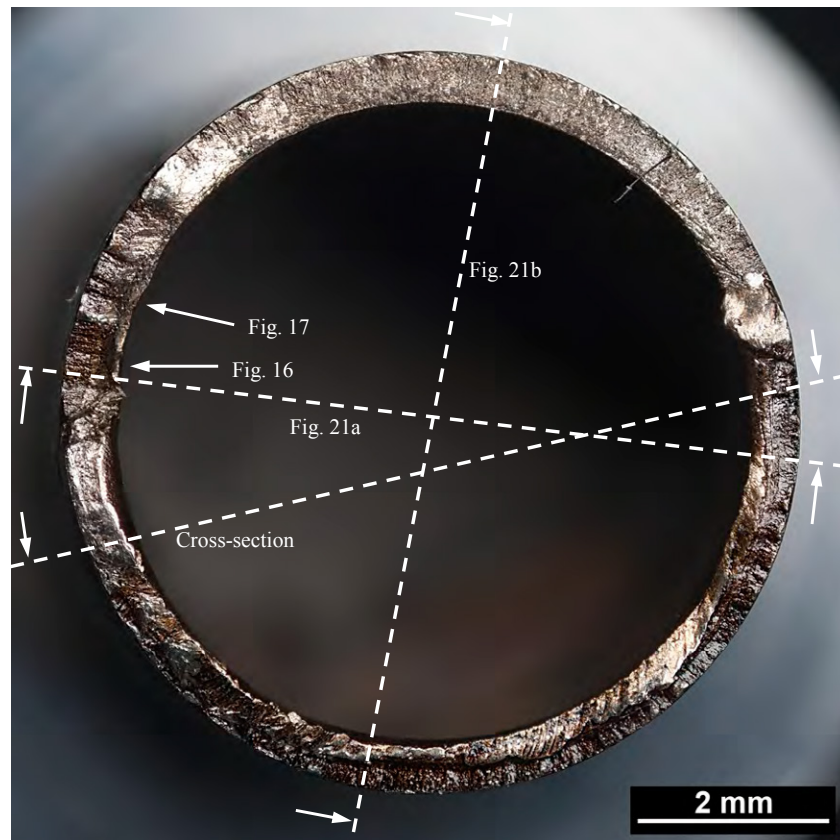
Fig. 15 shows the fractograph of fracture surface {1,1}. The fracture surface is not very clean and a lot of deposit is present (see Fig. 16). Therefore it is difficult to detect characteristic fractographic features. Fig. 16 does show small steps, which can be a sign of fatigue. Some fine lines were observed, but due to their appearance and orientation they are not regarded as fatigue striations.

Fig. 15 Fractograph of fracture surface {1,1}

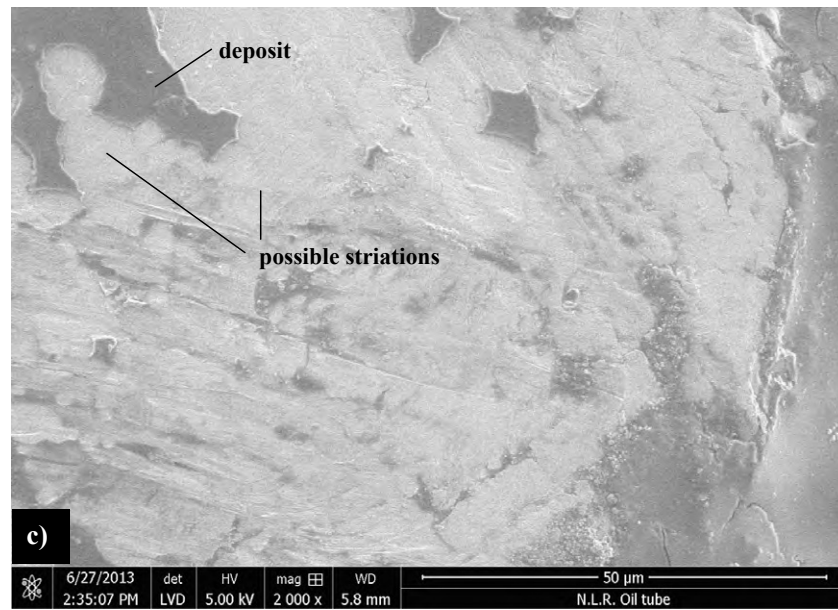
Fig. 17 SEM images of the oil tube fracture surface {1,1} at a) 200x, b) 500x and c) 2000x magnification (see Fig. 14 for location)

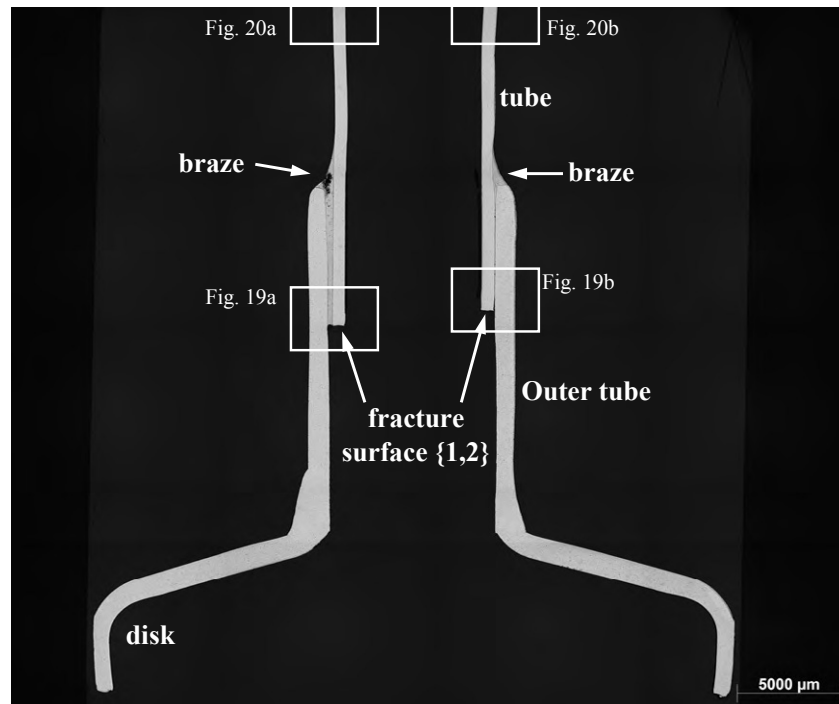
Fig. 18 Optical microscopy image of the cross-section of tube section 2 with fracture surface {1,2}

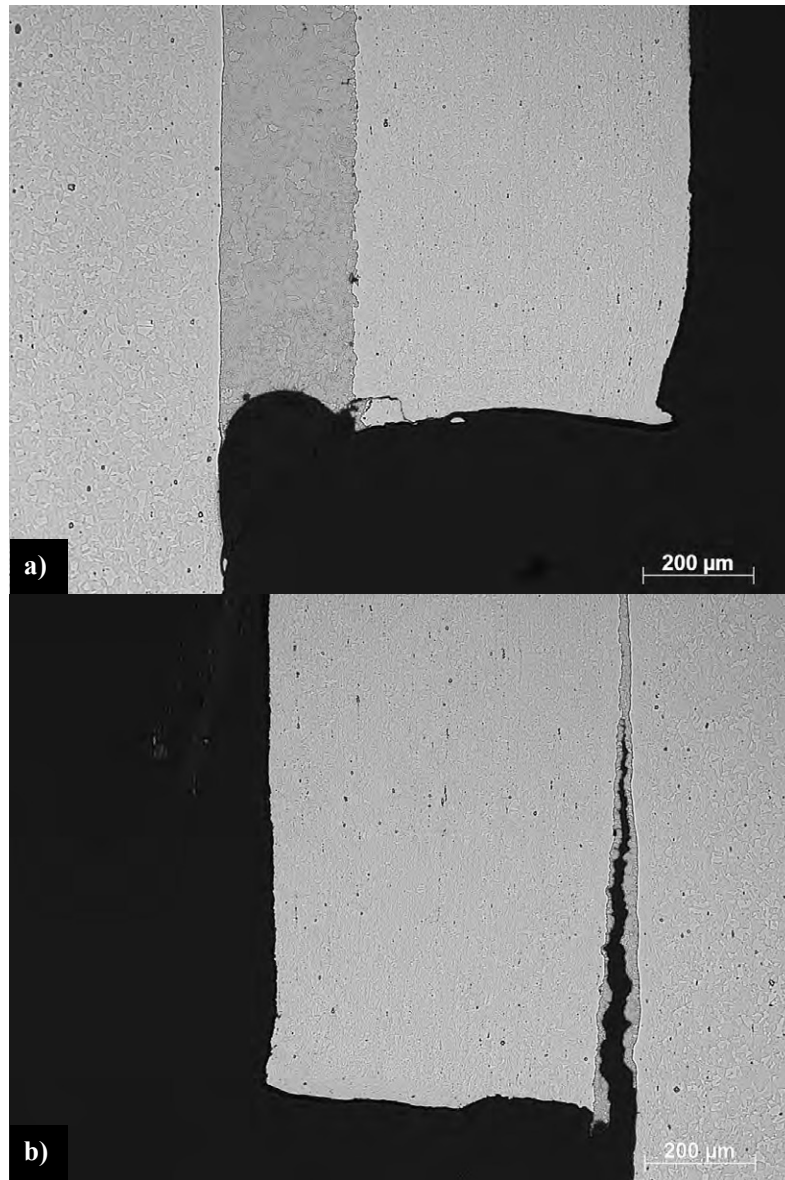
Fig. 19 Higher magnification OM images of fracture surface {1,2} on the a) left and b) right side of the cross-section of tube section 2 (see Fig. 18)

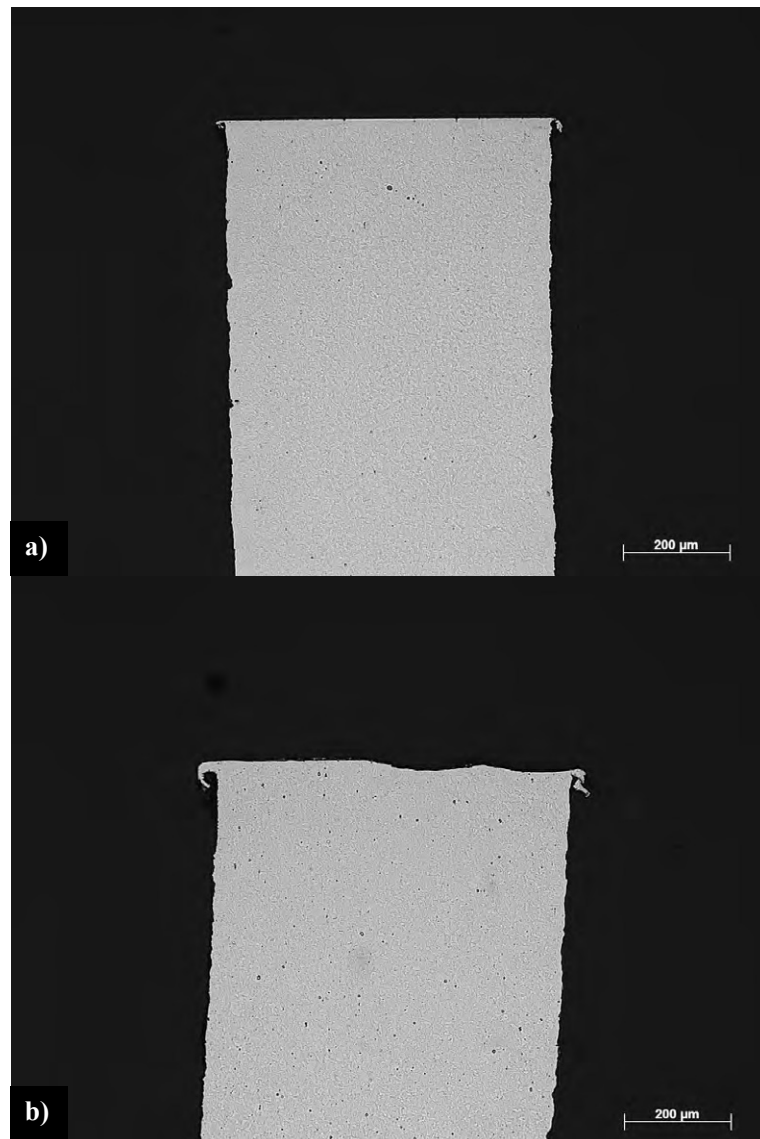
Fig. 20 Higher magnification OM images of the cross-section of the tube on the a) left and b) right side of the cross-section of tube section 2 (see Fig. 18)

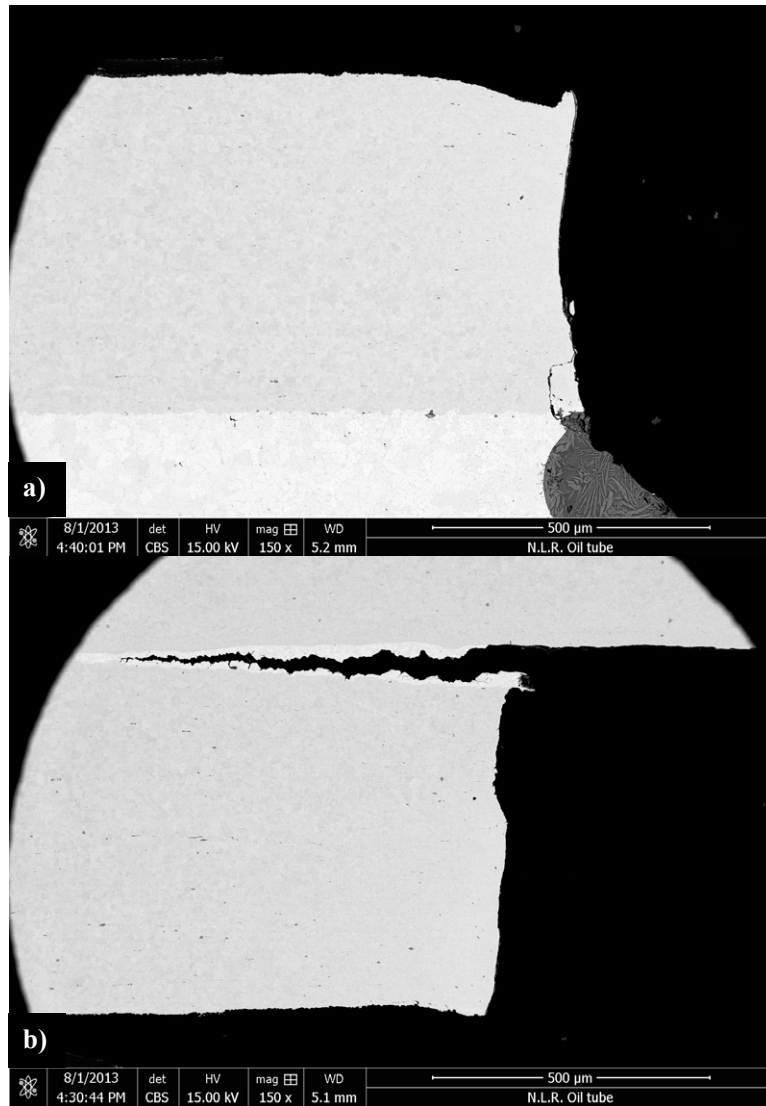
Fig. 22 shows SEM images of the cross-section of fracture surface {1,2}. Fig. 23 shows that a deposit is present on the inside of the tube at exactly the failure and brazing location. Fig. 23 also shows SEM images of the deposit and it can be observed that two different layers of

Fig. 22 SEM images of fracture surface {1,2} on the a) left and b) right side of the cross-section of tube section 2 (see Fig. 18)

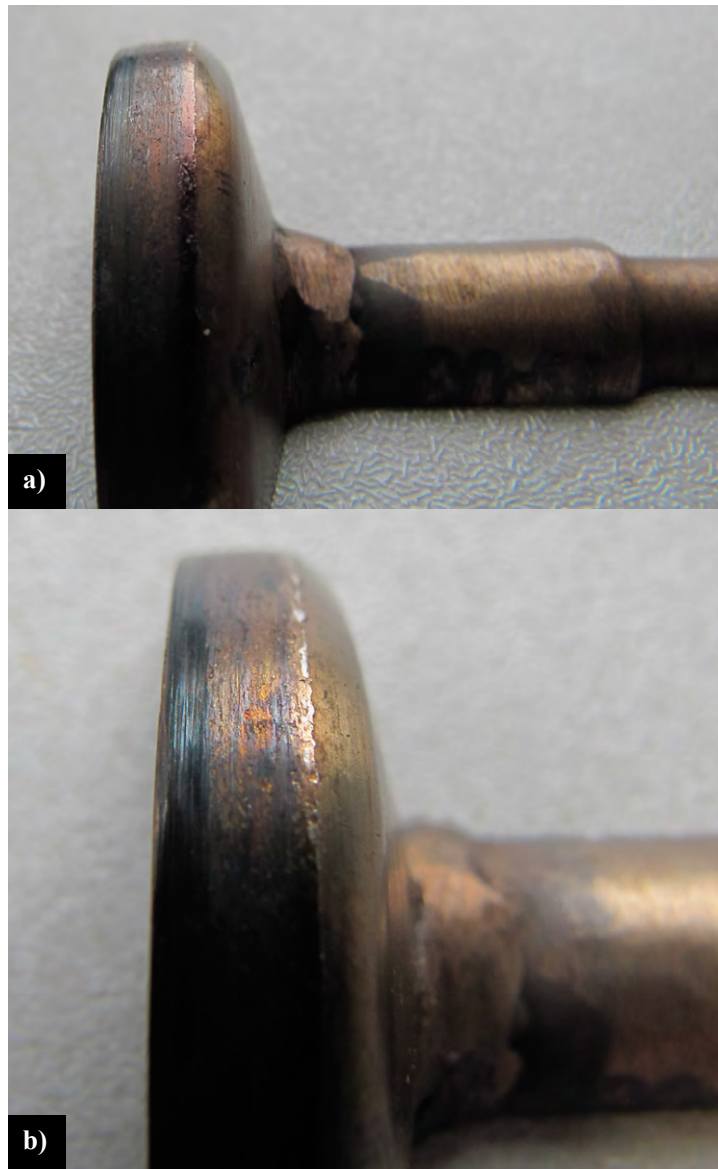
Fig. 14b clearly shows that Fracture 2 is due to torsion and the amount of rotation between the disk in section 2 and the tube end in section 3 is estimated to be $>90^\circ$. No clear rotation is observed in section 1, which means that the disk did not rotate considerably. Fig. 24 shows scratches in the circumferential direction and flattening of the outer edge of the disk, which can indicate that the disk was tightly locked in the shaft. Rotation is also prohibited at the tube end at section 1. It is therefore clear that rotation between the tube ends has occurred and that most of the rotation ended up in section 2. Torsion of section 2 results in shortening of this section. Since the disk does not rotate, the torsion in section 2 results in uniaxial tensile load in section 1. The cross-sections show necking of the cell wall at one side of the tube. Fig. 21a and b show necking of the tube on both sides for other locations around the fracture surface (see Fig. 15 for locations). It is therefore concluded that the tube also failed due to overload at fracture 1.

Fig. 24 Photograph of the outer edge of the disk around the oil tube with slightly different angles a) and b)
