الهيئة العامة للطيران المدني
GENERAL CIVIL AVIATION AUTHORITY

- Final Report -

AIFN/0001/2013

Loss of Control – On Ground

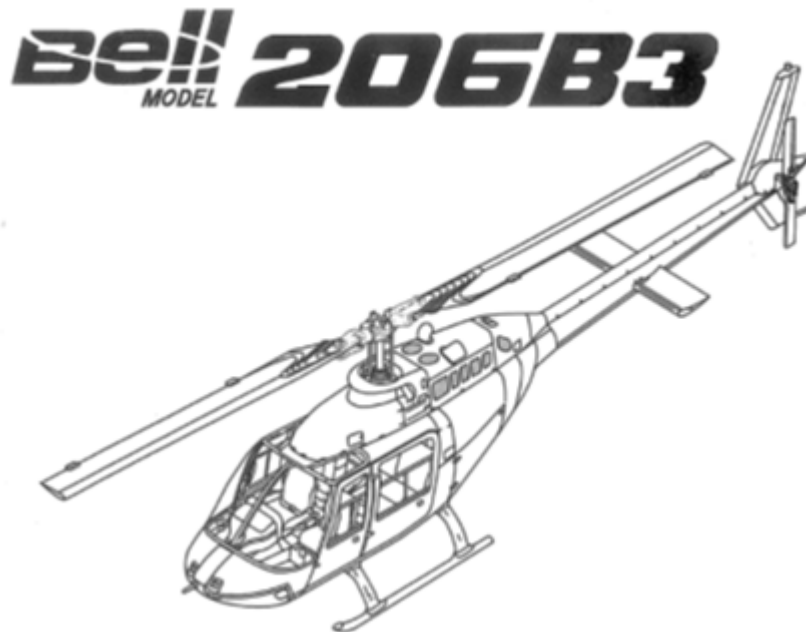
Figure 1: BHT 206-3B

The BHT 206-3B is a single pilot, five place, light helicopter with a two blade semi-rigid main rotor, and a tail rotor that provides directional control.

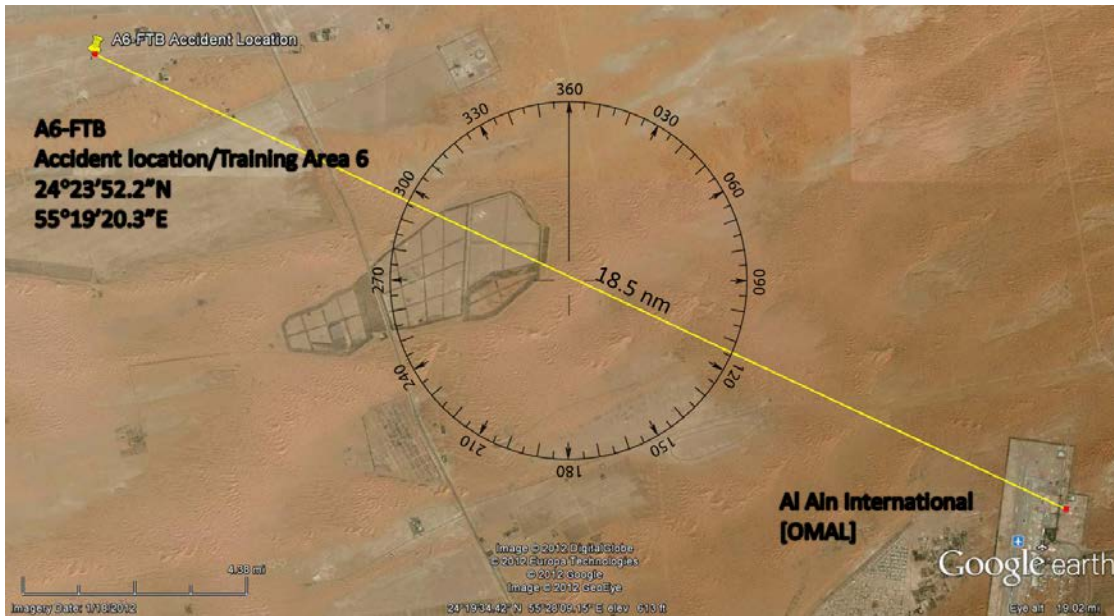
Figure 2 - Google Earth Overview - Accident location/airport proximity

The student was the handling pilot for the departure from Al Ain International Airport [OMAL] to the training area to the north west of the airport designated as Training Area 6 [TA6].

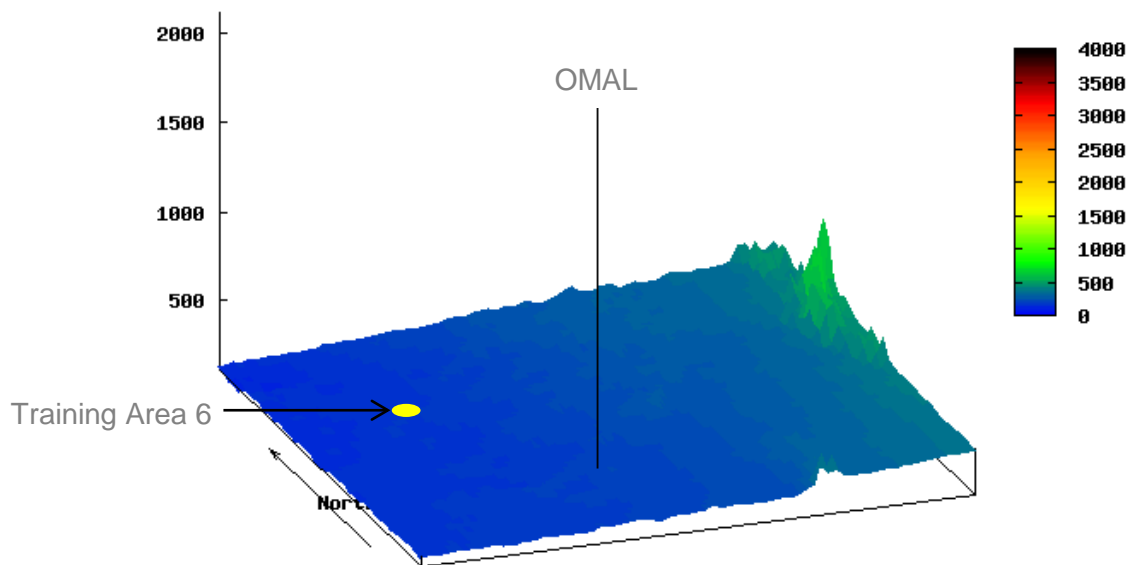
Figure 5: OMAL Aerodrome Elevation and High Ground

Elevation/Reference temperatures 866ft/39°C⁹, with the Geoid undulation at -104ft, at 1003 hPa, gives a corrected value of 1062ft. Based on the observed actual temperatures at the time of the accident [39°C], the DA for the T6 area elevation was approximately 4000ft.

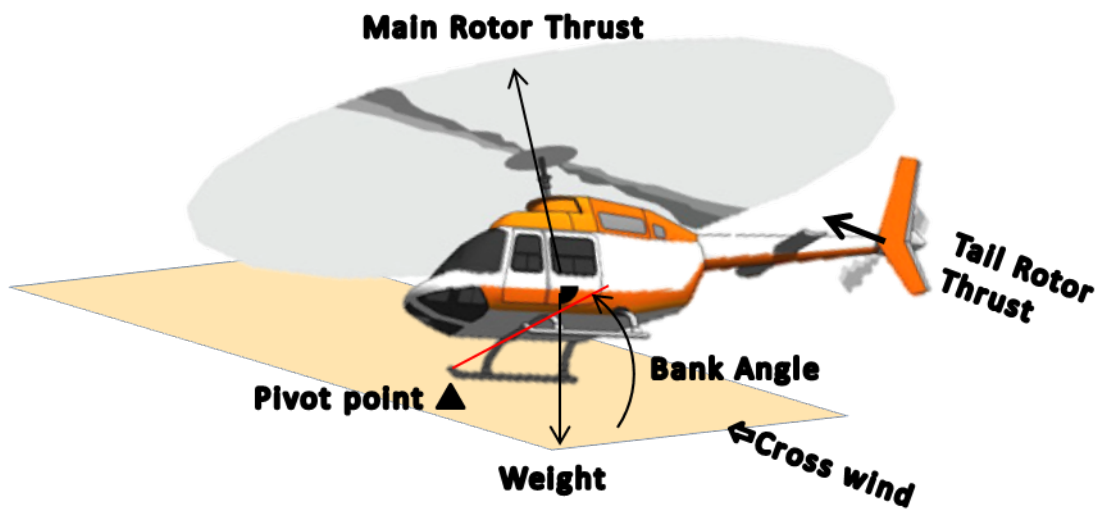
Figure 6: Dynamic Roll Over Force Vector Diagram

The critical rollover angle is further reduced under the following conditions:

- Right Side Skid Down Condition
- Crosswinds
- Lateral Center Of Gravity (CG) Offset to the right in an anticlockwise turning rotor
- Main Rotor Thrust Almost Equal to the Helicopter Weight
- Left Yaw Inputs

If the condition is permitted to develop beyond the critical roll angle, a combination of rotational inertia and coupling moments can lead to a recognised accident causal factor described as Dynamic Roll Over.
