<b>AIRCRAFT ACCIDENT REPORT AND EXECUTIVE SUMMARY</b>
---

Reference:	CA18/2/3/9122	
<b>Aircraft Registration</b>	ZU-BFP	<b>Date of Accident</b>	10 January 2013		<b>Time of Accident</b>	0420Z
<b>Type of Aircraft</b>	Windlass Aquilla		<b>Type of Operation</b>	Commercial		
<b>Pilot-in-command Licence Type</b>	RPL	<b>Age</b>	54	<b>Licence Valid</b>	Yes	
<b>Pilot-in-command Flying Experience</b>	Total Flying Hours	± 1634.98		Hours on Type	± 1228.53	
<b>Last point of departure</b>	Wintervogel Private Airfield (Western Cape Province)					
<b>Next point of intended landing</b>	Wintervogel Private Airfield (Western Cape Province)					
<b>Location of the accident site with reference to easily defined geographical points (GPS readings if possible)</b>						
To the left of the threshold of Runway 08 at Wintervogel Private Airfield at a GPS position of S 33°37'674" E 18°40'947"						
<b>Meteorological Information</b>	<b>Wind:</b> NW / 3kts <b>Visibility:</b> CAVOK <b>Temperature</b> 11°C <b>Cloud Cover:</b> 3/8 to 4/8 <b>Cloud base:</b> 3000ft <b>Dew point:</b> 9.511°C <b>Visibility:</b> CAVOK

## AIRCRAFT ACCIDENT REPORT

**Name of Owner/Operator** : Mr P. Louw  
**Name of Operator** : Aquill

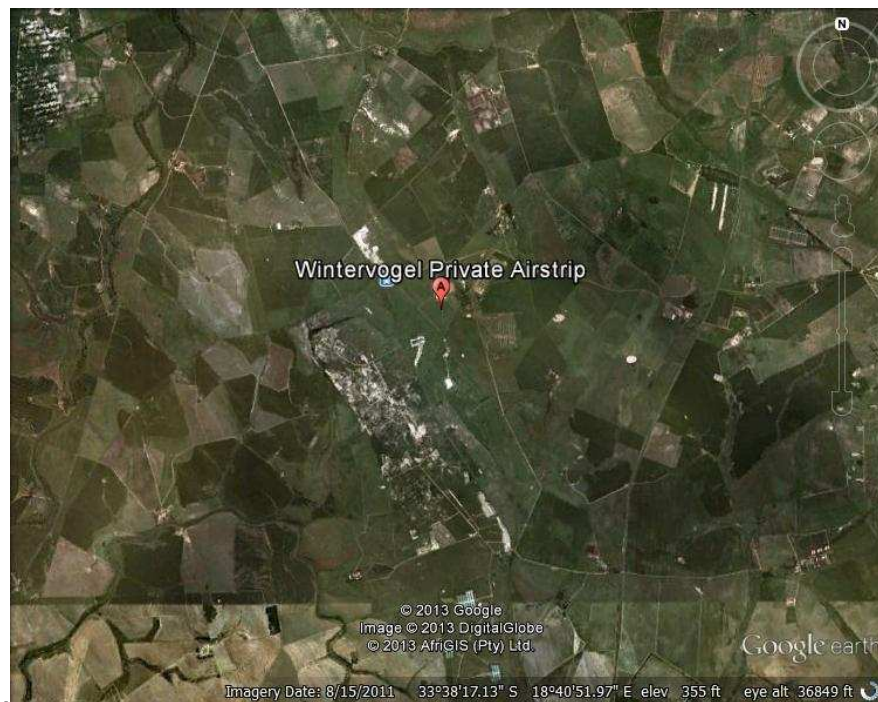
Figure 3: Wintervogel Private Airstrip

- 1.12.1 The wreckage was found at Wintervogel Private Airfield, adjacent to the hangars
