<b>AIRCRAFT ACCIDENT REPORT AND EXECUTIVE SUMMARY</b>
---

Reference:	<b>CA18/2/3/9165</b>	
<b>Aircraft Registration</b>	<b>ZS-OSS</b>	<b>Date of Accident</b>	16 April 2013		<b>Time of Accident</b>	1557Z
<b>Type of Aircraft</b>	DH-82 Tiger Moth		<b>Type of Operation</b>	Private		
<b>Pilot-in-command Licence Type</b>		CPL	<b>Age</b>	54	<b>Licence Valid</b>	YES
<b>Pilot-in-command Flying Experience</b>		Total Flying Hours	870.6		Hours on Type	252
<b>Last point of departure</b>		Mahikeng airport . (FAMM), Mahikeng, North West				
<b>Next point of intended landing</b>		Mahikeng airport . (FAMM), Mahikeng, North West				
<b>Location of the accident site with reference to easily defined geographical points (GPS readings if possible)</b>						
In the Modimola dam, under water. Located 3.4nm bearing 194° from FAMM airport (GPS S25° 51q55+ E025° 31q31+)						
<b>Meteorological Information</b>		Surface wind light and variable, Visibility >10km Temp. 28° Celsius dew point 04° Celsius. Few clouds at 4000 feet. No significant weather reported.

**Name of Owner/Operator** : Pearl Coral 1323 CC  
**Manufacturer** : De Havilland  
**Model** : DH 82  
**Nationality** : South African  
**Registratio

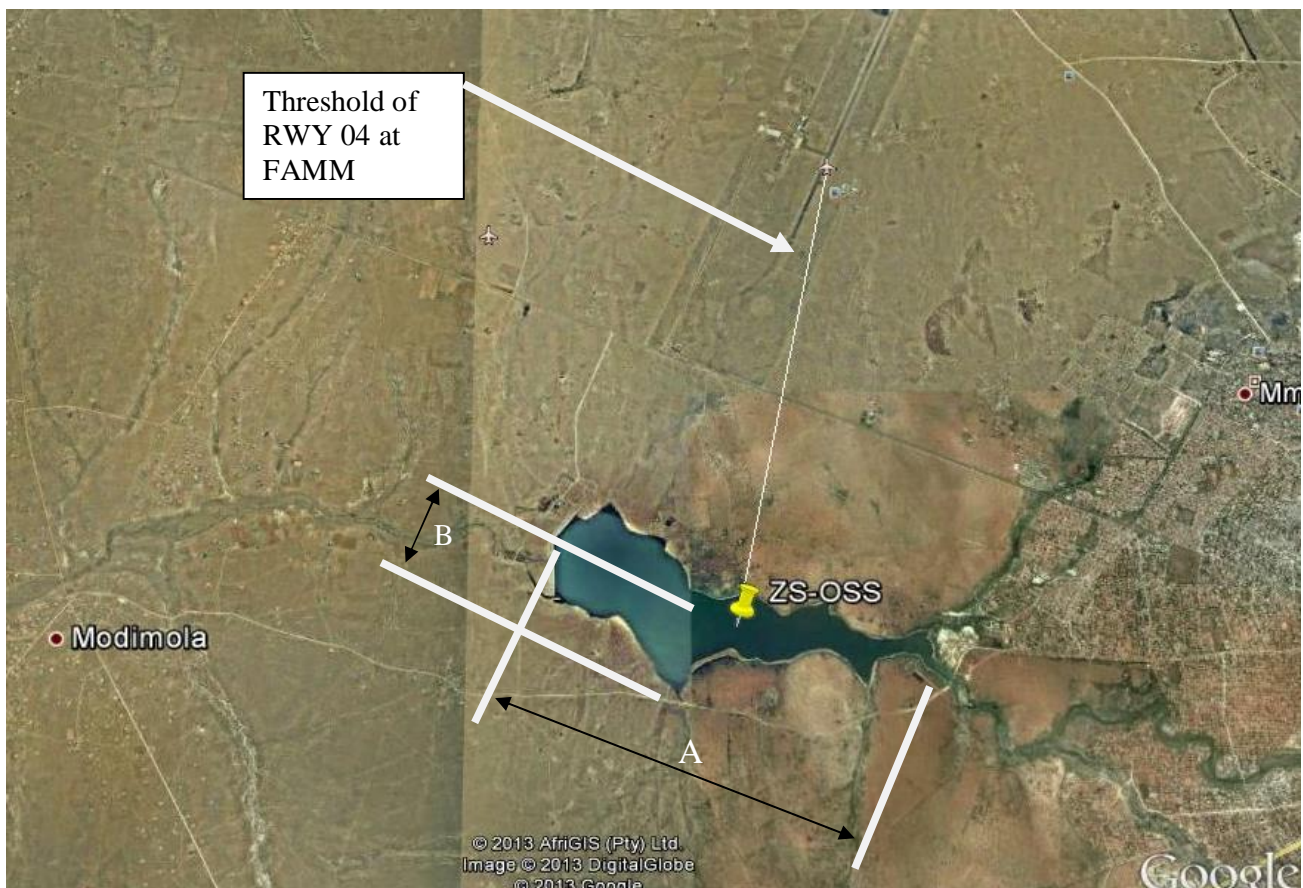
the Modimola Dam, see picture 1 (GPS S25° 51q55+ E025° 31q31+), and would report detail complete and then fly back for landing. That was their last recorded call to ATC. There was no other known traffic in the vicinity of the dam at the time. At 15:58Z the ATC tried at least three times to contact the aircraft but in vain.

**Figure 1:** The dam is situated 3.48nm (6.45km) bearing 194° from Mahikeng airport. Its **length -A-** is 4,137km and the **width -B-** is 1.276km; depth unknown. Elevation is 4041 ft. AGL
