Islamic Republic of IRAN
Civil Aviation Organization

Incident Final Report

State File Number: I139201299MXAC
Type of Occurrence: Incident (RWY Excursion)
Date of Occurrence: April 18th 2013
Place of Occurrence: I.R.IRAN
Aircraft Type: A340-300
Registration: 9M-XAC
Operator: Air Asia

State File Number: I139201299MXAC
Type of occurrence: Incident (Runway Excursion)
Date of occurrence: April 18th 2013
Place of occurrence: on RWY 30L, Tabriz INTL Airport (OITT) Islamic republic of Iran
Aircraft Model: A340-300
Registration: 9M-XAC
Operator: Air Asia
Lessor: Saudi Arabian Airlines

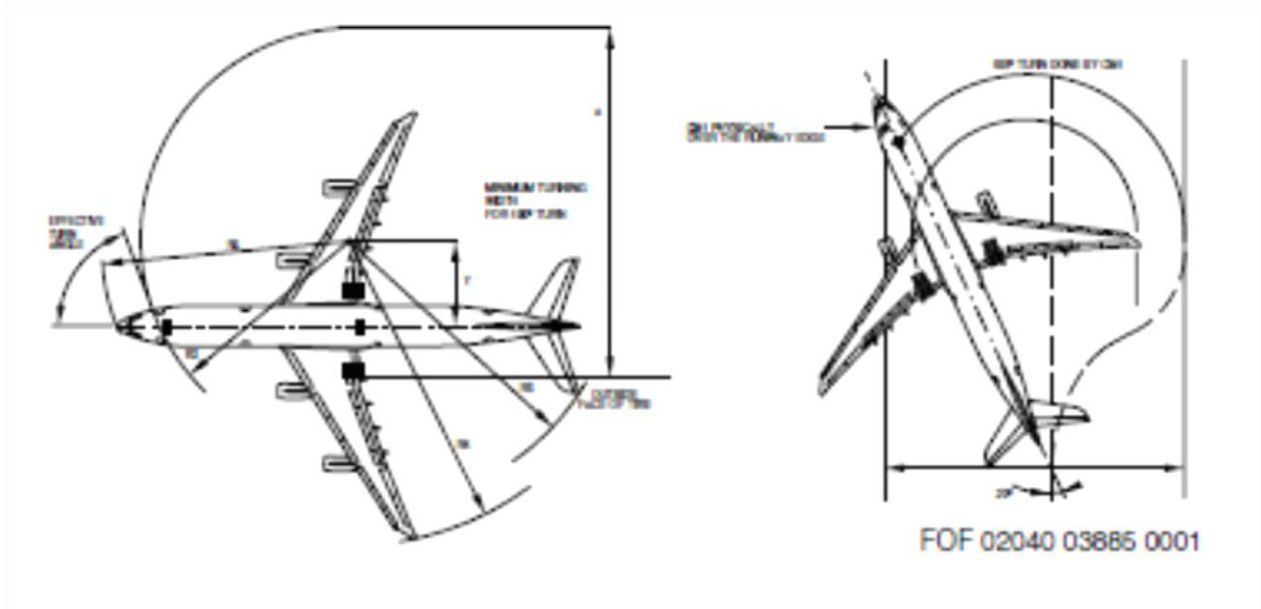
AIRCRAFT DIMENSIONS

With the maximum nose wheel steering angle (72 °), the actual turn width (**without margin**) is [...] 45 m for an A340-300.” This distance is based on the attached procedure provided in the FCOM and considering favorable circumstances, in particular dry and good condition runway.

❖ *Therefore, to verify the required runway width, some margins must be added to the turn width considering in particular the runway condition.*

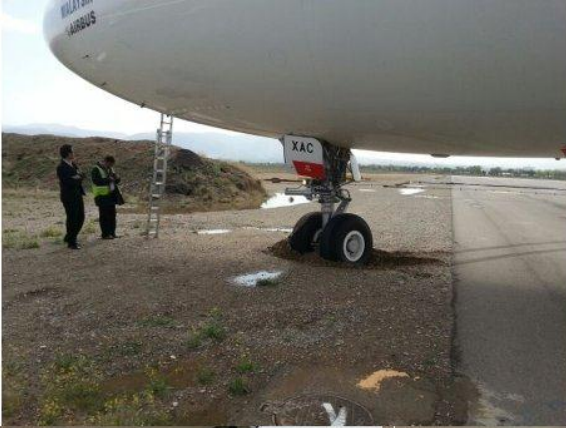
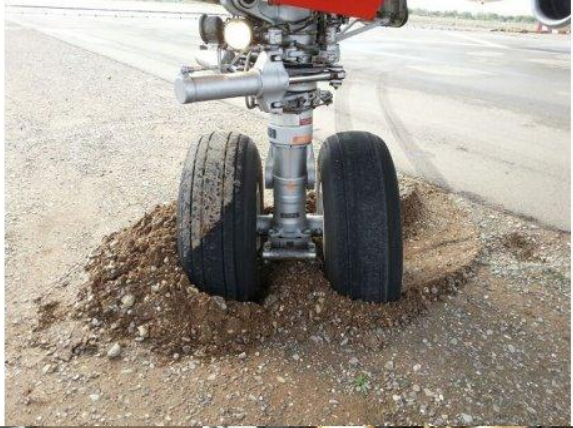
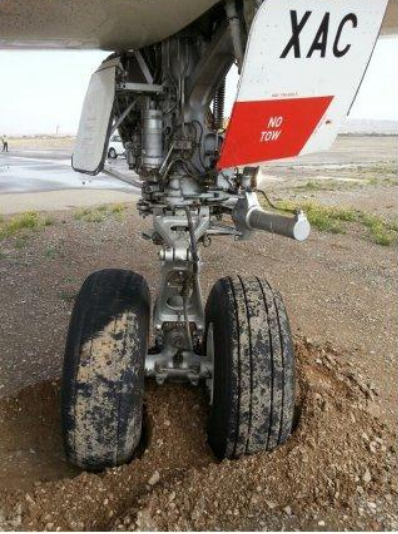
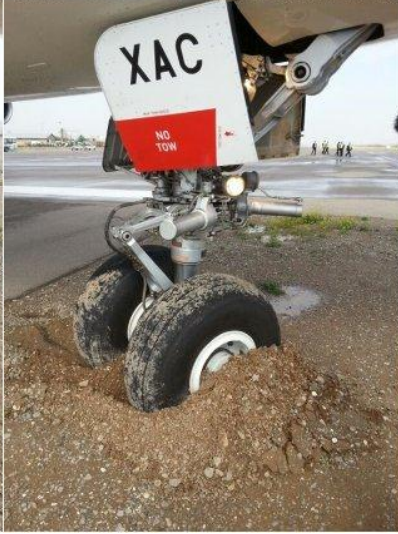
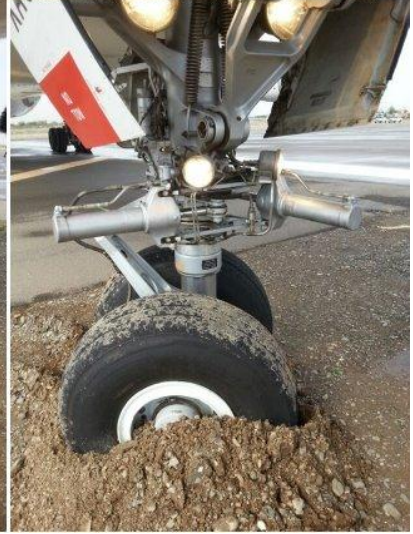
- ✓ Captain requested the travelling engineer to visually inspect the condition on ground, through the aircraft Avionics Compartment Access Door.
- ✓ Then it was discovered that the aircraft nose wheel was already out of the hard surface and landed on soft ground.
