<b>AIRCRAFT ACCIDENT REPORT AND EXECUTIVE SUMMARY</b>
---

Reference:	CA18/2/3/9174	
<b>Aircraft Registration</b>	<b>ZS-CBW</b>	<b>Date of Accident</b>	24 May 2013		<b>Time of Accident</b>	1100Z
<b>Type of Aircraft</b>	Mooney M20E (Aeroplane)		<b>Type of Operation</b>	Private Flight		
<b>Pilot-in-command Licence Type</b>		Private Pilot	<b>Age</b>	41	<b>Licence Valid</b>	Yes
<b>Pilot-in-command Flying Experience</b>		Total Flying Hours	102.8		Hours on Type	74.1
<b>Last point of departure</b>		Springs aerodrome ( FASI): Gauteng Province				
<b>Next point of intended landing</b>		Heidelberg aerodrome (FAHG): Gauteng Province				
<b>Location of the accident site with reference to easily defined geographical points (GPS readings if possible)</b>						
300m from the threshold of Runway 24 at FAHG (GPS position: 26°30' 05" South 28°23' 41" East)						
<b>Meteorological Information</b>		Temperature:23°C , Dew point:1°C , Surface wind:120°01kts,Gusting 12kts

<b>AIRCRAFT ACCIDENT REPORT</b>
---------------------------------

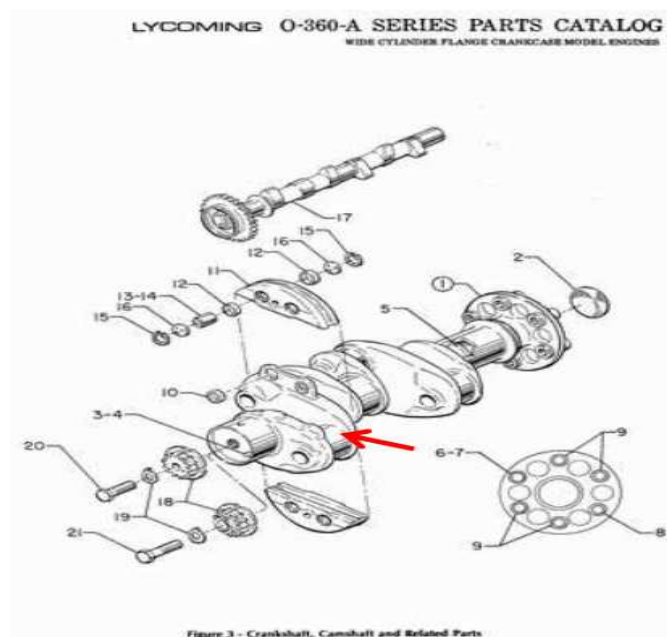
**Figure 4:** Typical Lycoming Crankshaft Assembly for 0-360 series engine

1.16.2.1 The fracturing of the crankshaft caused the engine failure, and the engine stopped rotating very shortly after the separation occurred.

1.16.3 The crankshaft was subjected for metallurgical analysis, a stereo and scanning electron microscope investigation was completed on the crankshaft to determine the cause of the failure. The investigation revealed the following:

- A fracture corresponding with a fatigue mode failure under conditions of high frequency and low load.
- The position of the point initiation proved to be in the radius area of the number 4 connecting rod big end bearing journal.
- The fatigue failure progressed over an undetermined period of operational time.
