AIRCRAFT ACCIDENT REPORT AND EXECUTIVE SUMMARY

Reference:	CA18/2/3/9182	
Aircraft Registration	V5-SMA	Date of Accident	04 June 2013		Time of Accident	1335Z
Type of Aircraft	Beechcraft King Air E90		Type of Operation	Training		
Pilot-in-command Licence Type	Airline Transport	Age	70	Licence Valid	Yes	
Pilot-in-command Flying Experience	Total Flying Hours	21107		Hours on Type	51	
Student pilot Licence Type	Commercial	Age	33	Licence Valid	Yes	
Student Pilot Flying Experience	Total Flying Hours	585		Hours on Type	6.1	
Last point of departure	Lanseria international airport (FALA): Gauteng province.					
Next point of intended landing	Rustenburg aerodrome (FARG):North West province.					
Location of the accident site with reference to easily defined geographical points (GPS readings if possible)						
On Runway 34 at Rustenburg aerodrome GPS coordinates determined to be S25°38' 40.67 E027°16'24.82 at an elevation of 3 671 feet above mean sea level (AMSL).

AIRCRAFT ACCIDENT REPORT

Name of Owner/Operator : Wings Over Africa CC
Manufacturer : Beech Aircraft Corporation
Model : Beechcraft King Air E90
Nationality : Namibian
Registration Marks : V5-SMA
Place : Rustenburg Aerodrome
Date : 04

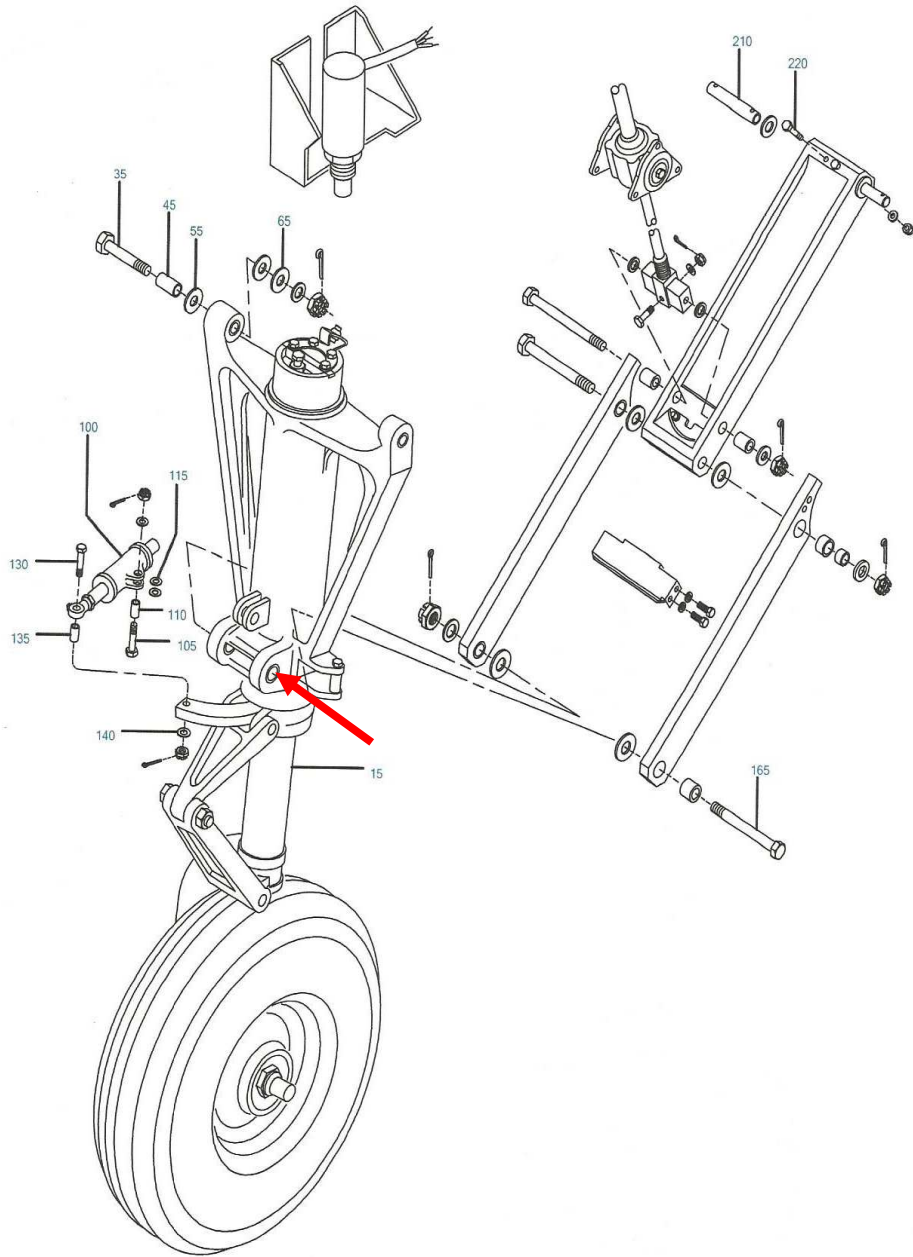
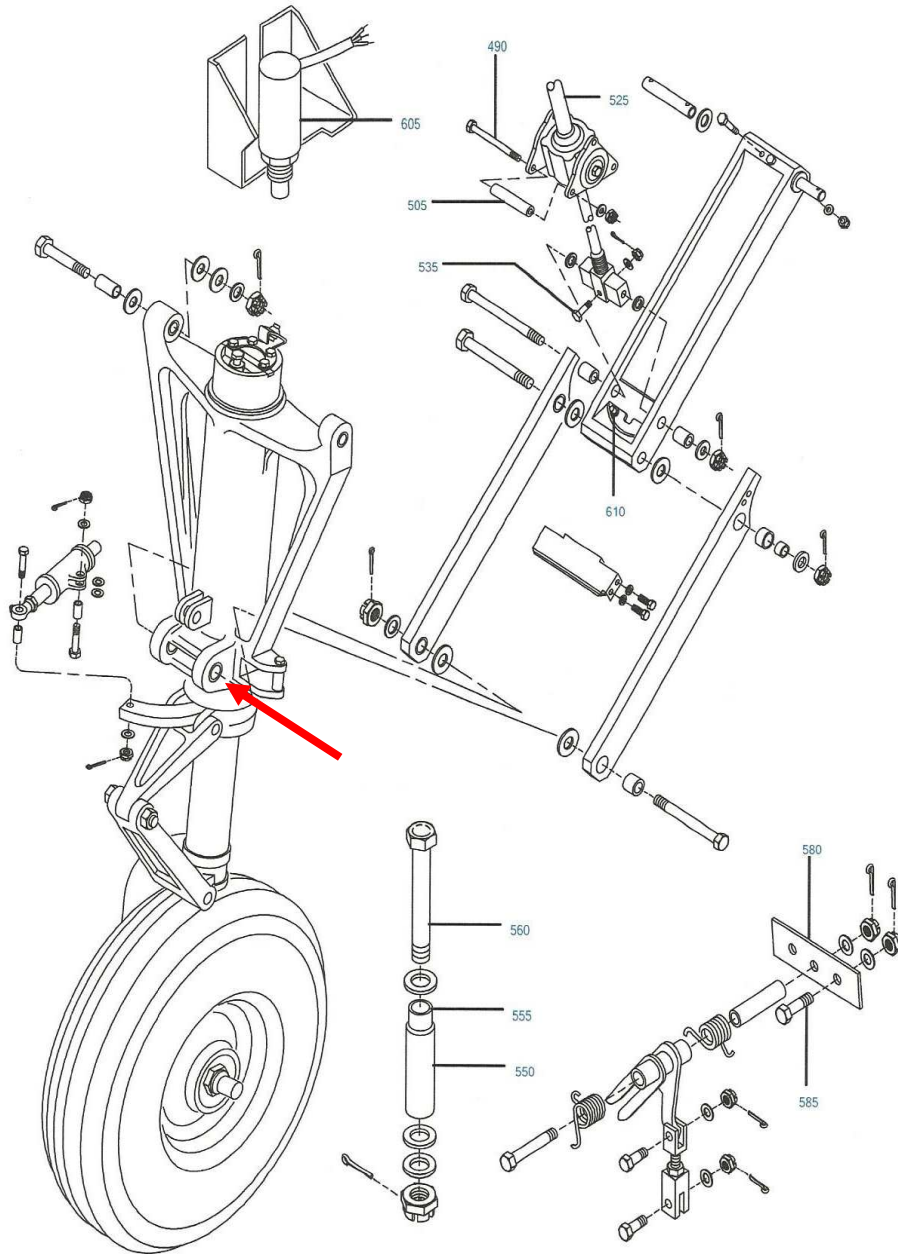
2.6 The wreckage was examined to determine the cause of the nose landing gear failure. The evidence found showed that the nose gear drag brace bracket failed during the last landing, debris of the drag brace bracket was recovered from the accident scene and sent for metallurgical testing and analysis. Refer to the Appendix "B"

2.7 The metallurgical testing and analysis revealed that neither fracture surfaces found on the drag brace bracket debris showed any sign of pre-existing defects. The drag brace bracket showed surface characteristics of the part failing quite rapidly. The fracture surfaces indicated that the failure occurred as a result of a severe, transient overload. There was no evidence of fatigue or material imperfection that was visually apparent on any of the fractures examined. However the conclusion was that the aircraft could have been exposed to a hard landing or subsequent bouncing which caused the drag brace bracket to fail.

- 3.1.6 The evidence found showed that the landing gear failure was as a result of the nose gear drag brace bracket that failed/broke while landing.
- 3.1.7 The nose drag brace bracket that failed was taken for metallurgical testing and analysis to determine its cause. The metallurgical analysis revealed that the part failed due to metal fatigue from overload.
