AIRCRAFT ACCIDENT REPORT AND EXECUTIVE SUMMARY

Reference:	CA18/2/3/9196	
Aircraft registration	ZU-FVY	Date of accident	16 July 2013		Time of accident	0945Z
Type of aircraft	Van's RV-7A (Aeroplane)		Type of operation	Private		
Pilot-in-command licence type	Private pilot		Age	64	Licence valid	Yes
Pilot-in-command flying experience	Total Flying Hours		661,0		Hours on type	55,0
Last point of departure	Baragwanath aerodrome (FASY), Gauteng province					
Next point of intended landing	Baragwanath aerodrome (FASY), Gauteng province					
Location of the accident site with reference to easily defined geographical points (GPS readings if possible)						
1,5 km from the threshold of runway 31 at FASY (GPS position: 26°21.297' South 027°47.905' East)						
Meteorological information	Surface wind: 230%5 knots, Temperature: 20°C, Visibility: + 10 km					
Number of people on board	1 + 0	No. of people injured	1	No. of people killed	0	
Synopsis	<p>The pilot, being the sole occupant onboard the aircraft was engaged in a private flight from Tedderfield aerodrome to Baragwanath aerodrome where he executed one touch-and-go, making use of runway 31. While positioning the aircraft for a second touch-and

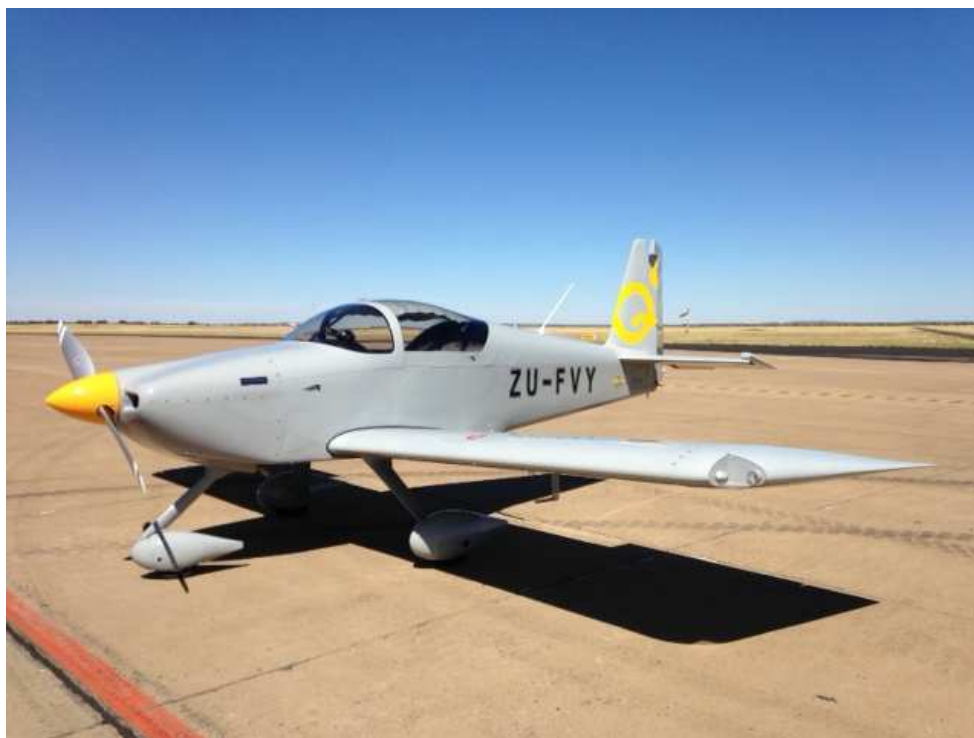
Figure 2. A view of the aircraft ZU-FVY.

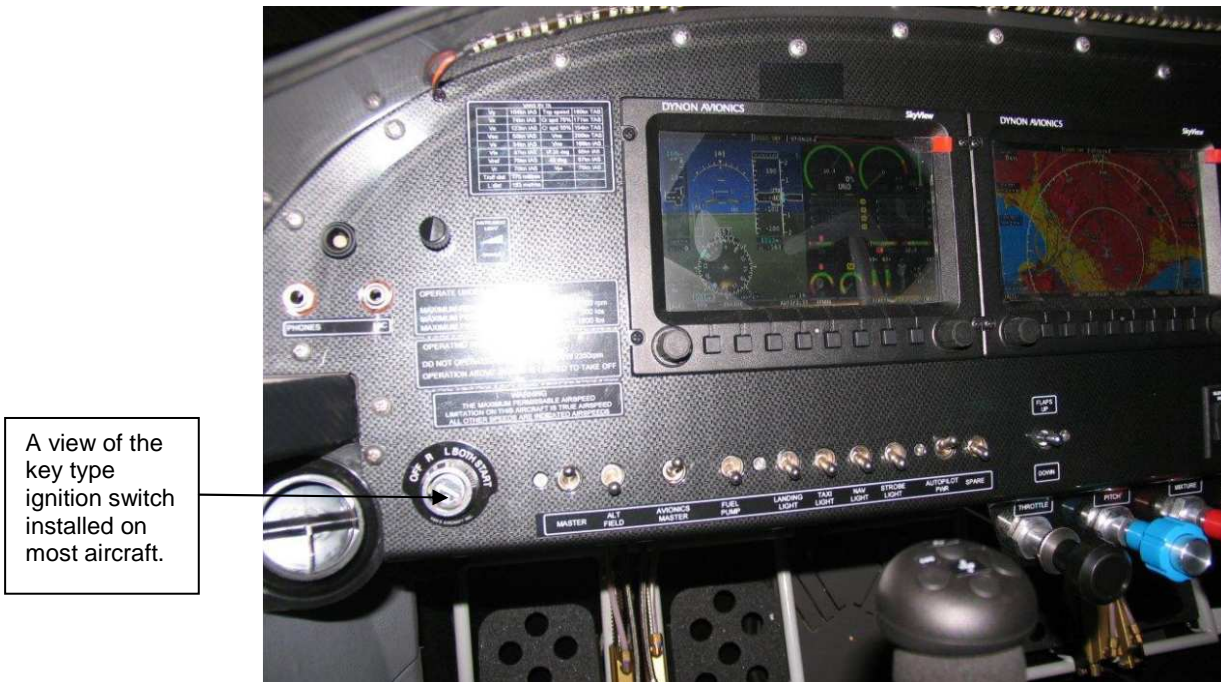
Figure 5. A view of the layout of the switches that was opted for by another owner, similar type of aircraft.

The aircraft owner, who was also the pilot at the time of the accident flight, had opted to install Dynon Skyview EFIS instrumentation and further to that he opted for an array of 'non standard' switches (meaning switches that did not form part of the aircraft kit as made available by the manufacturer). The switches he opted for excluded the installation of the key type ignition switch, which comes standard with the aircraft kit. The switch layout he opted for instead allowed for a separate 'Battery Masters' switch as well as a two separate magneto switches (left and right) as can be seen in figure 4, page 9 of this report.
