AIRCRAFT ACCIDENT REPORT AND EXECUTIVE SUMMARY
--

Reference:	CA18/2/3/9199	
<b>Aircraft Registration</b>	ZS-CAP	<b>Date of Accident</b>	18 July 2013		<b>Time of Accident</b>	0730Z
<b>Type of Aircraft</b>	Cirrus SR20		<b>Type of Operation</b>		Training (Check flight)	
<b>Pilot-in-command Licence Type</b>	Commercial Pilot		<b>Age</b>	24	<b>Licence Valid</b>	Yes
<b>Pilot-in-command Flying Experience</b>	<b>Total Flying Hours</b>		1 637,5		<b>Hours on Type</b>	777,3
<b>Private Licence Type</b>	Private Pilot		<b>Age</b>	19	<b>Licence Valid</b>	Yes
<b>Private Pilot Flying Experience</b>	<b>Total Flying Hours</b>		55,6		<b>Hours on Type</b>	50,8
<b>Last point of departure</b>	Lanseria International Airport (FALA), Gauteng Province					
<b>Next point of intended landing</b>	Lanseria International Airport (FALA), Gauteng Province					
<b>Location of the accident site with reference to easily defined geographical points (GPS readings if possible)</b>

## AIRCRAFT ACCIDENT REPORT

**Name of Owner/Operator** : CDC Aviation (PTY) LTD  
**Manufacturer** : Cirrus  
**Model** : SR20  
**Nationality** : South Africa  
**Registration Marks** : ZS-CAP  
**Place** : Farm Bultfontein, Muldersdrift

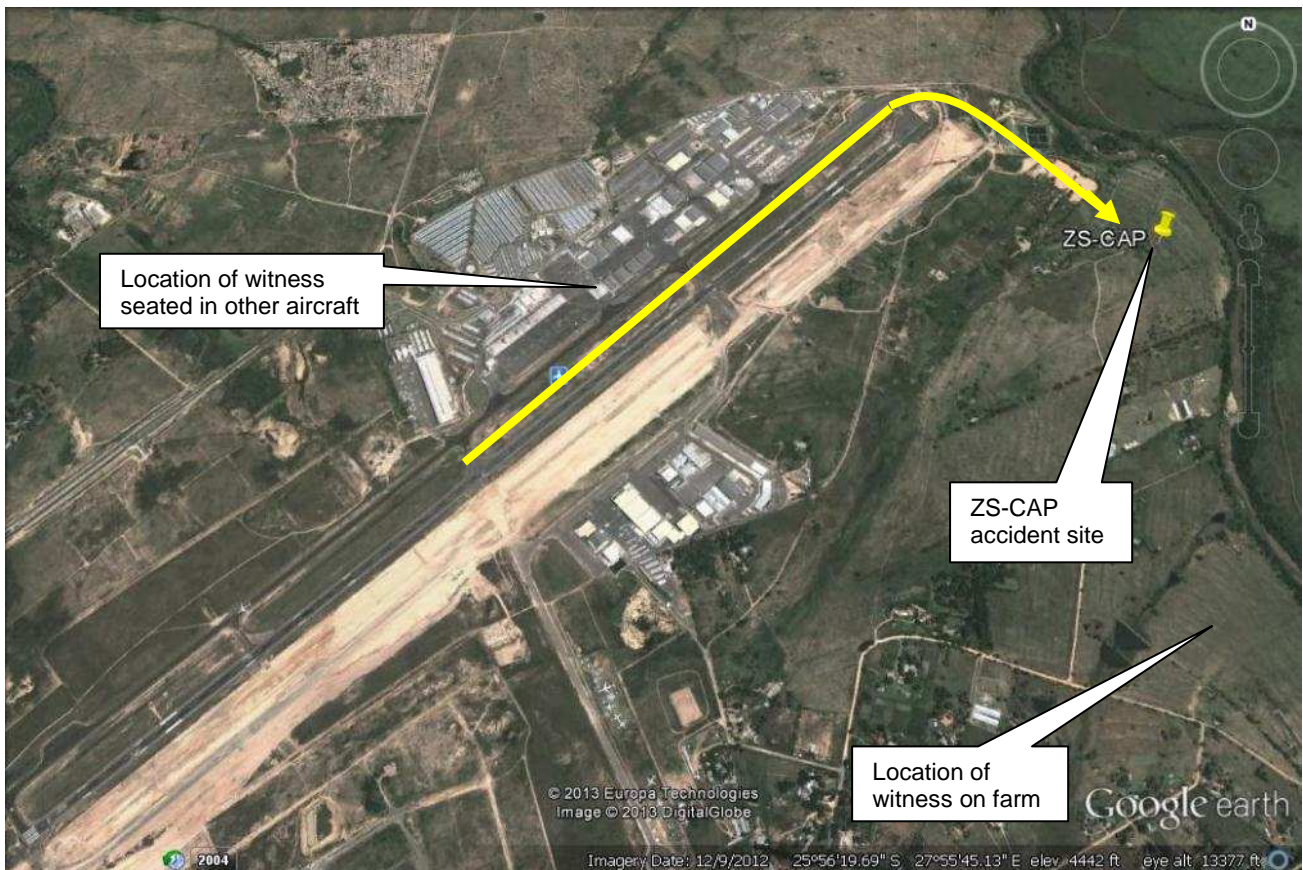
Figure 1: Google Earth view of the area and flight path

- 1.1.5 Another witness, who was walking on the farm Bultfontein where the accident occurred, saw the aircraft at approximately 50 feet above ground level (AGL) when its nose pitched down, followed by the deployment of the ballistic parachute. The aircraft impacted the ground on the private farm Bultfontein at approximately 0730Z. Bultfontein borders on the eastern boundary of FALA, and the accident occurred approximately 500 m from its north-eastern boundary at GPS coordinates S 25°55,986, E 027°56,628 at 4 327 feet elevation. The accident occurred during daylight conditions.

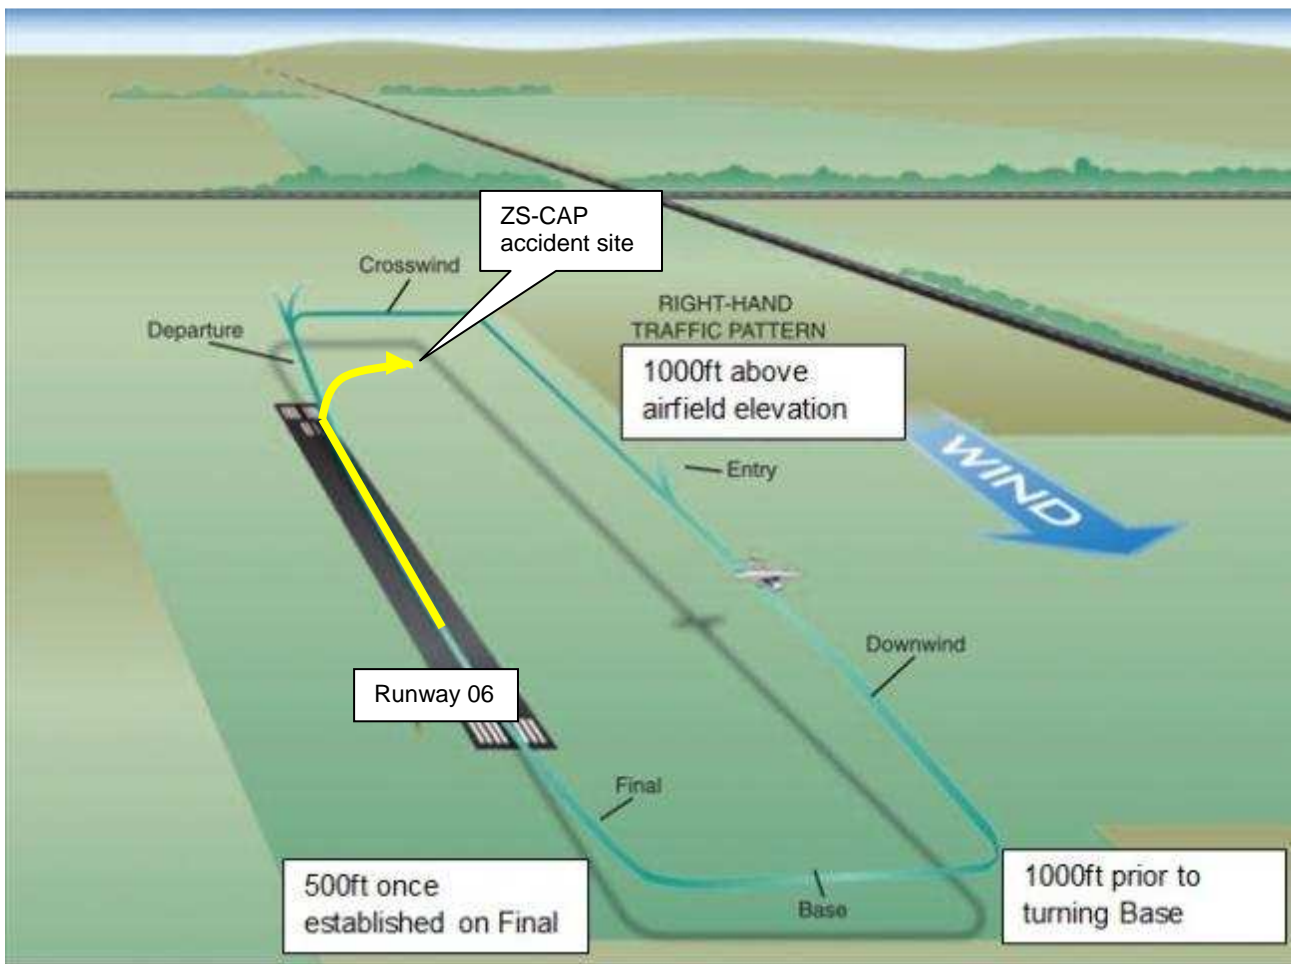
Figure 2: Illustration of the flight path

- 1.12.1 The aircraft was observed banking sharply to the right onto the crosswind leg and rolling level. The aircraft was then seen diving sharply towards the ground followed by the deployment of the ballistic parachute.

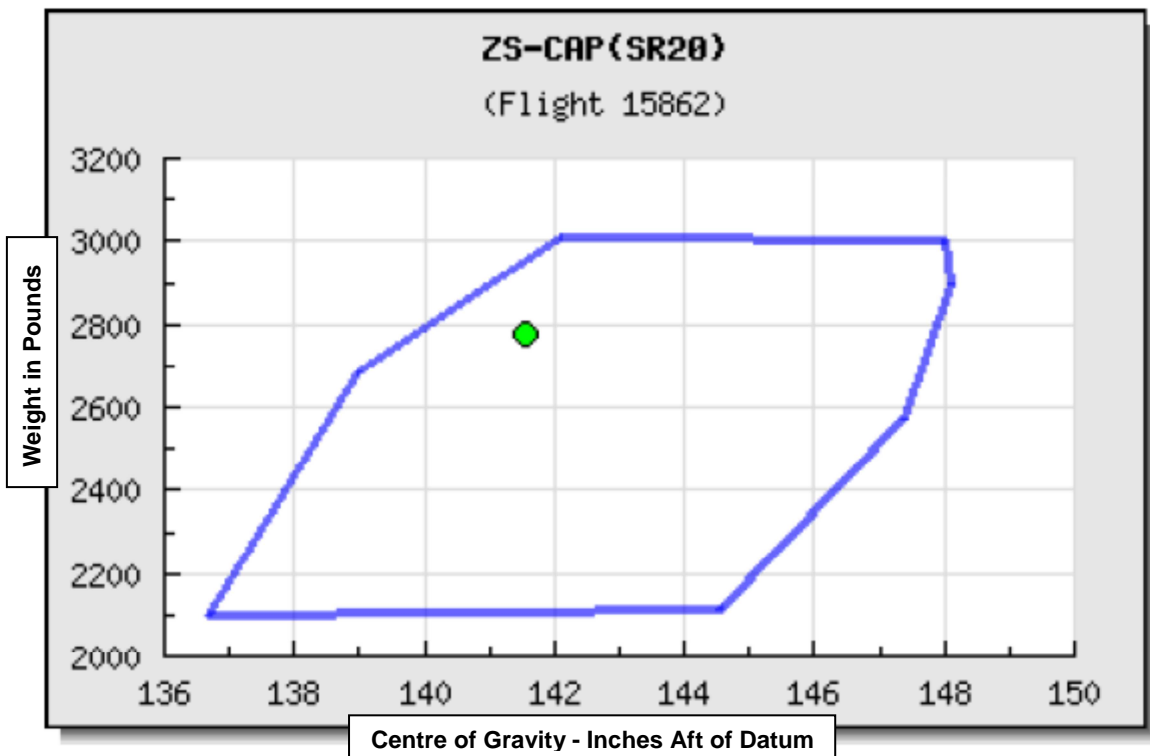
Figure 6: Centre of gravity calculation of the aircraft, represented by the green dot

b) The centre of gravity of the aircraft was also within limits as seen in Figure 6.

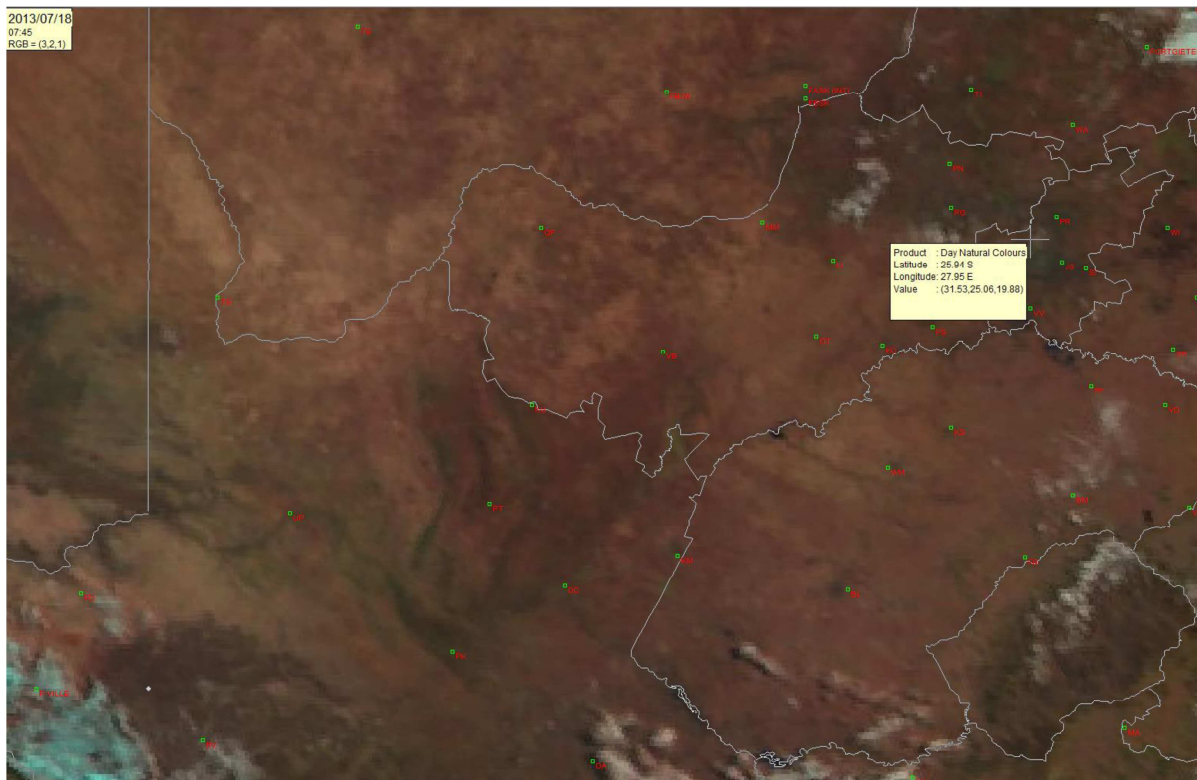
**Figure 7:** Satellite image of the weather in the area

- i. *The satellite image in Figure 7 shows patches of low cloud over the accident area (see the marked area on the satellite image). FALA, which is the closest weather station to the accident area, was reporting few clouds (1-2 oktas) at 1 500 ft AGL and visibility  $\geq$  9 km closest to the time of accident (see METARs provided).*
- ii. *Surface data*  
*FALA is the closest reporting weather station (see METARs). The 0800Z METAR closest to the time of accident contains the following weather variables:*

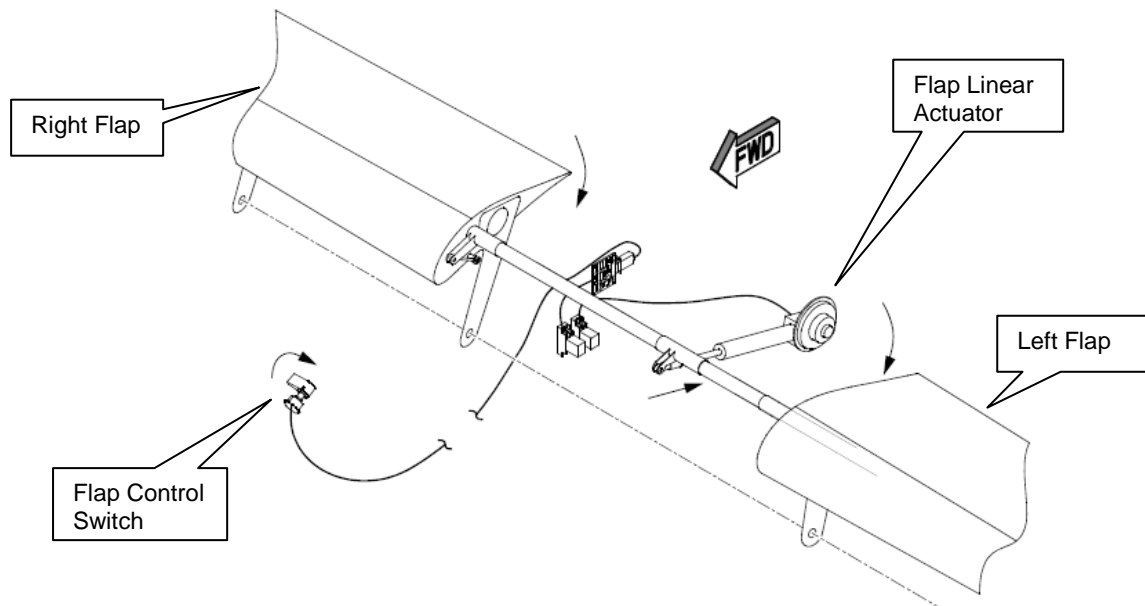
**Figure 15:** Illustration of the flap system

c) Flap Linear Actuator on ZS-CAP

The flap linear actuator was found in the extended position and removed for further investigation.
