| AIRCRAFT INCIDENT REPORT AND EXECUTIVE SUMMARY |

| | | | | Reference: | CA18/3/2/0999 | |
| Aircraft Registration | ZS-SMJ | Date of Accident | 10 September 2013 | | Time of Accident | 1848Z |
| Type of Aircraft | Boeing 737-300 | | Type of Operation | | Commercial – Cargo | |

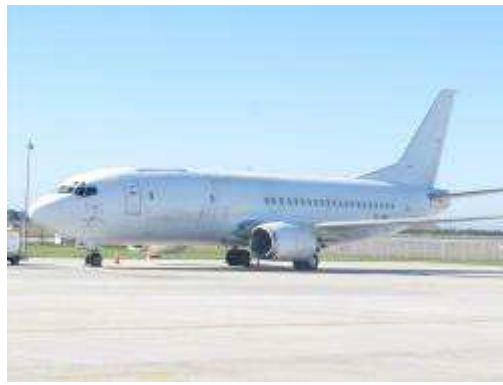
1.12.1 The aircraft landed safely at FACT and did not sustain any damage.

Figure 2: Aircraft parked at FACT after the incident.

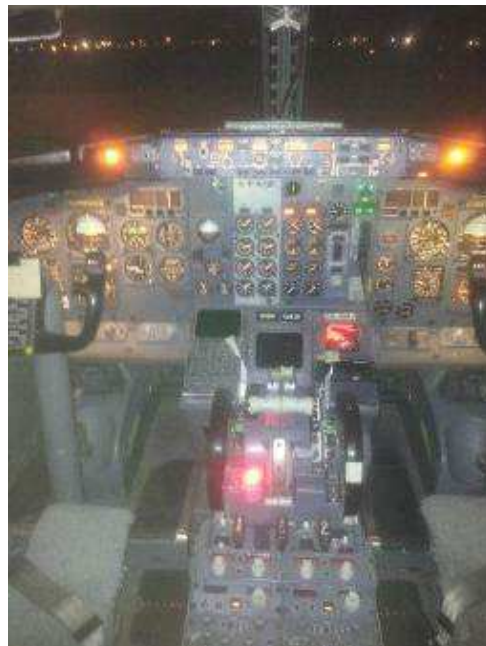
Figure 3: ZS-SMJ cockpit.
