<b>AIRCRAFT ACCIDENT REPORT AND EXECUTIVE SUMMARY</b>
---

Reference:	CA18/2/3/9235	
<b>Aircraft Registration</b>	ZU-FLE	<b>Date of Accident</b>	24 October 2013		<b>Time of Accident</b>	1002Z
<b>Type of Aircraft</b>	YAK-18T (Fixed Wing)		<b>Type of Operation</b>		Private	
<b>Pilot-in-command Licence Type</b>		Private Pilot	<b>Age</b>	40	<b>Licence Valid</b>	Yes
<b>Pilot-in-command Flying Experience</b>		Total Flying Hours	2980.0		Hours on Type	63.35
<b>Last point of departure</b>		Stellenbosch Aerodrome (FASH) in Western Cape Province				
<b>Next point of intended landing</b>		Stanford in Western Cape Province				
<b>Location of the accident site with reference to easily defined geographical points (GPS readings if possible)</b>						
On Ingwi Farm, 100 m outside the boundary of Stellenbosch Aerodrome (FASH) in Western Cape Province						
<b>Meteorological Information</b>		Wind direction:210°, Wind Speed: 11 knots, Temperature: 25°C, Visibility: CAVOK.

## AIRCRAFT ACCIDENT REPORT

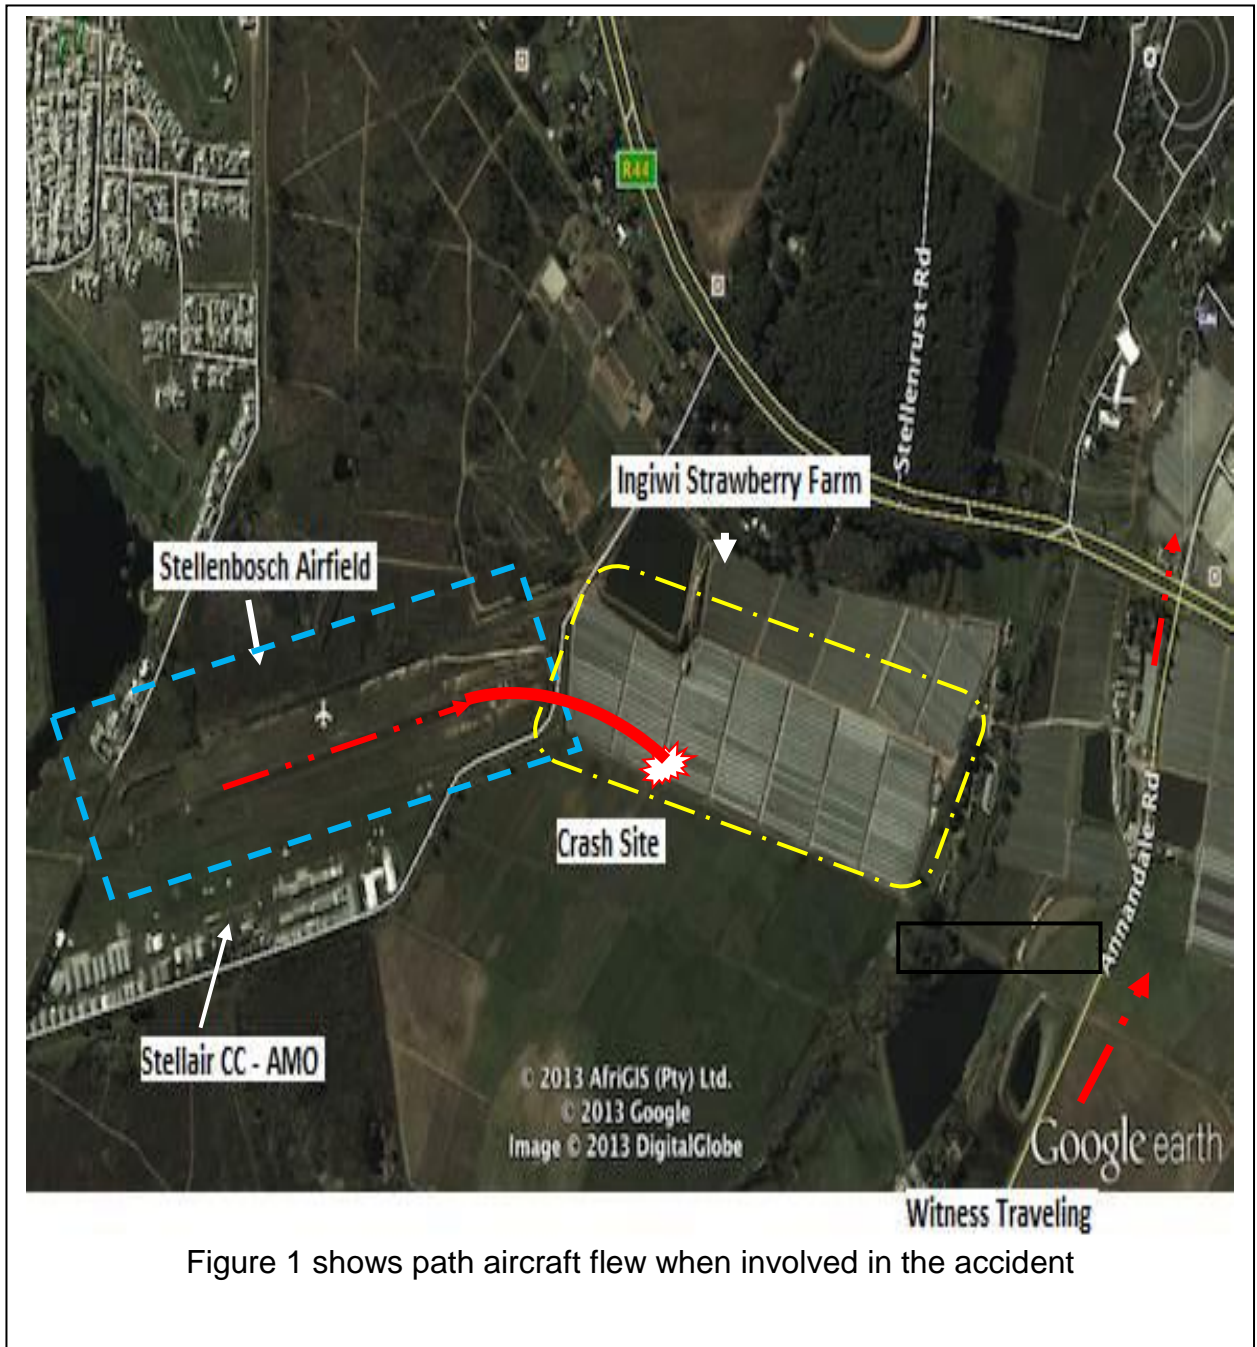
While he was still speaking to the golfers he could hear the affected aeroplane becoming airborne as indicated by the change in its engine noise. About a minute or so later they heard the engine “stuttering” and “cutting out” for 3 seconds, but it started running again. A second later the engine was cutting out again. He was not sure whether after this second cut out the engine started running again; however, he told the golfers that the aeroplane was in serious trouble. A couple of seconds later they heard a loud bang and five minutes later saw the cloud of smoke coming from the southern side of the airstrip. See below a picture of Google Map created to show what the witnesses have stated.

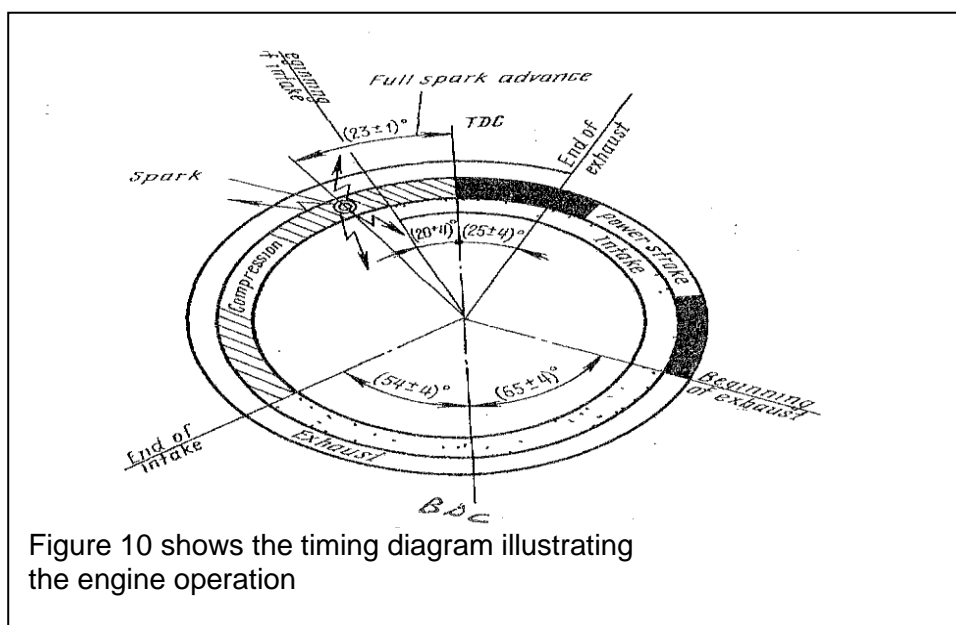
Timing Angle (Cylinder No 4), beginning of admission before TDC should be  $(20 \pm 4)^\circ$ , end of admission after BDC to be  $(54 \pm 4)^\circ$ , beginning of exhaust before BDC to be  $(65 \pm 4)^\circ$  and end of exhaust after TDC to be at  $(25 \pm 4)^\circ$ .

**NB:** The advance angle for LH and RH magneto (before TDC at end of compression stroke) should be  $(23 \pm 1)^\circ$ .
