ESTONIAN SAFETY INVESTIGATION BUREAU

INVESTIGATION REPORT

SE-FVP SERIOUS INCIDENT IN KÄRDLA ON 28.10.2013

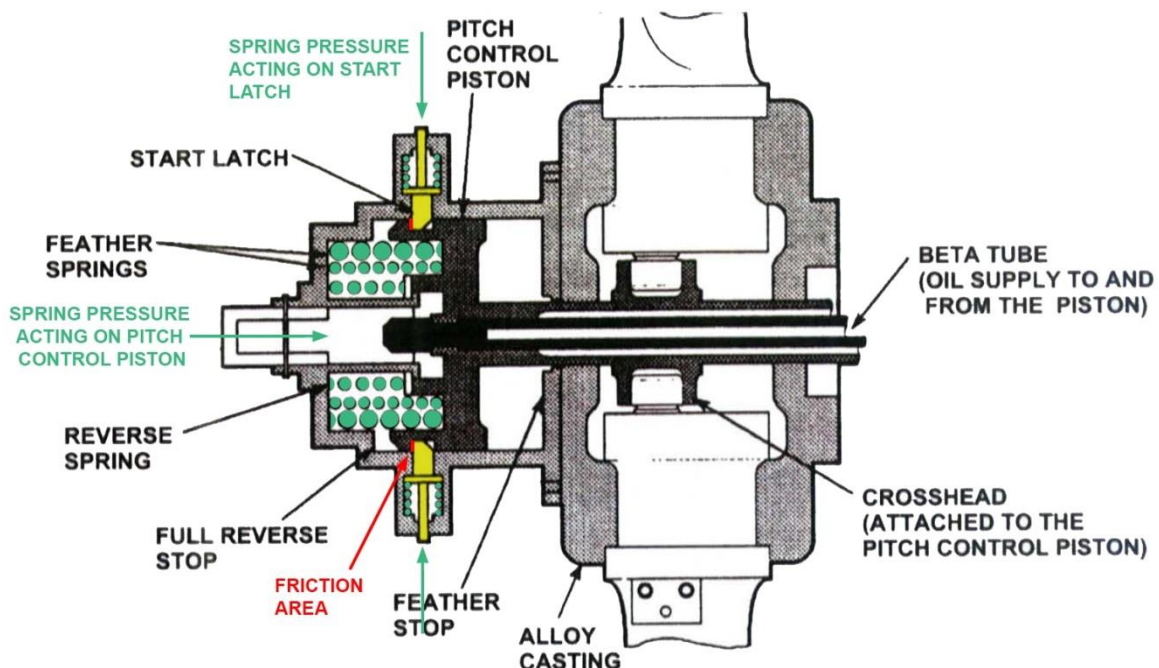
In order to disengage the starting lock system, sufficient centrifugal force and hydraulic pressure need to be generated. To overcome the spring force holding the latches in engaged position sufficient RPM must be applied to the engine and sufficient hydraulic pressure must be applied to the fine pitch side of the pitch change mechanism in order to reduce the friction forces between the mating faces of the latches and piston (Figure 1).

Figure 1. Single-acting pitch change mechanism with start lock system engaged on the start latches

Start locks on a Jetstream 31 aircraft will disengage by attaining engine RPM greater than 28% (450 rpm and above) overcoming the elastic forces of the springs and holding the latches in the “engaged” position. To reduce the frictional forces acting on the start latch and pitch control piston mating faces and to assist latch outward movement, hydraulic pressure needs to be applied to the fine side of the pitch control piston to move it forward. This is achieved by moving the power levers to REVERSE position until increase in torque and RPM is observed – indicating that propeller blade and control piston has moved to reverse position and the starting latches have been pushed fully to the disengaged position.
