AIRCRAFT ACCIDENT REPORT AND EXECUTIVE SUMMARY

Reference:	CA18/2/3/9236	
Aircraft registration	ZS-RTV	Date of accident	29 October 2013		Time of accident	0700Z
Type of aircraft	Robinson R22 Beta – Helicopter		Type of operation		Private (Part 91)	
Pilot-in-command licence type		Private	Age	22	Licence valid	Yes
Pilot-in-command flying experience		Total flying hours	118.6		Hours on type	97
Last point of departure		Mossel Bay Aerodrome (FAMO), Western Cape				
Next point of intended landing		Mossel Bay Aerodrome (FAMO), Western Cape				
Location of the accident site with reference to easily defined geographical points (GPS readings if possible)						
On a farm approximately 4 km from George Aerodrome (GPS position: S34° 02'36.41" E022° 22'10.89")						
Meteorological information		Surface wind: 040°/5 kt, temperature: 22 °C, visibility: +10 km				
Number of people on board		1 + 0	No. of people injured	1	No. of people killed	0
Synopsis		<p>The pilot conducted a private flight from Mossel Bay Aerodrome with the intention of flying to Knysna and back to Mossel Bay Aerodrome. In the cruise at 1100 feet AMSL whilst approaching Herolds Bay and flying along the coast, the engine of ZS-RTV star

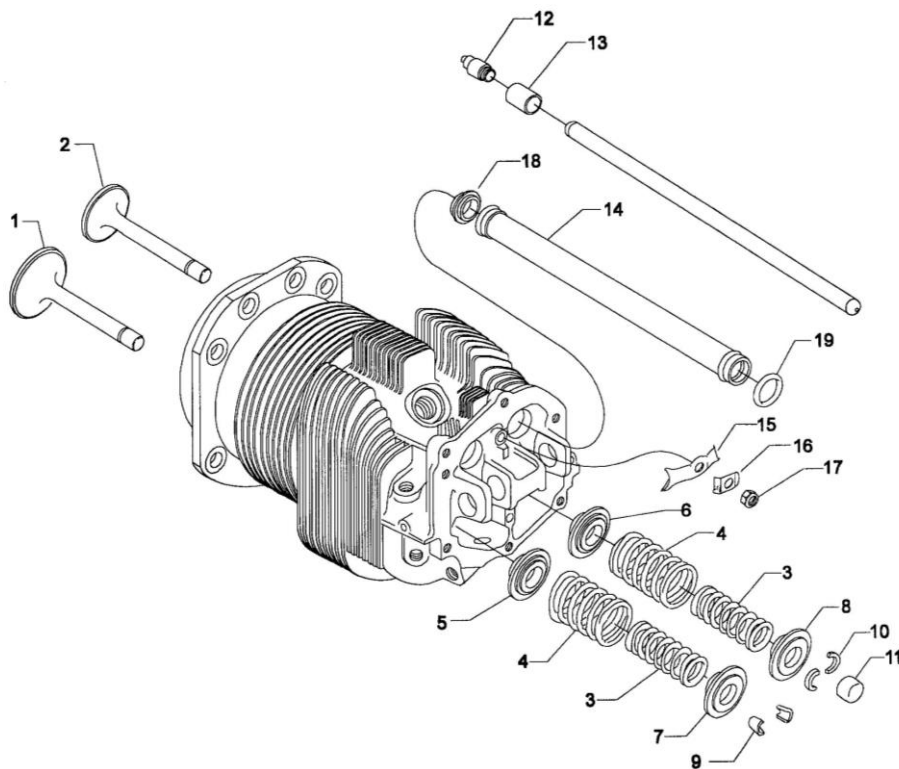
Figure 9: A schematic of the cylinder assembly
1-Intake Valve; 2- Exhaust Valve; 3- Valve Spring Inner; 4- Valve Spring Outer; 5,6,7,8-Valve Seat;
9,10- Valve Key; 11- Valve Stem Cap; 12- Hydraulic Tappet Plunger; 13- Hydraulic Tappet Socket;
14- Push Rod Shroud Tube Assembly

2.2 During the investigation the exhaust pushrod on No. 1 cylinder of the engine was found bent. The exhaust valve was fractured with the stem remaining in the cylinder head. History suggests that since 1980 the engine type experienced similar failures that were caused by valve sticking.

- A conventional camshaft is located above and parallel to the crankshaft.
- The camshaft actuates tappets (*Figure 9-12 & 13*) which operate the valves (*Figure 9-1 & 2*) through pushrods (*Figure 9-1*) and valve rockers (*Figure 9-2*).

- The valve rockers (*Figure 9-2*) are supported on full floating steel shafts.
- The valve springs (*Figure 9-3 & 4*) bear against hardened steel seats (*Figure 9-5;6;7;8*) and are retained on the valve stems by means of split keys (*Figure 9-9 & 10*).

- A rotator cap is employed on sodium cooled exhaust valves.
- The purpose of the valve guides is to support the side forces operating on the valve stem. The guide also centres the valve on the valve seat and conducts a part of the heat from the valve head via the valve stem to the cylinder head. Valve stems and guides are normal wear items. Mutual wear increases the stem to guide clearances and exhaust valves, particularly sodium filled valves, rely on proper clearance to the guide to maintain good heat transfer properties.
