AIRCRAFT ACCIDENT REPORT AND EXECUTIVE SUMMARY

Reference:	CA18/2/3/9240	
Aircraft Registration	ZS-ZZX	Date of Accident	04 November 2013		Time of Accident	0925Z
Type of Aircraft	Air Tractor-502B (Aeroplane)		Type of Operation	Commercial		
Pilot-in-command Licence Type	Airline Transport		Age	36	Licence Valid	Yes
Pilot-in-command Flying Experience	Total Flying Hours	2 793.5		Hours on Type	785.4	
Last point of departure	Kimberly aerodrome (FAKM): Northern Cape province.					
Next point of intended landing	Kimberly aerodrome (FAKM): Northern Cape province.					
Location of the accident site with reference to easily defined geographical points (GPS readings if possible)						
Approximately 11 kilometres West of Barkly West on the bank of Vaal river at GPS co-ordinates determined to be S28°34.07' E024°24.39' at an elevation of 3 677 feet above mean sea level (AMS).						
Meteorological Information	Temperature, 30°C: Visibility, 10 kilometres: Wind Direction, North Westerly: Wind speed, 10 knots: Cloud cover, 1/8.

AIRCRAFT ACCIDENT REPORT

Name of Owner/Operator : Xcalibur Resources (Pty) Ltd
Manufacturer : Air Tractor, INC
Model : Air Tractor 502-B
Nationality : South African
Registrati

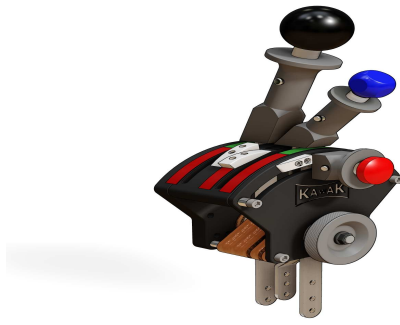
Figure 6: View of an aircraft throttle.

1.16.1 Post accident examination of the airframe revealed no anomalies with the aircraft flight controls. There was sufficient Jet A1 fuel on the aircraft, free from contamination and the fuel selector was found on a closed position, most probably by the pilot after the accident. Inspection on the engine revealed that the self locking castellated nut and the split pin that fasten or secure the bolt that holds the fuel control unit throttle linkage was missing and the bolt disconnected and fell to the bottom of engine onto the nacelle. Throttle “a means for the pilot to control and monitor the operation of the aircraft's powerplant or engine” response was lost and the engine instantaneously went into idle and the aircraft couldn't maintain flying speed. Below are pictures of an air tractor aircraft throttle, a detached fuel control unit linkage and the bolt that was found onto the bottom on the engine nacelle.
