<b>AIRCRAFT ACCIDENT REPORT AND EXECUTIVE SUMMARY</b>
---

<b>Reference:</b>	CA18/2/3/9268	
<b>Aircraft Registration</b>	ZU-DVM	<b>Date of Accident</b>	4 January 2014		<b>Time of Accident</b>	1510Z	
<b>Type of Aircraft</b>	Rans S-6ES Coyote II		<b>Type of Operation</b>		Private		
<b>Pilot-in-command Licence Type</b>		Private Pilot License	<b>Age</b>	46	<b>Licence Valid</b>	Yes	
<b>Pilot-in-command Flying Experience</b>		<b>Total Flying Hours</b>	223.6		<b>Hours on Type</b>	51.4	
<b>Last point of departure</b>		Khunskraal Farm in Cape Infanta, Western Cape					
<b>Next point of intended landing</b>		Swellendam Airfield (FASX), Western Cape					
<b>Location of the accident site with reference to easily defined geographical points (GPS readings if possible)</b>							
Khunskraal Farm in Cape Infanta (GPS position: 33°01'47" South 18°54'40" East, elevation 276 ft. AMSL)							
<b>Meteorological Information</b>		<b>Temperature:</b> 27°C; <b>Surface wind:</b> 225°/10kts; <b>Visibility:</b> <1000m <b>Cloud cover:</b> Broken; <b>Cloud base:</b> 1000ft; <b>Dew point:</b> 4°C

COMPILED BY  	<b>CrashLAB</b>	PAGE 1 OF 10	
COMPILED FOR: S.A. Civil Aviation Auth.		DOCUMENT NUMBER AAI-003-02-14

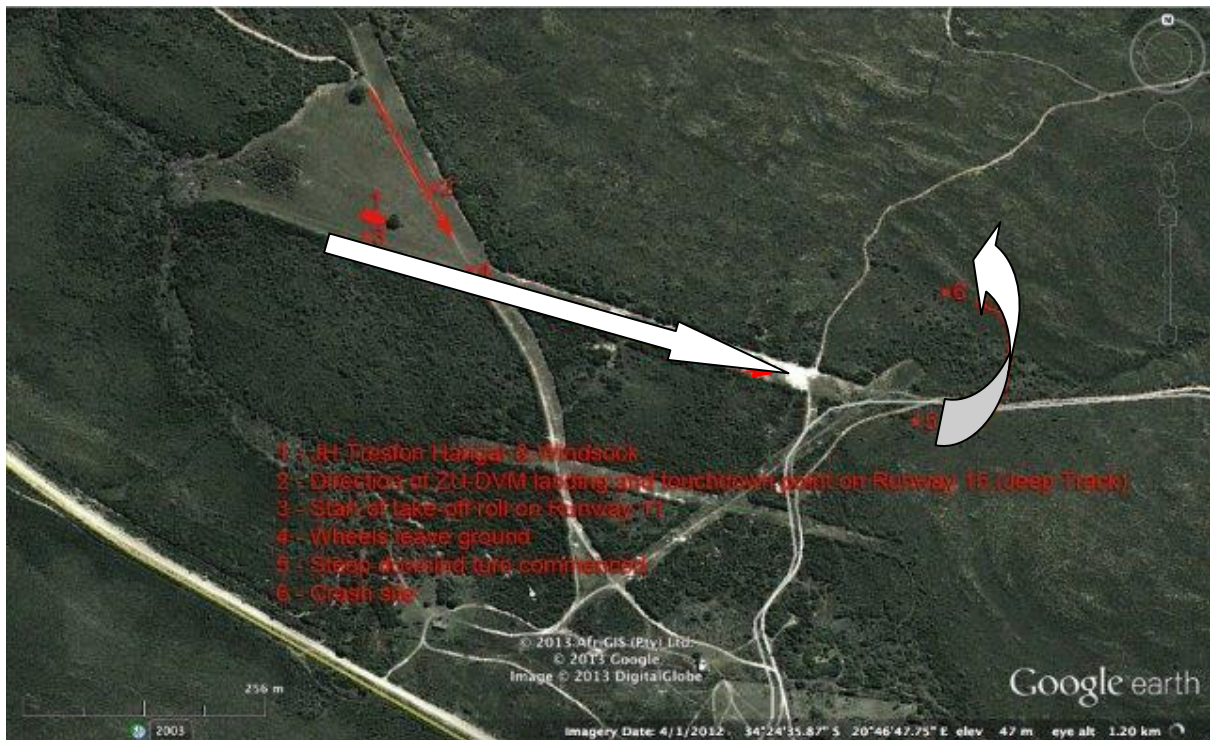
**Figure 6:** Depicts flight path of the aircraft

1.12.1 The aircraft impacted the ground in a nose down attitude and came to rest in a westerly direction in an open field surrounded by vegetation.

1.12.2 The aircraft sustained substantial damage to the forward engine section of the fuselage, propeller, wings, tail plane and undercarriage.
