AIRCRAFT ACCIDENT REPORT AND EXECUTIVE SUMMARY

Reference:	CA18/2/3/9269	
Aircraft Registration	ZU-FXI	Date of Accident	5 January 2014		Time of Accident	0630Z
Type of Aircraft	Bat Hawk (Aeroplane)		Type of Operation	Private		
Pilot-in-command Licence Type	NPL Airplane		Age	55	Licence Valid	Valid
Pilot-in-command Experience	Flying	Total Hours	Flying	935,48	Hours on Type	202,0
Last point of departure	Andrew's Field (FAAF)- Western Cape					
Next point of intended landing	Andrew's Field (FAAF)- Western Cape					
Location of the accident site with reference to easily defined geographical points (GPS readings if possible)						
Suiderstrand near Struis Bay (fynbos) at GPS position: S 34°49'02.65", E 019°57'28.38"						
Meteorological Information	Wind direction: SWS, Wind speed: 6 knots, Visibility: Good. Temperature: 19 °C, Cloud base: 2 000 ft					
Number of people on board	1+1	No. of people injured	0	No. of people killed	0	
Synopsis	<p>An aircraft with two occupants on board experienced an engine failure during a scenic flight. The pilot initiated a glide to execute a forced landing onto the beach, which was approximately 49,2 feet (ft.) from the bush. During the glide, the pilot was

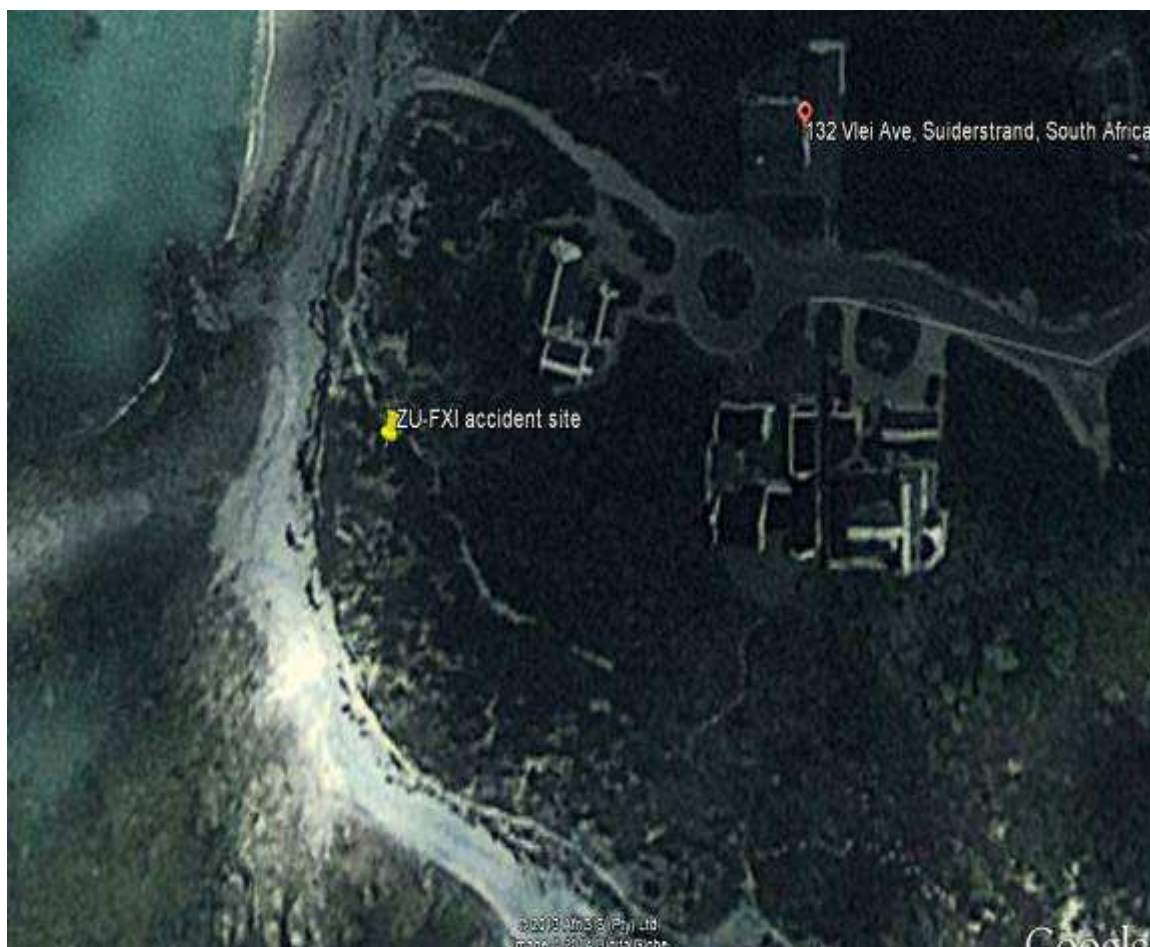
1.12.1 The place at which the aircraft crashed was a bushy environment. The accident site is not suitable for landing.

Figure 2: Google view of accident site

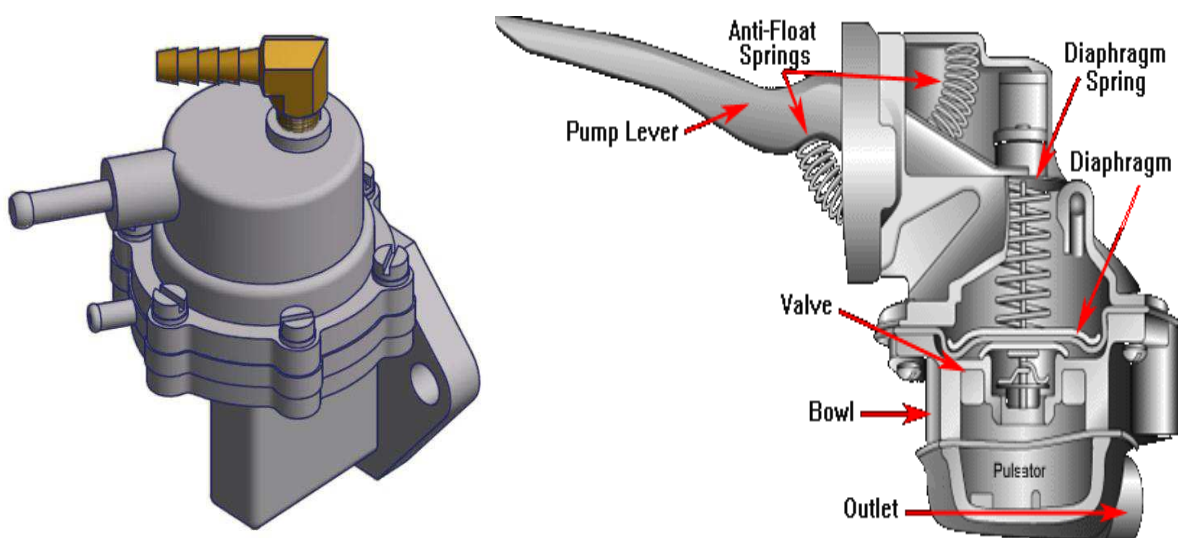
Figure 7: Typical mechanical fuel pump

A leak in the diaphragm or one-way valve inside a mechanical fuel pump will cause a loss of fuel pressure and starve the carburettor for fuel. This may cause the engine to run lean, misfire, hesitate or stall. If the pump fails entirely, no fuel will be delivered to the carburettor and the engine will not start or run.
