## *Final report RL 2015:10e*

**Serious incident on 31 January 2014  
involving the aircraft ES-PJR of the model  
Bae Jetstream 3200, operated by AS Avies  
at Torsby airport, Värmland county.**

File number L-0018/14

22/06/2015

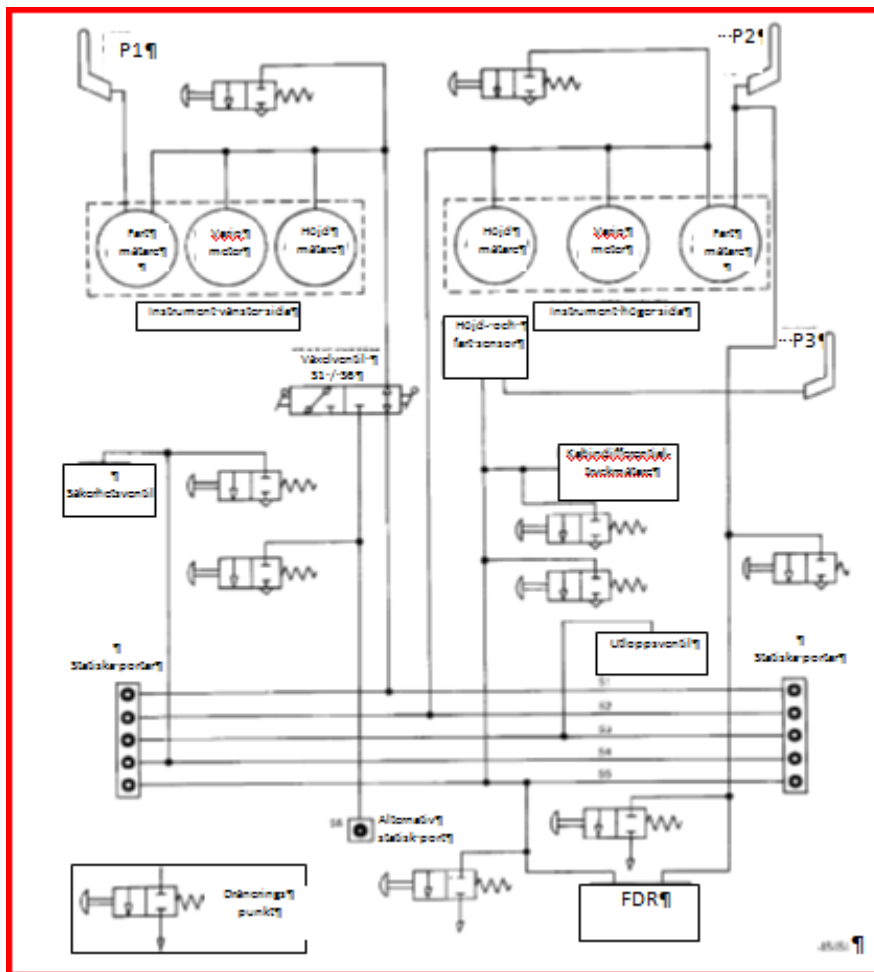
Figure 4. Schematic view of the pressure system.

Since the forward speed recorded by the FDR is based on the pressures S5 and P2, and the altitude recorded by the FDR is based on the pressure S5, an assessment of the source of error can be made. The minor erroneous display on the right side's airspeed indicator that had been noted by the co-pilot indicates that a partial explanation for the FDR fault can be found in the P2 system. If the fault had been found in the S5 system, the recorded altitudes from the FDR and transponder would have differed, which it has not been possible to establish (see Figure 4).

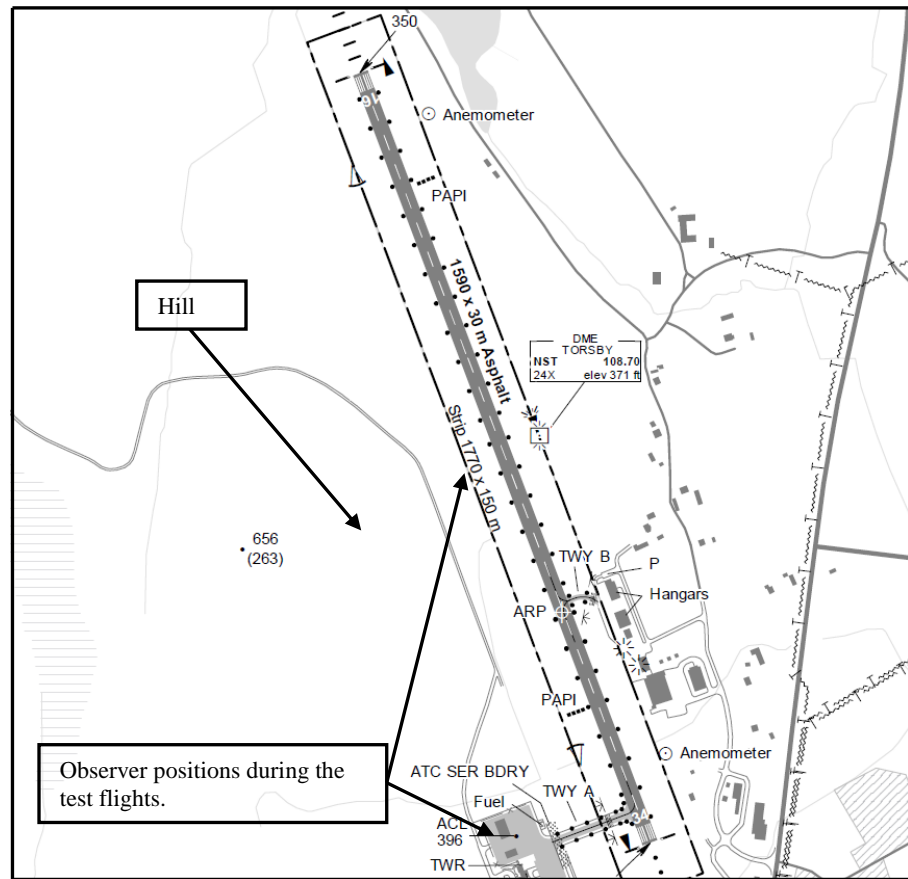
Figure 11. Conditions during the test flights.

The tests began with normal approach and landing within the normal touchdown zone about 300 metres into the runway. In these conditions, the aircraft was visible during approach and touchdown but not during parts of the rollout towards the far end of the runway.
