AIRCRAFT ACCIDENT REPORT AND EXECUTIVE SUMMARY

Reference:	CA18/2/3/9286	
Aircraft Registration	ZS-NTY	Date of Accident	06 February 2014		Time of Accident	0730Z
Type of Aircraft	Cessna A188B (Aeroplane)		Type of Operation	Commercial		
Pilot-in-command Licence Type	Commercial Pilot Licence		Age	22	Licence Valid	Yes
Pilot-in-command Flying Experience	Total Flying Hours	602.9		Hours on Type	352.0	
Last point of departure	Joubertina aerodrome: Eastern Cape province.					
Next point of intended landing	Joubertina aerodrome: Eastern Cape province.					
Location of the accident site with reference to easily defined geographical points (GPS readings if possible)						
On the mountain lee side at GPS coordinates determined to be S 33°47.201 ' E 25°32.618 '.						
Meteorological Information	Dry-bulb temperature, 21°C: Temperature 15°C: Wind speed@ 07 knots: No clouds.					
Number of people on board	1 + 0	No. of people injured	1	No. of people killed	0

AIRCRAFT ACCIDENT REPORT

Name of Owner/Operator : Sand River Crop Protection CC
Manufacturer : Cessna Aircraft Company
Model : Cessna A188B
Nationality : South African
Registration Marks : ZS-NTY
Place : S 33°47.201 ' E 25°32 .618 '
Date : 06

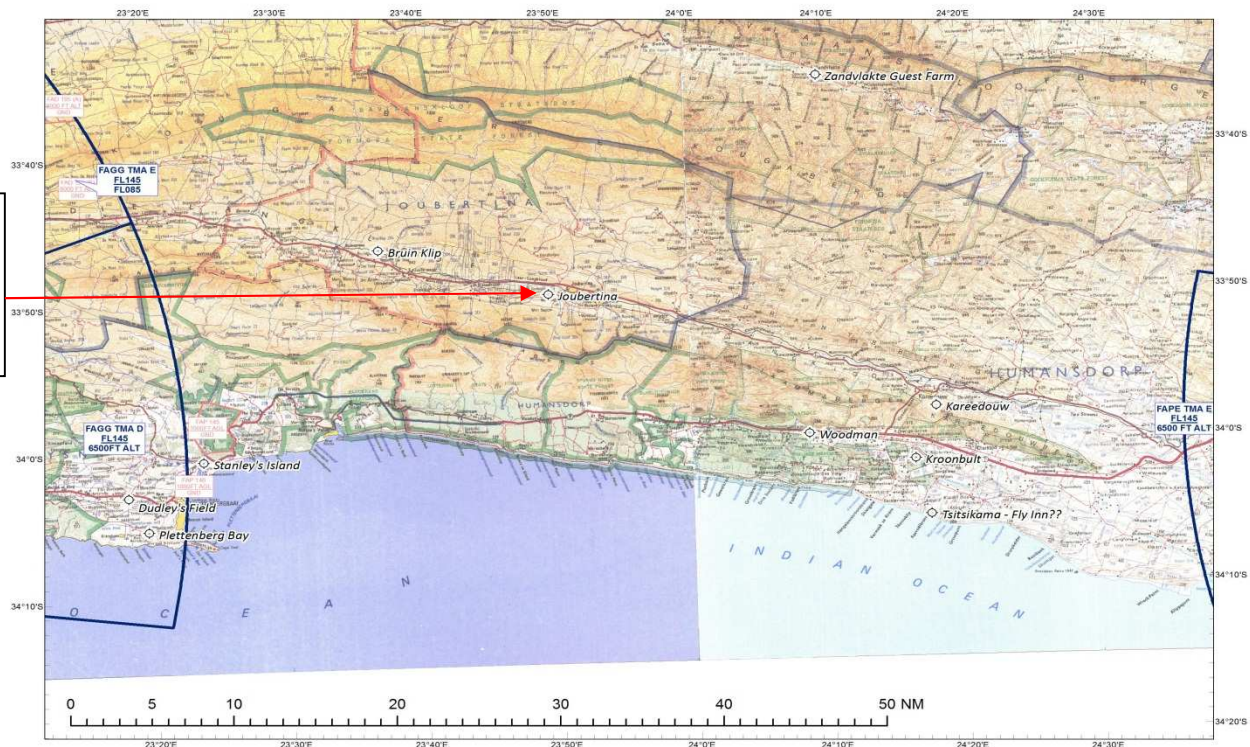
- 1.1.3 The aircraft steadily lost height and the pilot immediately jettisoned the remaining chemical (approximately 460 litres) with the intention to get rid of additional weight and recover the aircraft, but was unsuccessful. The aircraft propeller made contact with tall trees and nosed over coming to a halt in a bushy area. The aircraft was destroyed by impact and no fire was reported.
- 1.1.4 The pilot who was wearing his safety harness sustained minor bruises to his shoulders and jaw. The farmer who was located approximately 400 metres from the accident site immediately drove to the site and rescue the pilot from the wreckage. The pilot was then taken to a nearby private hospital where he received medical attention.
- 1.1.5 The accident happened in the morning on the lee site of the mountain at GPS coordinates determined to be South 33°47.201 ' East 25°32 .618'.

Figure 1: Location of the accident site on shown on the area chart.

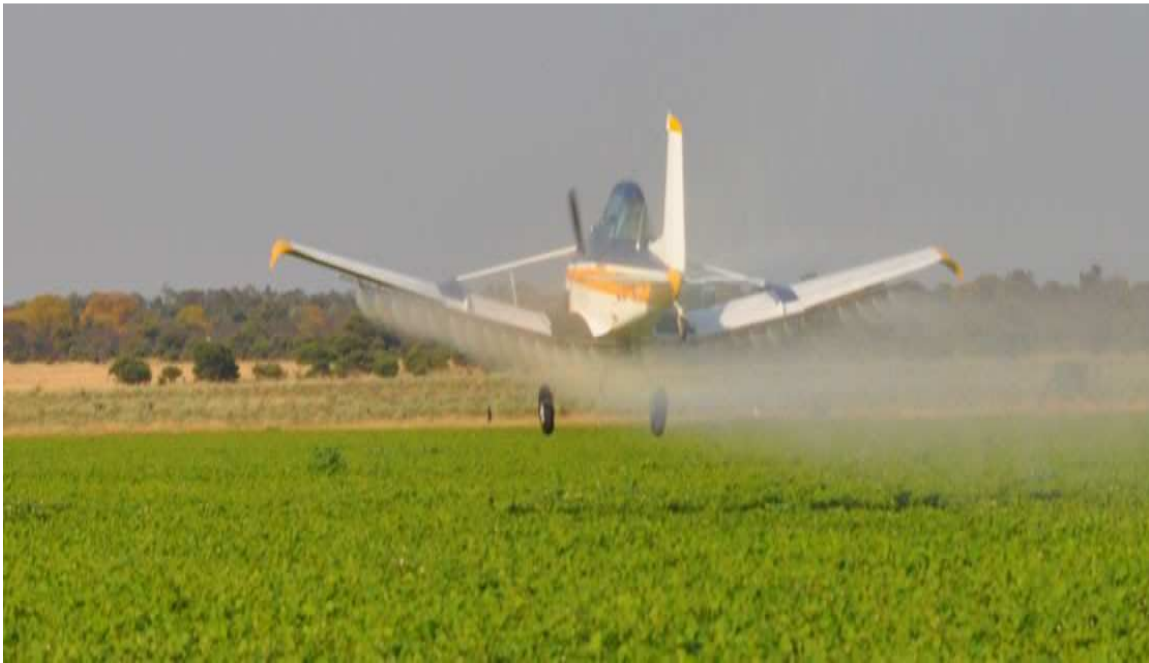
Figure 4: The photo shot during crop spraying before the accident.

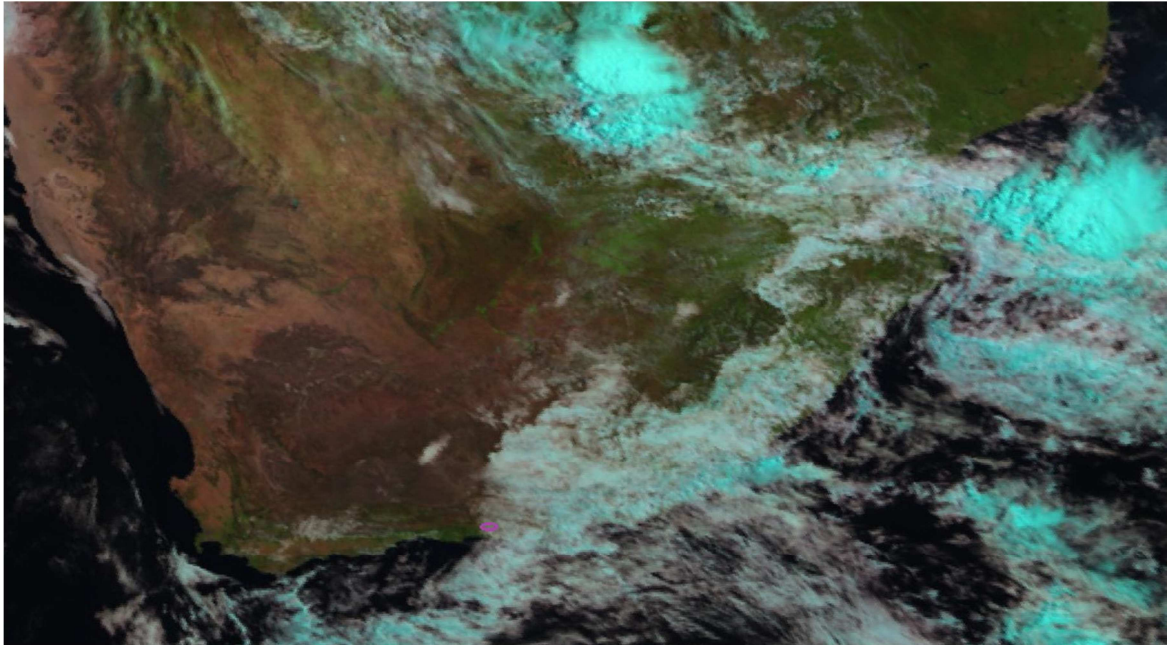
Plattenburg (FAPG) is the closest reporting weather station. The METAR's from 0700Z to 0800Z for this automatic weather station are included in figure 5. There is no cloud amount and visibility report since this is an automatic weather station. The 0700Z METAR closest to the time of accident contains the following weather variables:

Figure 5: Satellite observational data for FAPG.

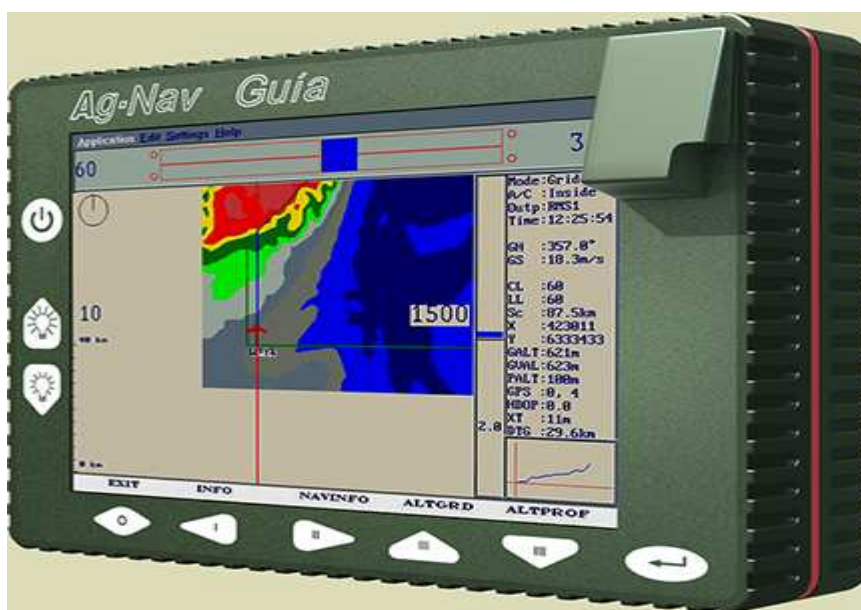
1.16.3 It also enables the pilot to fly and spray precise or accurate patterns using constant or variable rate flow control and spraying costs. During the investigation this device was retrieved from the wreckage and downloaded. The data showed multiple passes being flown above the first field and sprays being performed after which two successful landings were executed. After the third take off the aircraft proceeded or headed towards the second field where it performed the first pass and spray, and in an attempt to execute a 180 degree turn to the right the aircraft collided with the terrain. Just before the accident, the GPS data showed a sign of decrease in aircraft airspeed and abrupt changes in deviations on aircraft flight path most probably due to the pilot trying to recover the aircraft. GPS data is attached in the Appendices to the report. Picture of the GPS installed on the aircraft is shown below.

Figure 8: AG-NAV Guia GPS primarily used for aerial agricultural and forestry applications.
