AIRCRAFT ACCIDENT REPORT AND EXECUTIVE SUMMARY

Reference:	CA18/2/3/9287	
Aircraft Registration	ZS-JTW	Date of Accident	6 February 2014		Time of Accident	17:20Z
Type of Aircraft	PA-25-260 (Aeroplane)		Type of Operation	Agricultural		
Pilot-in-command Licence Type		Commercial	Age	52	Licence Valid	Yes
Pilot-in-command Flying Experience		Total Flying Hours	5 345,8		Hours on Type	47
Last point of departure		Parys Aerodrome, Free State (FAPY)				
Next point of intended landing		Parys Aerodrome, Free State (FAPY)				
Location of the accident site with reference to easily defined geographical points (GPS readings if possible)						
At the geographical coordinates S26 53,538 E027 29,567. Elevation 1407m.						
Meteorological Information		Surface wind: easterly at 10kt. Visibility: good. Cloud base: 1 000 ft				
Number of people on board	1 + 0	No. of people injured	1	No. of people killed	0	
Synopsis						
<p>The pilot took off from Runway 06 at Parys Aerodrome at 17:20Z for a night crop-spraying exercise. During take-off, and while at approximately 100 feet above ground level, the pilot experienced turbulences, due to a thunderstorm in the area, which caused the airspeed to decay in a stall

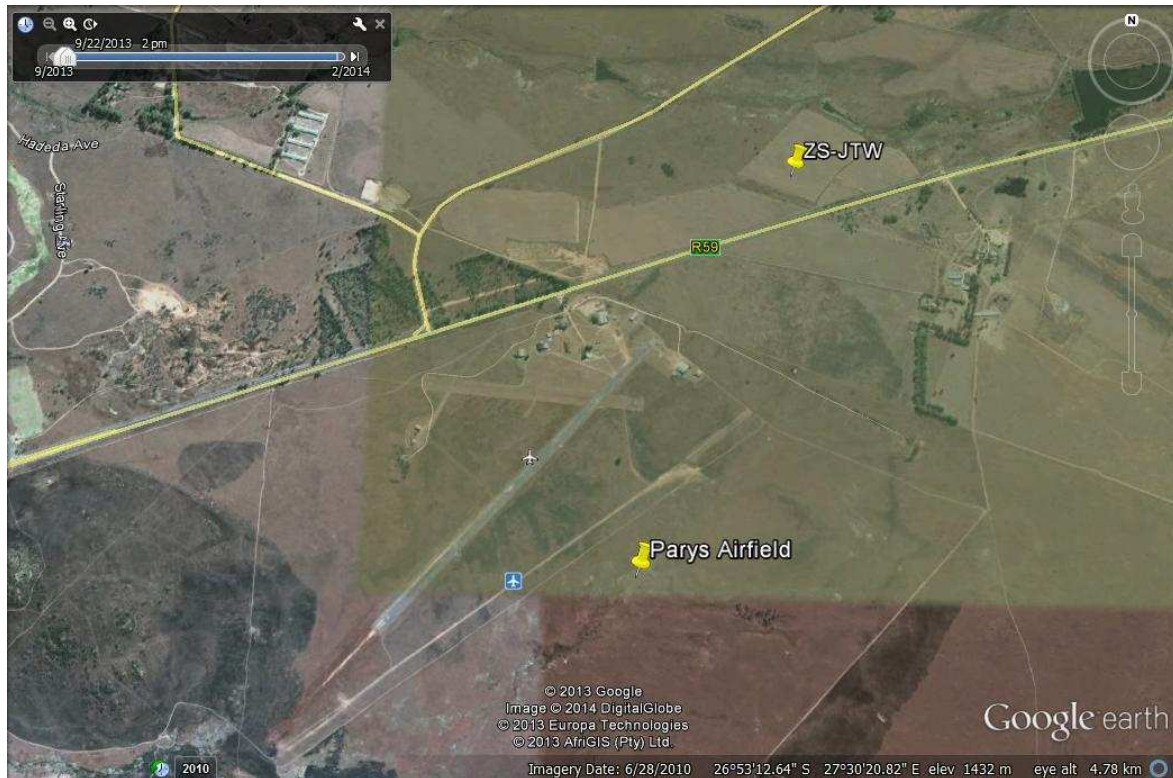
Figure 2: Aerodrome layout as obtained from Google Earth.

1.12.1 The airspeed decayed and the aircraft impacted with the ground approximately 800m from the runway threshold. The wreckage of the aircraft remained intact following the accident.

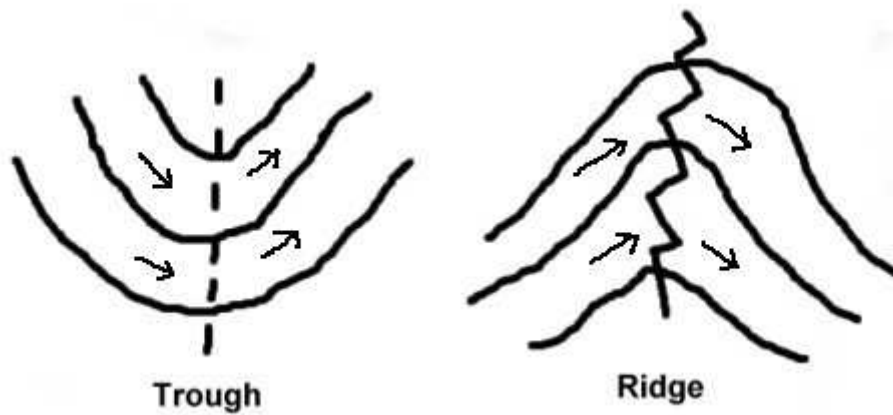
Trough of low

A trough is generally associated with bad weather. Frequently, a hot or cold front lies along the centre line of the trough. A front is the boundary between two masses of air at different temperatures. Under these conditions the weather will be in accord with the type of front: either cold-front weather or warm-front weather. Even if there is no front present, then the strong convergence of the air on either side of the trough centre line, meeting from different directions, can cause the air to lift sharply. The weather can include towering clouds, thunderstorms and heavy showers.

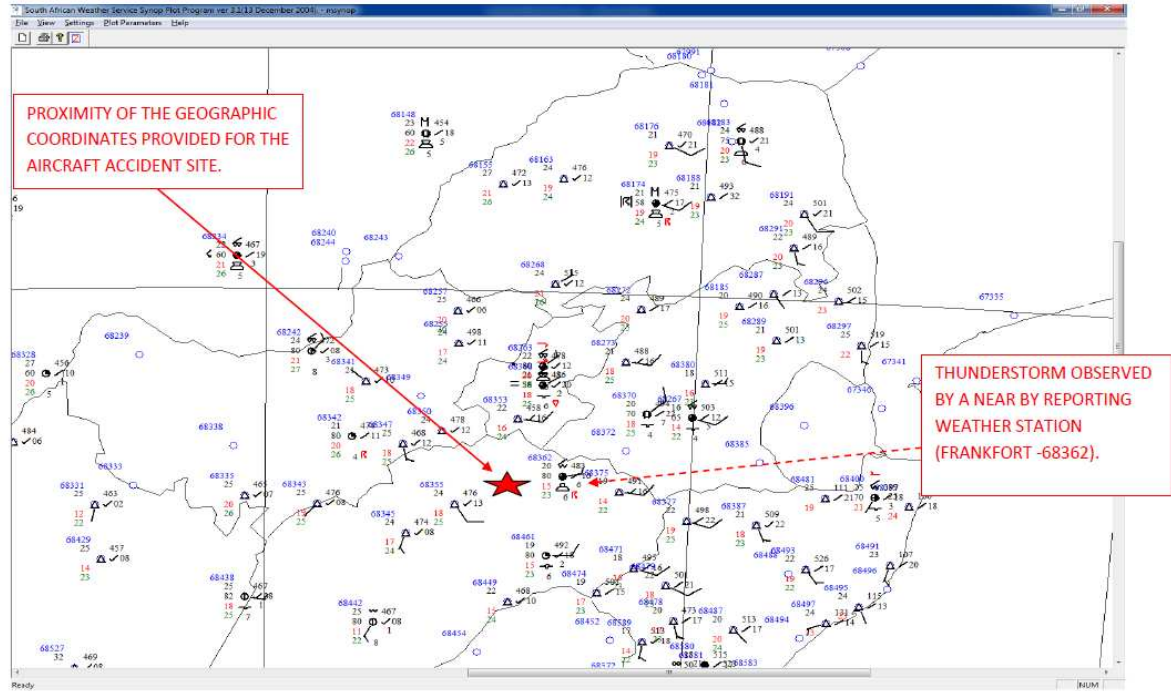
ATTACHMENT B: 1800 UTC Synoptic chart for the 06th February 2014

Observational data in the form of a [Synoptic](#) chart and a meteorological aerodrome reports ([METAR](#)) made at Kroonstad (FAKS) is included as Attachments B and C respectively - to reflect on the most likely surface conditions within the estimated time of occurrence of the accident. The observational data is also summarised below:
