AIRCRAFT ACCIDENT REPORT AND EXECUTIVE SUMMARY

Reference:	CA18/2/3/9292	
Aircraft Registration	ZS-LIO	Date of Accident	13 February 2014		Time of Accident	0820Z
Type of Aircraft	Beech Baron 58		Type of Operation		Private	
Pilot-in-command Licence Type		Commercial Aeroplane	Age	51	Licence Valid	Yes
Pilot-in-command Flying Experience		Total Flying Hours	5 151,4		Hours on Type	10
Last point of departure		Rustenburg Aerodrome (FARG), North West Province				
Next point of intended landing		Lanseria Aerodrome (FALA), Gauteng Province				
Location of the accident site with reference to easily defined geographical points (GPS readings if possible)						
The accident occurred on runway 07R at Lanseria aerodrome (GPS position: S25°56'22.89" E027°55'32.07", GL elevation 4 517 ft A)						
Meteorological Information		The pilot reported that the weather was CAVOK at the time of the accident: Wind direction: 140°–160°; Wind speed: 6–7 knots; Visibility: 10 km; Temperature: 20 °C; Dew point: Unknown; Cloud cover: Scattered; Cloud base: 2 000–2 500 feet.

AIRCRAFT ACCIDENT REPORT

Name of Owner/Operator : Jynco Farming Consultants CC
Manufacturer : Beech Aircraft Corporation
Model : Beech Baron 58

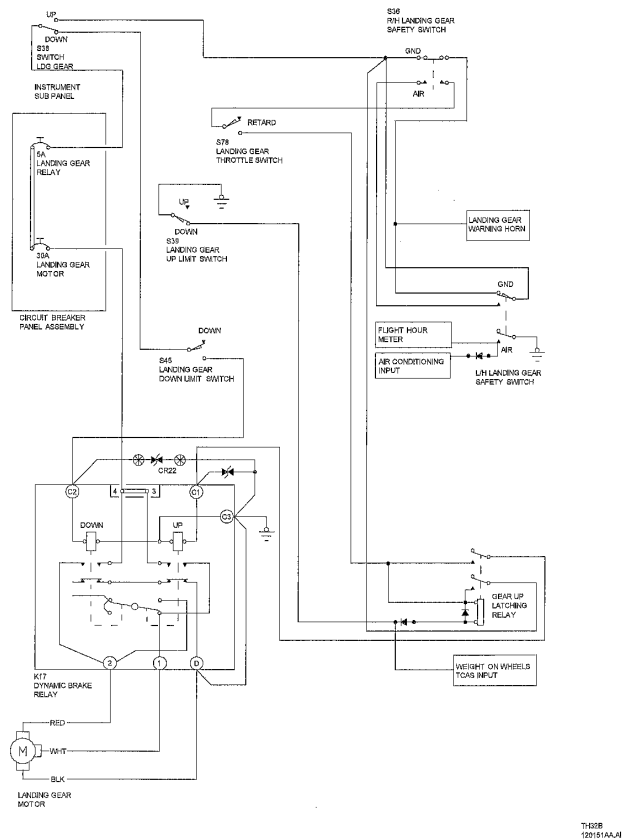
32-00-00-001

Fig 1 (Rev.) - Landing Gear System
 Printed from Beechcraft Corporation Interactive Maintenance Library (IML).
 P/N 55-590000-13 Revision G7 - October 1, 2013
