<b>AIRCRAFT ACCIDENT REPORT AND EXECUTIVE SUMMARY</b>
---

Reference:	CA18/2/3/9301	
<b>Aircraft Registration</b>	ZS-KCP	<b>Date of Accident</b>	18 March 2014		<b>Time of Accident</b>	1550Z
<b>Type of Aircraft</b>	Beech Baron BE55 (Aeroplane)		<b>Type of Operation</b>	Private		
<b>Pilot-in-command Licence Type</b>		CPL	<b>Age</b>	23	<b>Licence Valid</b>	Yes
<b>Pilot-in-command Flying Experience</b>		Total Flying Hours	521.3		Hours on Type	211.6
<b>Last point of departure</b>		Vryheid Aerodrome (FAVY):KwaZulu Natal				
<b>Next point of intended landing</b>		Vryheid Aerodrome (FAVY): KwaZulu Natal				
<b>Location of the accident site with reference to easily defined geographical points (GPS readings if possible)</b>						
On the grass at right-hand side of Runway 11. GPS co-ordinates: S 27°47'13.71", E030°47'37.17"						
<b>Meteorological Information</b>		Wind direction: 320°; Wind speed: 9kts; Visibility: CAVOC; Air temp: 23°C				
<b>Number of people on board</b>	1+4	<b>No. of people injured</b>	0	<b>No. of people killed</b>	0

## AIRCRAFT ACCIDENT REPORT

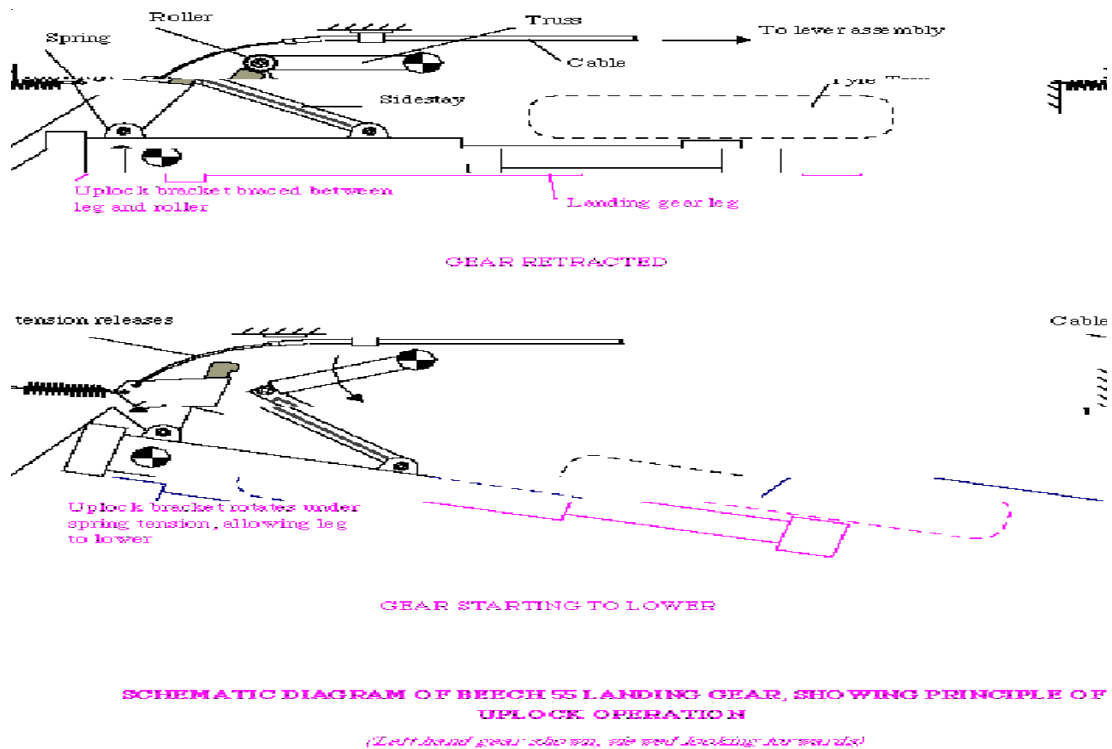
**Figure 7:** Schematic diagram of up-lock mechanism

1.16.3 On the day of the accident the recovery team informed the investigation team that they observed that the main gear up-lock block stopped on the wrong side of the main gear brace assembly (forward of up-lock rolled). The up-lock consists of a bracket assembly which operates by forming a geometric brace between its mounting on the gear leg, and the roller. The bracket is connected to the gear bay structure by a spring, the tension of which opposes a cable linking the bracket to the gear operating motor lever assembly. The system is designed so that the cable is under tension when the gear is retracted.

When the gear is selected down, the first effect of the motor lever assembly is to relax the cable tension. This results in the spring tension moving the up-lock bracket away from the roller, thus allowing movement of the truss/side stay assembly, and in consequence, extension of the gear. The principle of operation is shown in Figure 7 above.
