DUTCH
SAFETY BOARD

Crashed during aerobatic flight

Bussloo, 19 March 2014

The Hague, June 2016

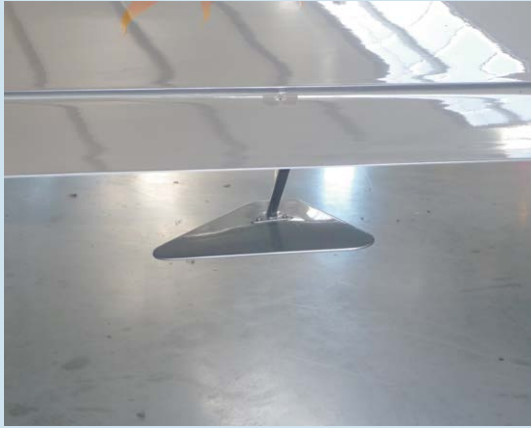
Figure 5: 'Spade'. (Photo: Dutch Safety Board)

Beneath the ailerons, the aircraft is equipped with so-called 'spades' (see figure 5). These are installed to reduce excessive forces on the pilot's steering column, so that movements around the longitudinal axis can be made with much less effort. Both wing tips are equipped with a construction of bars that help the pilot to determine the position of the aeroplane relative to the horizon (see figure 6).

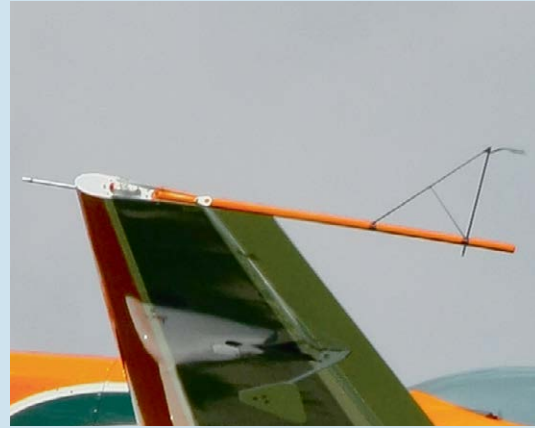
Figure 6: Construction of bars on the wingtips.
(Photo: J. Hage)

The orange metal tubes, which were found at an angle in the ground, proved to be the reference bars that had been mounted at the wingtips. These bars stuck into the ground at an angle of approximately 20 to 30 degrees. As the bars were mounted parallel to the longitudinal axis of the aeroplane, it can be concluded that D-EXIR impacted the ground at an angle of approximately 20 to 30 degrees.
