AIRCRAFT ACCIDENT REPORT AND EXECUTIVE SUMMARY

Reference:	CA18/2/3/9313	
Aircraft Registration	ZS-LLD	Date of Accident	22 April 2014		Time of Accident	0921Z
Type of Aircraft	Piper PA-46-310P (Malibu)		Type of Operation	Private (Part 91)		
Pilot-in-command Licence Type		Commercial	Age	35	Licence Valid	Yes
Pilot-in-command Flying Experience		Total Flying Hours	1569.4		Hours on Type	163.2
Last point of departure		Cape Town International Airport (FACT), Western Cape				
Next point of intended landing		Swartwater, in the Limpopo Province				
Location of the accident site with reference to easily defined geographical points (GPS readings if possible)						
Farm Rooisand in the Niekerkshoop area, Northern Cape (GPS S29°26.103 E022°43.722)						
Meteorological Information		Temperature: 25 °C; Dew Point: 06 °C; Wind 300°/167 kt; Visibility: 10 000 m; QNH: 1 016 hPa				
Number of people on board	1 + 1	No. of people injured	0	No. of people killed	2	
Synopsis

AIRCRAFT ACCIDENT REPORT

Name of Owner : L. Botha
Name of Operator : Private
Manufacturer : Piper Aircraft Corporation
Model : PA-46-310P (Malibu)
Nationality : South African
Registration Marks : ZS-LLD
Place : Farm Rooisand, Niekerksh

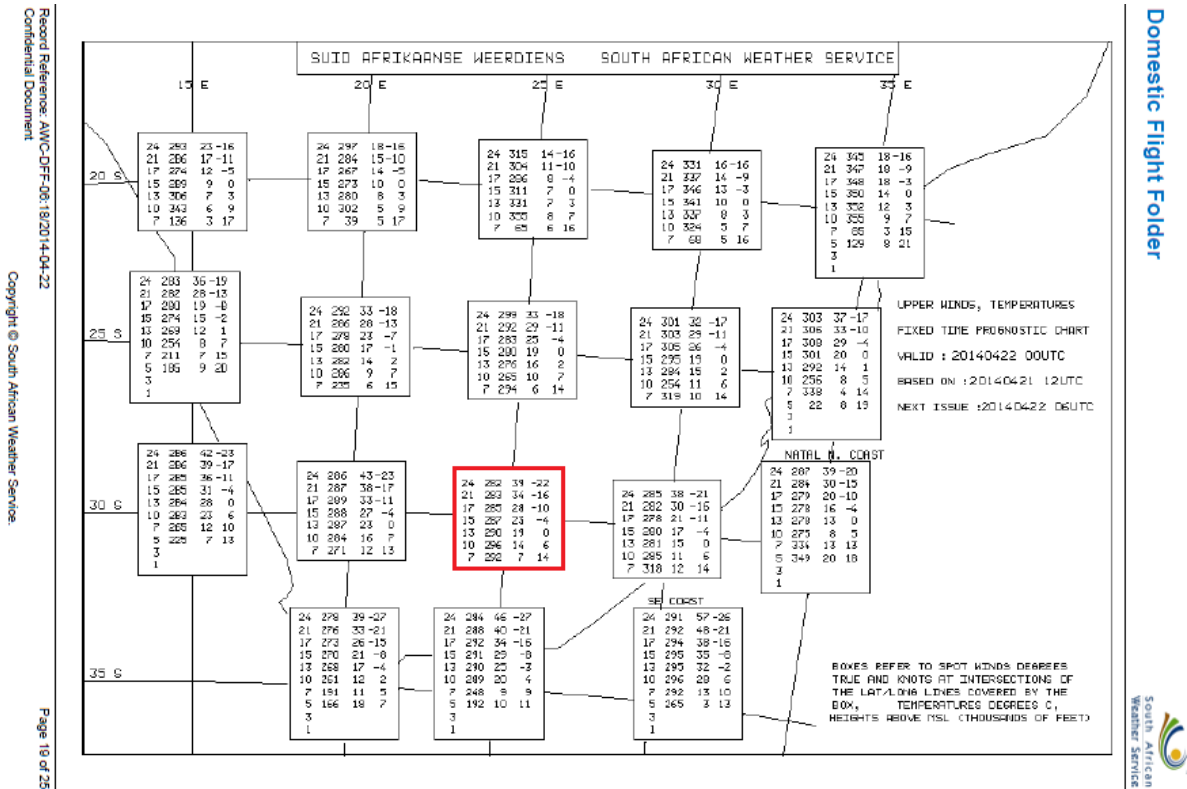
Figure 5: Upper winds chart

The Upper Wind Charts taken from Figure 5 indicated the temperature at Cape Town at 13000 AMSL was -4°C.

AMSL in feet	Temperature	
	Cape Town	At accident site
5000	7	n/a
7000	5	14
10000	2	6
13000	- 4	0
15000	- 8	- 4
17000	- 15	- 10
21000	- 21	- 16
24000	- 27	- 22

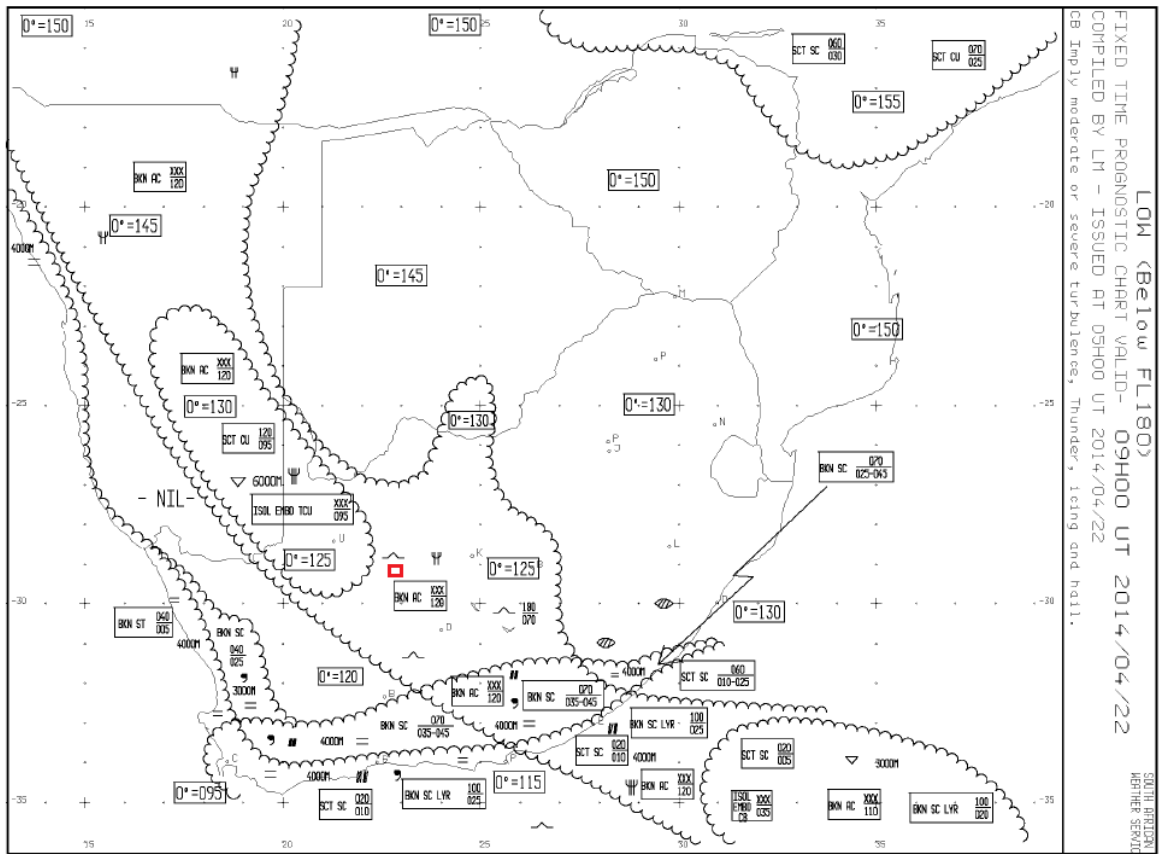
Figure 6: Low Level Significant Weather Chart valid from 0600Z to 0900Z

The Low Level Significant Weather Chart in Figure 6 below shows that in Cape Town between 0600Z and 0900Z, the freezing level started at 9500 feet AMSL and In the vicinity of the accident site the freezing level started at 12000 feet AMSL.

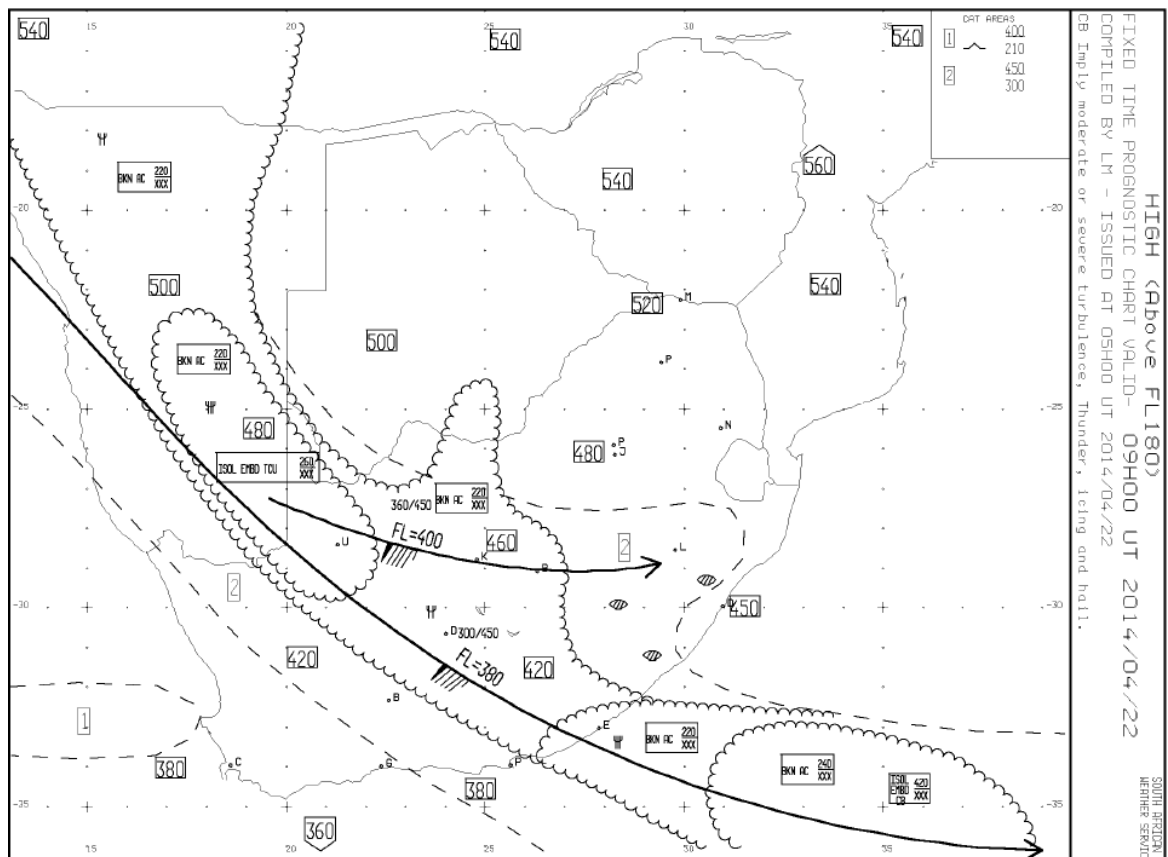
Figure 7: High Level Significant Weather Chart valid from 0600Z to 0900Z

The 0900Z Significant Weather Chart shows that altocumulus clouds at 12000ft above mean sea level were forecasted over the accident area with moderate turbulence between FL070 and FL180, see Figure 7.

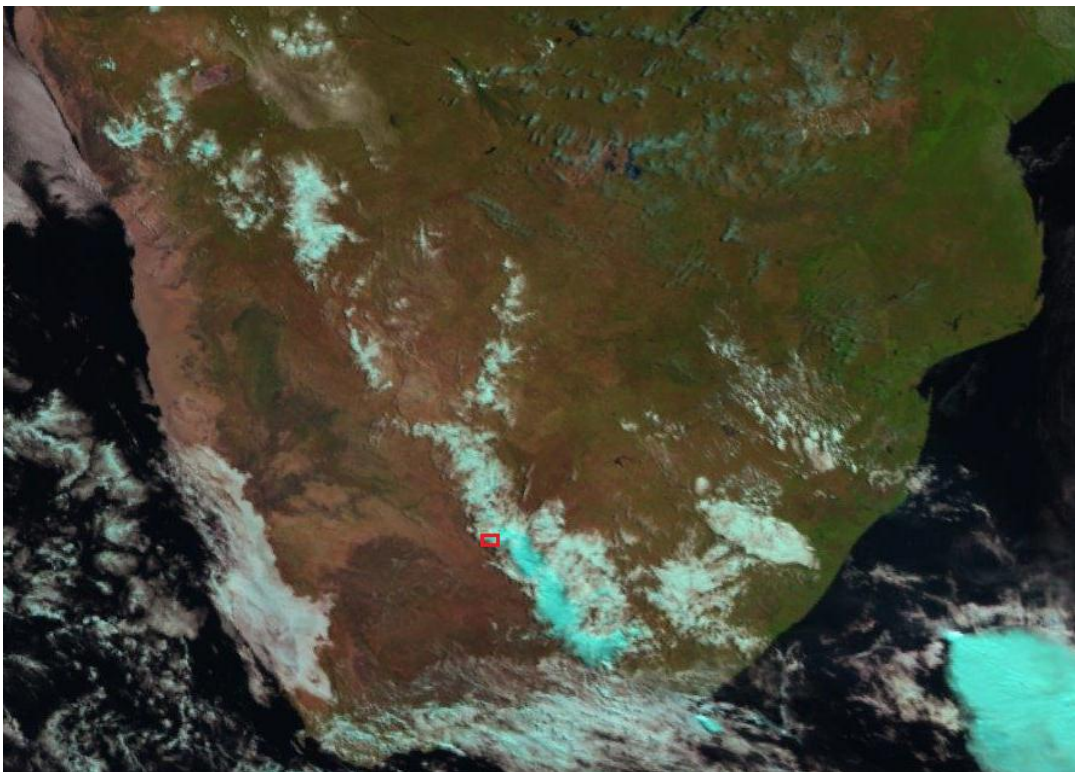
Figure 8: Satellite image for 22 April 2014

The satellite image in Figure 8 shows cloudy conditions over the accident area. FAKM is the closest reporting weather station to the accident area and CAVOK condition was reported at 0900Z which were about 20 minutes before the accident occurred. At 1000Z a few towering cumulus at 4000ft AGL were reported.

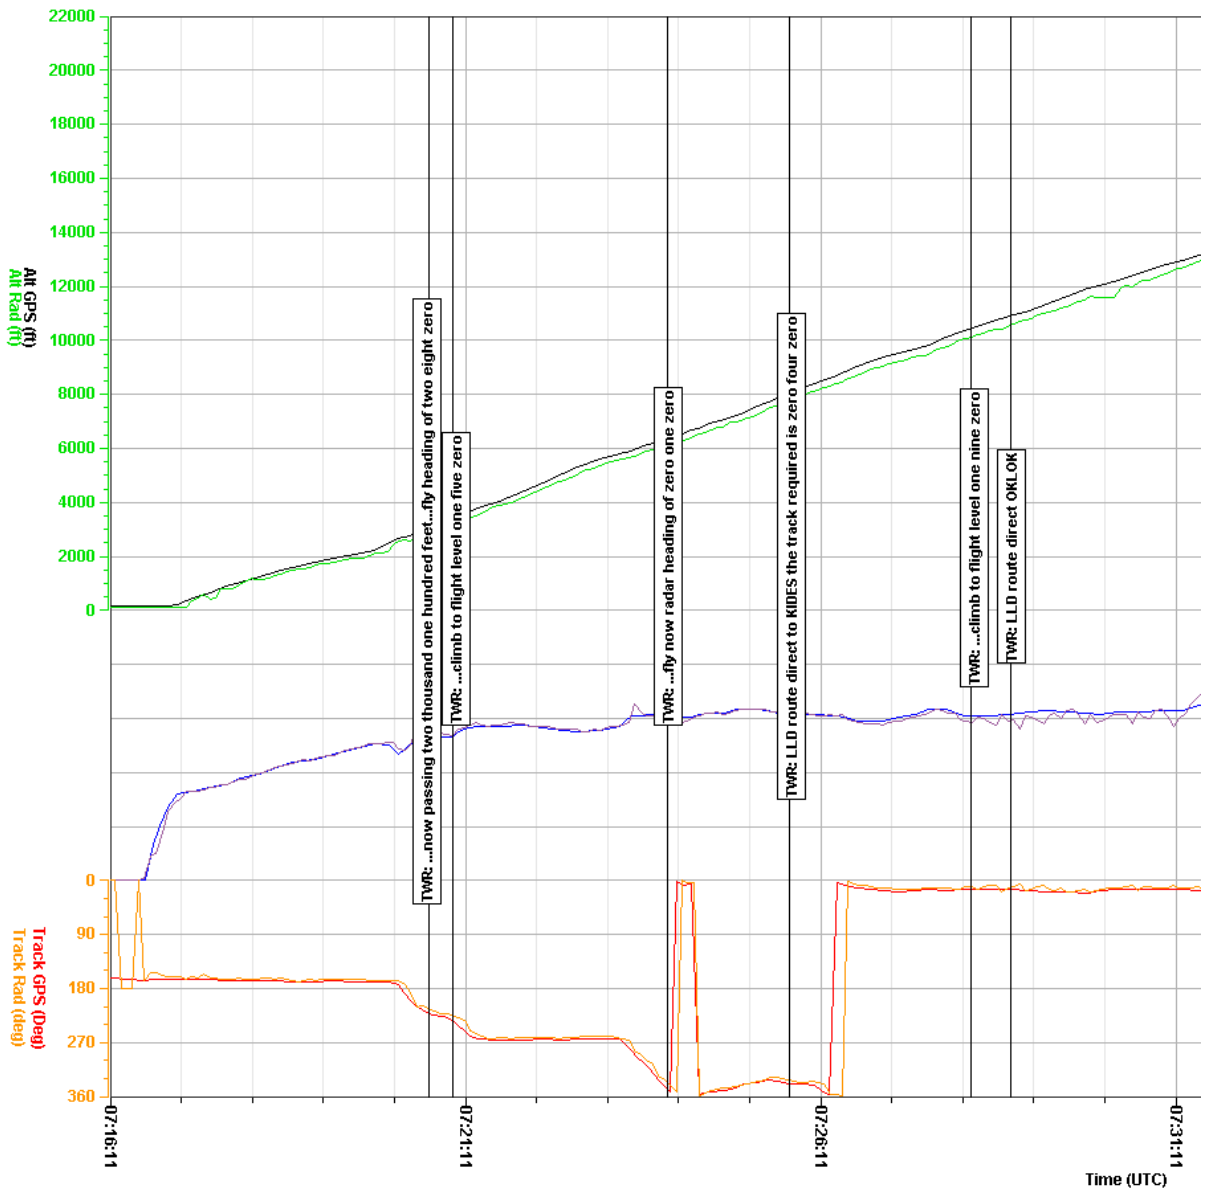
Figure 12: The GPS download and Radar Data overlay with the communication between ATC and the pilot as supplied by the NTSB

1.11.3 The downloaded GPS data in Figure 10 and Figure 11 was overlaid on the radar data obtained from ATC. This indicates the actual flight with erroneous radar data information ATC received and from the GPS. The aircraft GPS data graph also shows the erroneous data captured at altitude of 13500 ft before the aircraft reached an altitude of 17000 ft and during the flight.

1.11.4 The abovementioned figures illustrate the actual flight path prior and at the point where the aircraft experienced inflight breakup, at figure 10, is evident that the aircraft ascended to an altitude of 17000 ft, the graph indicate that there was definitely a problem with a transponder and the aircraft descended to an altitude of approximately 13500 ft. in figure 11 indicate the aircraft ascending to altitude of 21 000 ft and flew for approximately 52 min before diving and experience inflight breakup of altitude of 17000 ft.

1.12.1 According to the aircraft GPS that was downloaded and radar information the aircraft exceeded the VNO of 173 airspeed and VNE airspeed of 203 airspeed causing a catastrophic inflight failure and destruction of the aircraft during the flight and impact sequence with terrain.

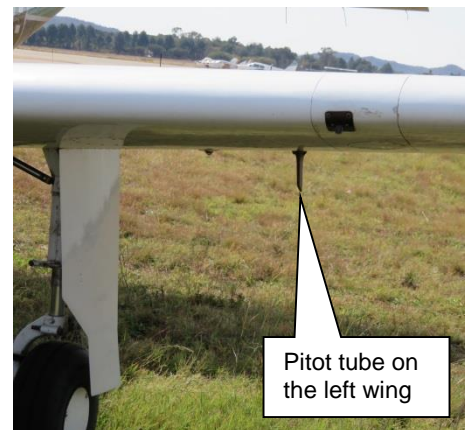
- 1.4 It can only be assumed that during the flight that the pitot tube and head heating element was serviceable but it is uncertain whether the pilot selected the pitot heat switch to on. However, If the pitot tube inlet was restricted by any foreign object like sand, the heating element could not have solved the problem . According to the pilot's flight folio, the accident aircraft took off and landed several times on gravel runways at Swartwater and Khami. An obstruction of dust and sand in the pitot head assembly will cause erroneous airspeed and altitude indications to the cockpit which can be disastrous should the pilot be unaware of the actual problem.

Pitot pressure for the airspeed indicator is sensed by a heated pitot head installed on the bottom of the left wing and is carried through lines within the wing and fuselage to the gauge on the instrument panel. Static pressure for the altimeter, vertical speed and airspeed indicators is sensed by two static source pads, one on each side of the rear fuselage forward of the elevator. They connect to a single line leading to the instruments. The dual pickups balance out differences in static pressure caused by slight side slips or skids.

Figure 16: Pitot tube on a similar aircraft

Do not attempt to drain static system during pressurized flight. The holes in the sensors for pitot and static pressure must be fully open and free from blockage. Blocked sensor holes will give erratic or zero readings on the instruments.

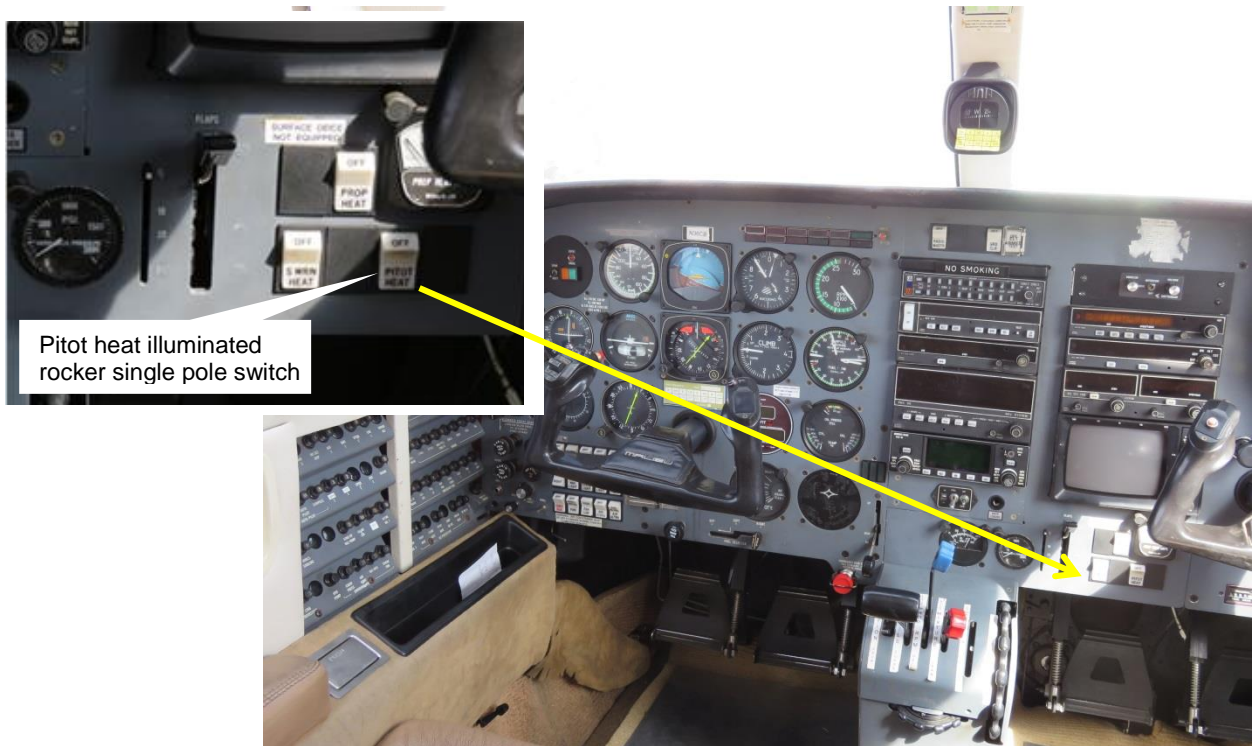
The heated pitot head, which alleviates problems with icing and heavy rain, is standard equipment and the switch for pitot heat is located on the lower centre instrument panel.

Figure 17 & Inset: Pitot heat switch in the cockpit on a similar aircraft
