AIRCRAFT ACCIDENT REPORT AND EXECUTIVE SUMMARY

Reference:	CA18/2/3/9323	
Aircraft Registration	ZS-GIA	Date of Accident	24 May 2014		Time of Accident	12:20Z	
Type of Aircraft	Glider Schleicher ASK 13		Type of Operation		Private		
Pilot-in-command Licence Type		Glider Pilot's Licence	Age	65	Licence Valid	Yes	
Pilot-in-command Flying Experience		Total Flying Hours	330		Hours on Type	280	
Last point of departure		Howick Airfield (FAHC), KwaZulu-Natal					
Next point of intended landing		Howick Airfield (FAHC), KwaZulu-Natal					
Location of the accident site with reference to easily defined geographical points (GPS readings if possible)							
Next to Howick Airfield, approximately 21km north-west of Pietermaritzburg Airport (coordinates S29° 34q023+E030° 12q266+)							
Meteorological Information		Sky clear, visibility >10km, with a north-easterly wind of 04kt					
Number of people on board	1 + 1	No. of people injured	0	No. of people killed	2

Name of Owner : Howick Flying Club
Name of Operator : Howick Flying Club
Manufacturer : Schleicher
Model : ASK13
Nationality : South African
Registration Marks : ZS-GIA
Place : Howick Airfield (FAHC)
Date : 24 May 2014
Time : 12:20Z

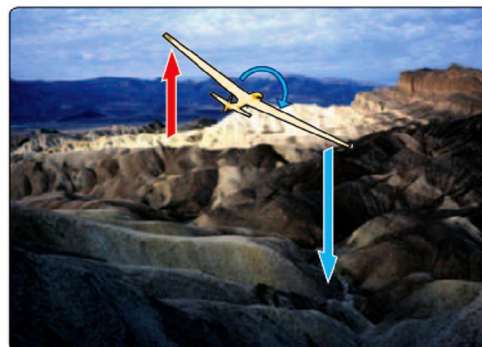
Figure 5: Thermal sink can roll the aircraft.

- 2.5 The investigation found that the glider had encountered a thermal sink on top of the ridge. This had caused the right wing to drop and strike the ground. The glider then pivoted around that point, spinning in a clockwise direction, and struck the ground in a nosedive attitude. The right wing and its main spar broke in the middle. The impact broke the fuselage and its tubing. The passenger was killed instantly
