AIRCRAFT INCIDENT REPORT AND EXECUTIVE SUMMARY

Reference:	CA18/3/2/1058	
Aircraft registration	ZU-FTC	Date of incident	6 June 2014		Time of incident	0720Z
Type of aircraft	Jabiru SP (aeroplane)		Type of operation		Training (Part 141)	
Pilot-in-command licence type		Private	Age	29	Licence valid	Yes
Pilot-in-command flying experience		Total flying hours	104.4		Hours on type	9.2
Last point of departure		George Aerodrome (FAGG), Western Cape Province				
Next point of intended landing		George Aerodrome (FAGG), Western Cape Province				
Location of the accident site with reference to easily defined geographical points (GPS position)						
Keurboomstrand, 3nm east of Plettenberg Bay (GPS position: 34°01'35.51" South 023°24'04.57" East)						
Meteorological information		Surface wind: 330°5kt; Temperature: 12°C; Visibility: +10km				
Number of people on board	1 + 0	No. of people injured	0	No. of people killed	0	
Synopsis						
<p>The pilot, who was the sole occupant on board, was engaged in a cross-country navigational flight from George aerodrome to Tsitsikamma and back to George. As he passed abeam Beacon Island at Plettenberg Bay, he initiated a climb from 1 500ft to 3 500ft above mean

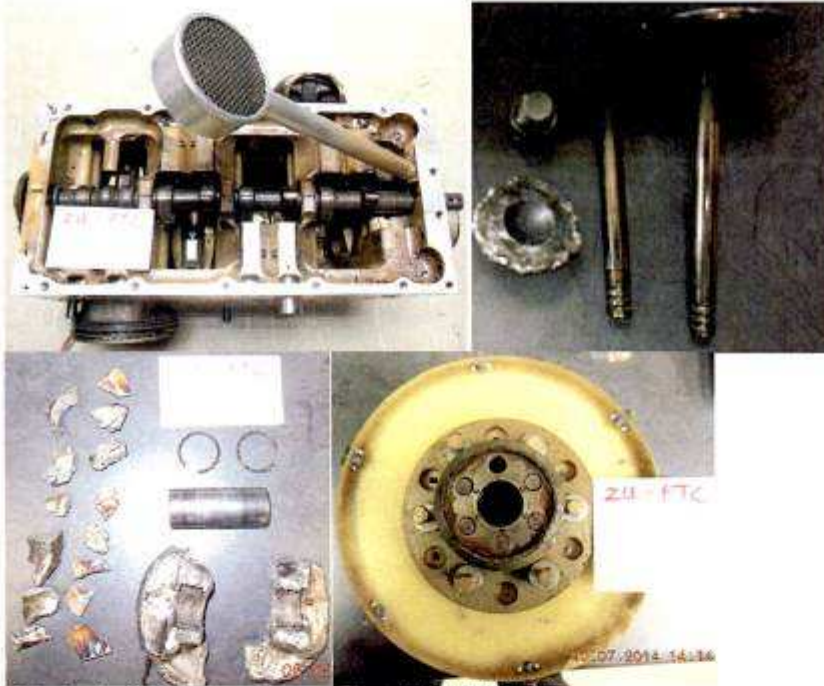
- 1.1. Selected parts (Photo 1) from a failed model 2200A Jabiru aircraft engine and propeller flange assembly, serial number 22A 3311, originating from Jabiru J160 aircraft, number ZS-FTC, were submitted to determine the most probable cause/s for failure during operation.
- 1.2. The relevant aircraft was involved in an emergency landing (Photo 2) following the separation of the propeller in flight.

Photo 1: Components, as supplied (digital)
