FINAL INVESTIGATION REPORT OF SERIOUS INCIDENT TO M/S JET AIRWAYS
ATR 72-212A AIRCRAFT VT-JCS AT BENGALURU ON 13/06/2014

On 13.06.2014, M/s Jet Airways Ltd. ATR 72 -212A aircraft VT-JCS while operating flight 9W-2731 (Bengaluru to Cochin) was involved in a serious incident during pushback at Bengaluru.

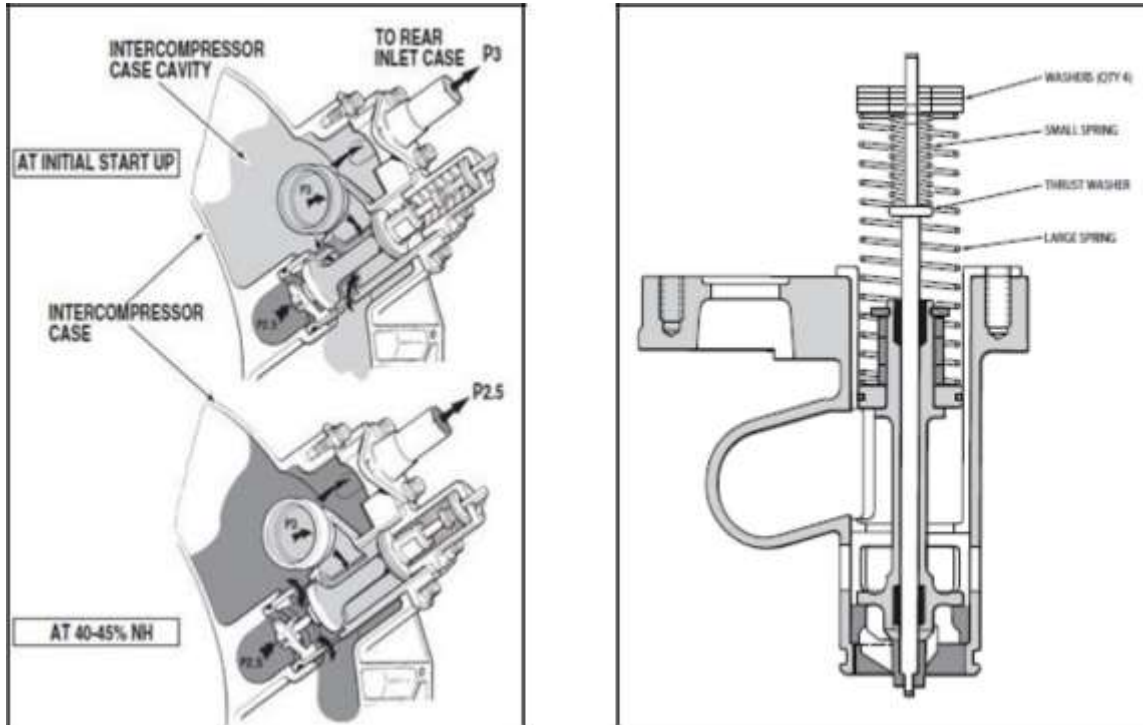
AIR PRESSURE SWITCHING VALVE

The switching valve is located in the intercom pressure case and provides adequate air supply during starting by directing P3 air to areas normally pressurized by P2.5 (during initial start-up, P3 is the only sufficiently pressurized air available). The valve spring holds the valve against the seat, blocking P2.5 air. P3 air enters the intercom pressure case through slots in the valve housing and exits through the adapter to the rear inlet case. P2.5 increases with increasing NH, and at 40% to 45% NH, P2.5 overcomes the spring and pushes the valve and piston up to back P3 air. P2.5 air enters the intercom pressure case and also replaces P3 air in the power turbine shaft seal housing situated in the rear inlet case. As per the maintenance practices the four washers as shown in the figure above are to be installed at all times.

The involved P 2.5/3 Air Switching Valve was removed on 16.06.2014 and inner valve of the Air Switching Valve sent to P&W (SEA) for further investigation due reported smell and cabin and cockpit. Visual inspection to determine any anomalies was carried out. During inspection of the valves, outer diameter was observed with burr and inner diameter of bushing was observed with wear beyond serviceable limits. It was opined that the burr found on outer diameter could cause some restriction to the valve movement as evidence of wear was observed in the internal diameter of the valve that slide along the guide pin. As a result, the valve may not be able to move smoothly within the inner housing and disturbing the balance of the secondary sealing air to the bearing compartment. Any parts within air switching valves could also affect the operation of the P 2.5/3 air switching valve. '

Wear in bushing inner diameter in two of the P 2.5/3 Air Switching Valve
