<b>AIRCRAFT ACCIDENT REPORT AND EXECUTIVE SUMMARY</b>
---

Reference:	CA18/2/3/9350	
<b>Aircraft Registration</b>	ZU-UBB	<b>Date of Accident</b>	18 August 2014		<b>Time of Accident</b>	0908Z
<b>Type of Aircraft</b>	Bat Hawk LSA		<b>Type of Operation</b>	Private		
<b>Pilot-in-command Licence Type</b>		Foreign Validation PPL	<b>Age</b>	53	<b>Licence Valid</b>	Yes
<b>Pilot-in-command Flying Experience</b>		Total Flying Hours	165		Hours on Type	9,5
<b>Last point of departure</b>		Private airstrip (Hazyview, Mpumalanga)				
<b>Next point of intended landing</b>		Bathawk city private airstrip (Nelspruit, Mpumalanga)				
<b>Location of the accident site with reference to easily defined geographical points (GPS readings if possible)</b>						
Bathawk city private airstrip in near Nelspruit left of runway 09 (GPS position: 25°24'59" South 030°5' 4'39" East), elevation 2477 feet						
<b>Meteorological Information</b>		Temperature: 24 °C, Dewpoint: 05 °C, Wind: 330° at 7 knots

**Name of Owner** : Van der Ploeg GJ  
**Name of Operator** : Private  
**Manufacturer** : Pappas AJ  
**Model** : Bat Hawk LSA  
**Nationality** : South African  
**Registration Marks** : ZU-UBB  
**Place** : 25°24'5

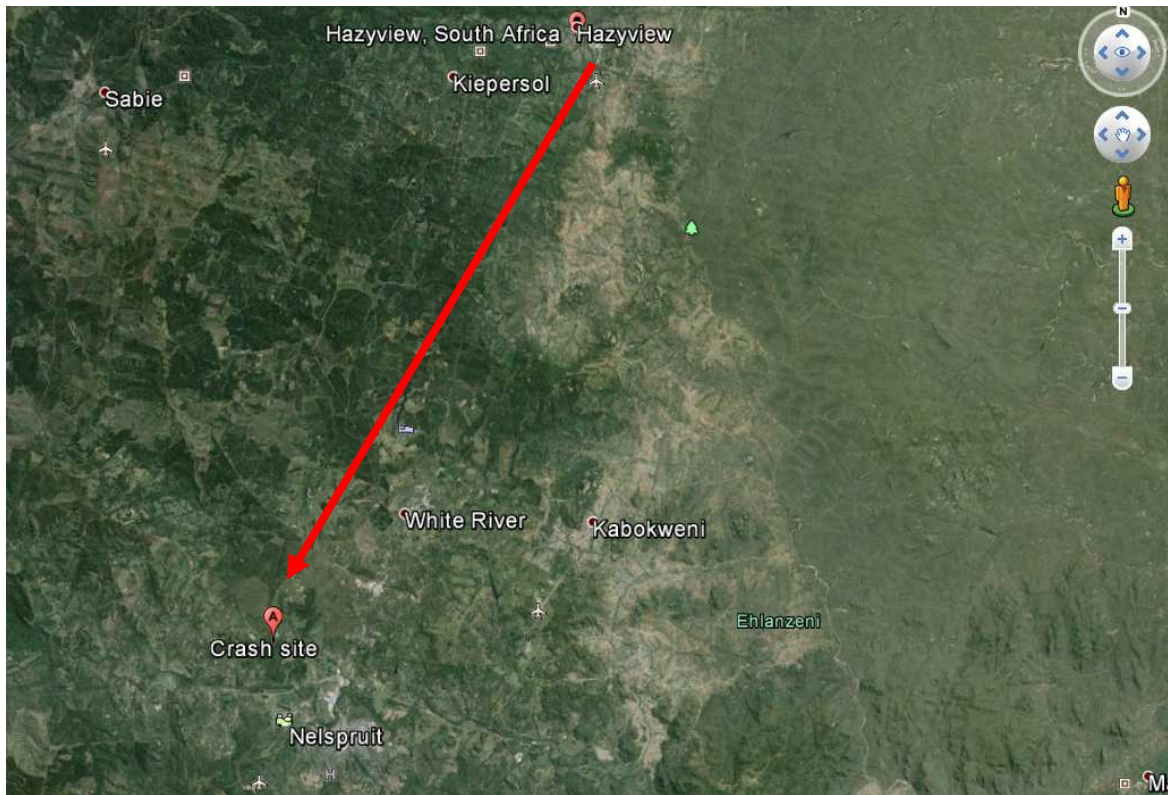
Figure 1: Flight path of aircraft

the active runway. The aircraft sustained damage to the nose gear, windscreen and fuselage. The occupants evacuated without any assistance or injury.
