<b>AIRCRAFT ACCIDENT REPORT AND EXECUTIVE SUMMARY</b>
---

Reference:	CA18/2/3/9356	
<b>Aircraft registration</b>	ZS-ION	<b>Date of accident</b>	12 September 2014		<b>Time of accident</b>	07:10Z
<b>Type of aircraft</b>	Cessna Agwagon A188B		<b>Type of operation</b>	Agriculture Restricted Part 137		
<b>Pilot-in-command licence type</b>	Commercial (CPL)	<b>Age</b>	21	<b>Licence valid</b>	Yes	
<b>Pilot-in-command flying experience</b>	Total flying hours	438.9		Hours on type	149.6	
<b>Last point of departure</b>	Private airstrip near the Waterkloof farm in Heidelberg area, Western Cape Province. GPS Coordinates: S34°17.686' E20° 42.319'					
<b>Next point of intended landing</b>	Private airstrip near Waterkloof farm in the Heidelberg area					
<b>Location of the accident site with reference to easily defined geographical points (GPS readings if possible)</b>						
Open gravel field at the Waterkloof farm, between Heidelberg and Witsand in the Western Cape Province. GPS coordinates : S34°17.686' E20° 42.319' elevation 1843 feet

<b>Probable cause</b>						
The aircraft collided with electrical wires during the agriculture crop spraying operation.						
SRP date	08 August 2017		Release d

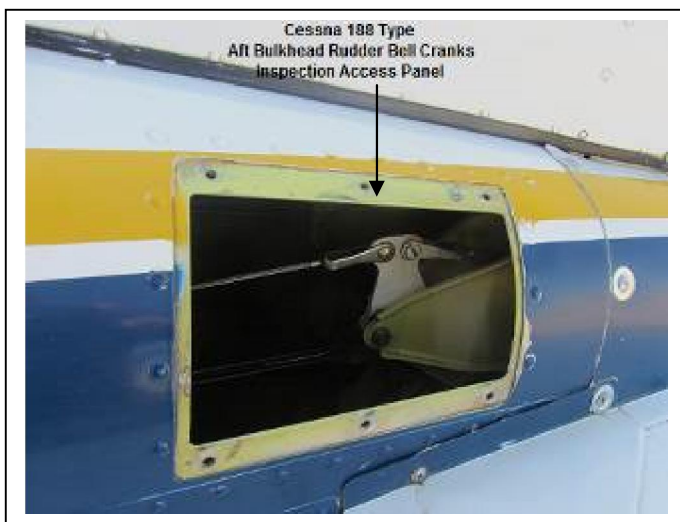
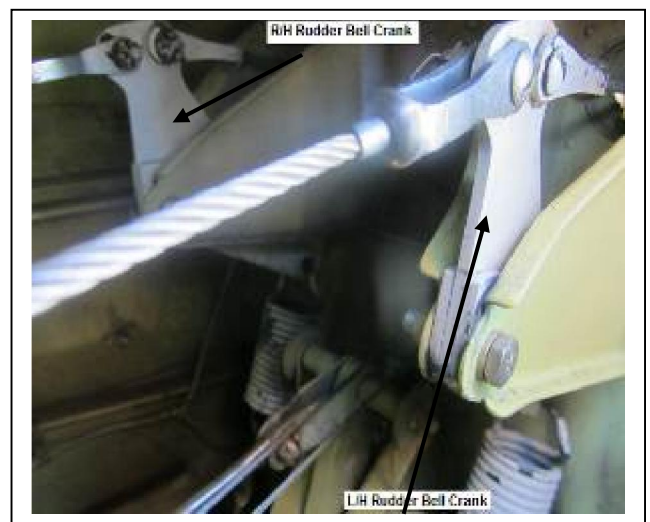
Figure 4 & 5 Example of access panel and bell crank installation in a similar type of aircraft

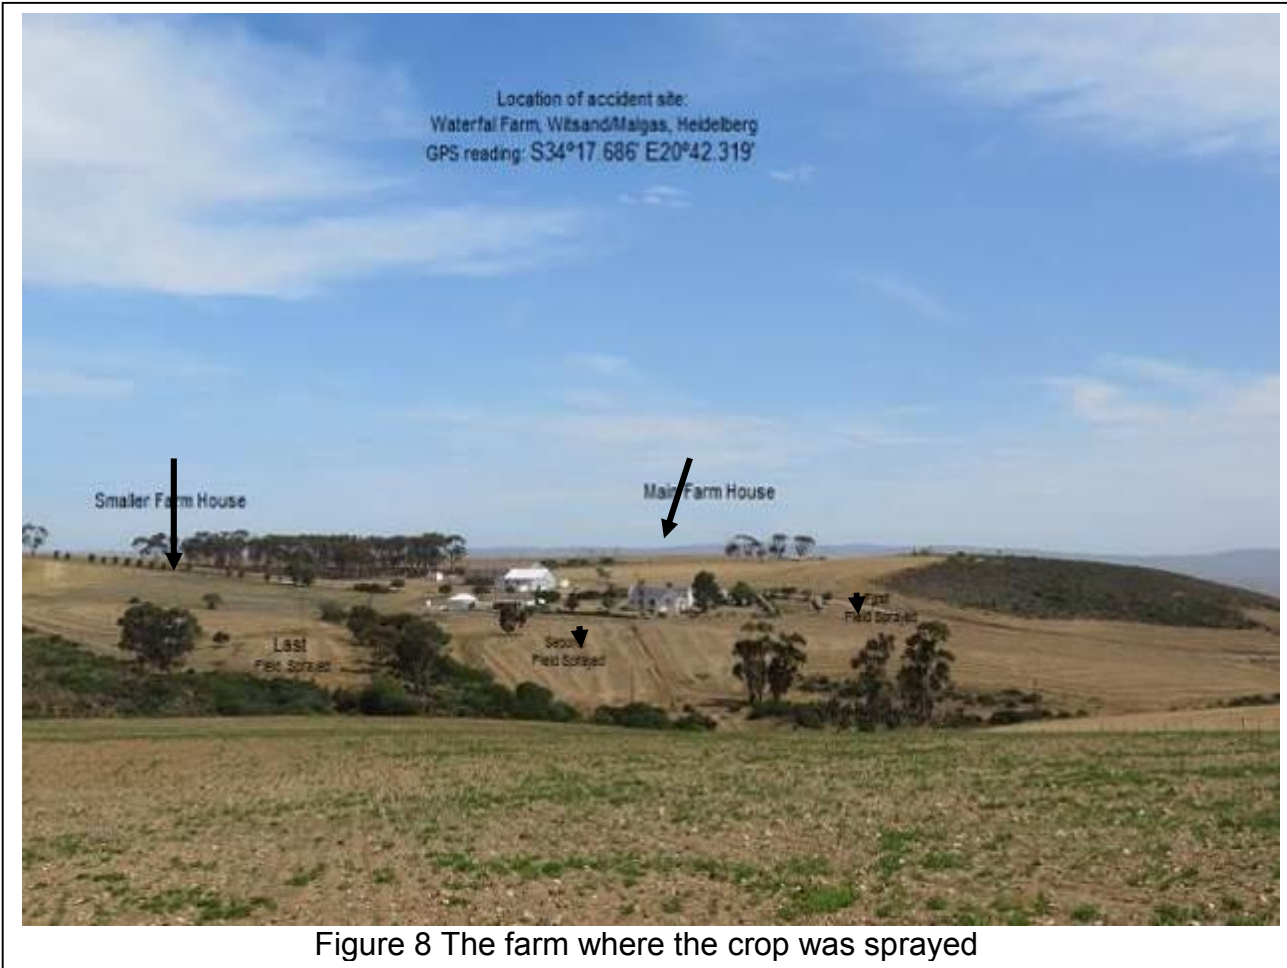
1.12.2 According to witnesses, they heard the sound and saw the aircraft flying over their house at a very low level in the direction of the field. At the time the witnesses saw the aircraft flying overhead, it was heading straight towards the Electrical Wires.

Figure 8 The farm where the crop was sprayed
