**FINAL ACCIDENT REPORT OF
ADVANCE AVIATION COMPANY, LTD'S
EUROCOPTER EC 130 B4, HS- CCN
NEAR PUTAO (NAUNG MOON)
(27- 09- 2014)**

1. Registered owner and operator : Advance Aviation Company Ltd.
2. Aircraft type : Helicopter, Eurocopter EC 130 B4
3. Nationality : Thailand
4. Registration : HS- CCN
5. Place of accident : Near Putao (Nanug Moon)
Latitude N 27° 34' 37.80"
Longitude E 98° 1' 42.42"
6. Date& Time : 27 September 2014 at 14:40 Local time
(+6:30 UTC)
7. Type of operation : Search and Rescue
8. Phase of operation : En-route

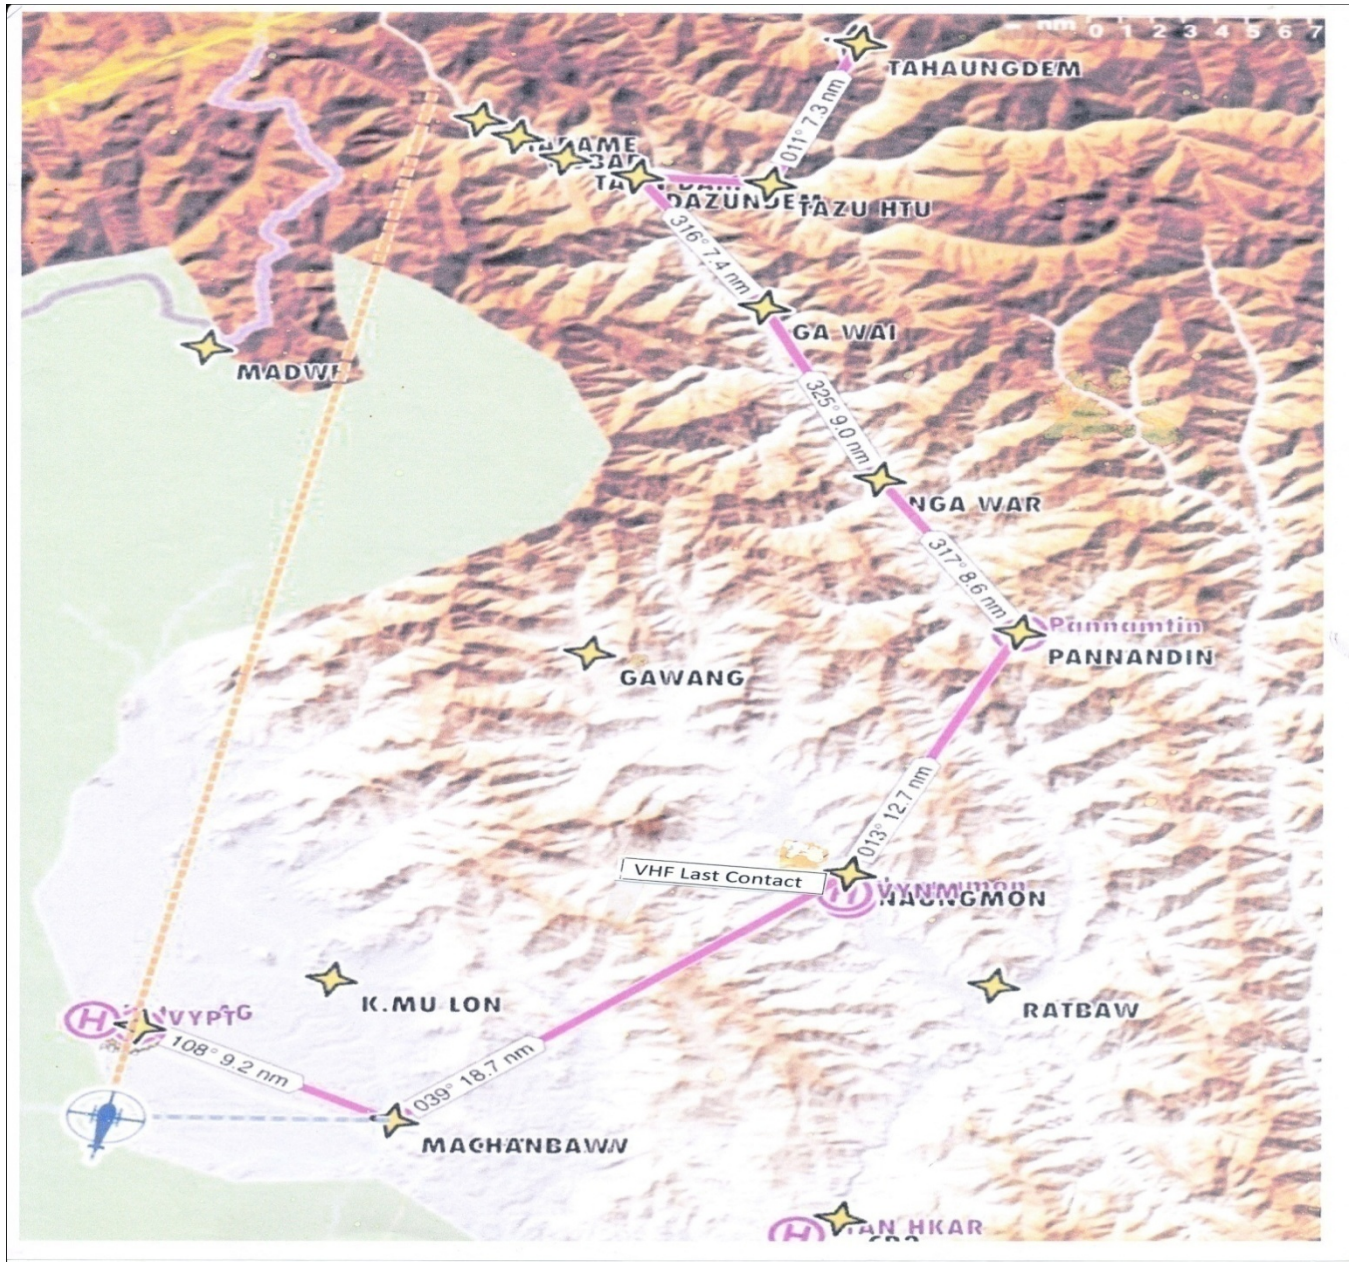
Figure 1: HS- CCN route plan

After received message from Htoo foundation for supply operation to Tahuangdem Search and Rescue team, the Pilot completed the flight planning and prepared the helicopter. The route was planned Putao- Machanbawn- Naung Moon- Pannadin- Dazundem- Tahuangdem. The helicopter was operated by single Pilot with one Navigator (safety Pilot) and one passenger.
