**FINAL REPORT No.4-02/7-14(6-2015)**

**LOSS OF SEPARATION BETWEEN THE AIRCRAFT Bombardier DH8D, flight  
BTI34H and ATR-72-500, flight FCM-72TX, ON November 15, 2014**

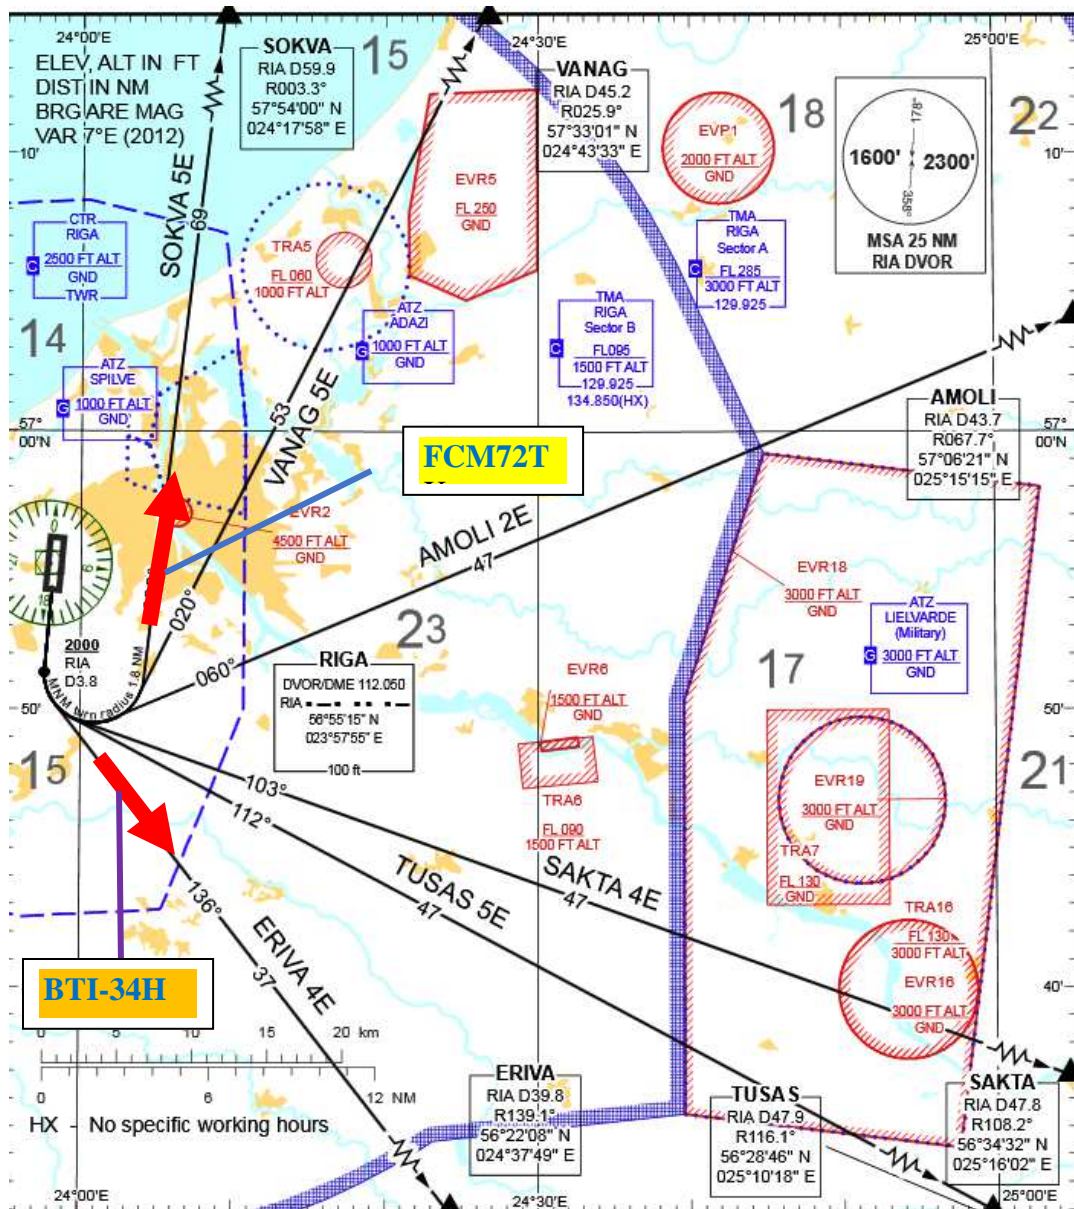
The FCM72TX departed from RWY18 Riga International airport (EVRA) on SID “SOKVA 5E”

The BTI34H departed from RWY18 on SID “ERIVA4E”.

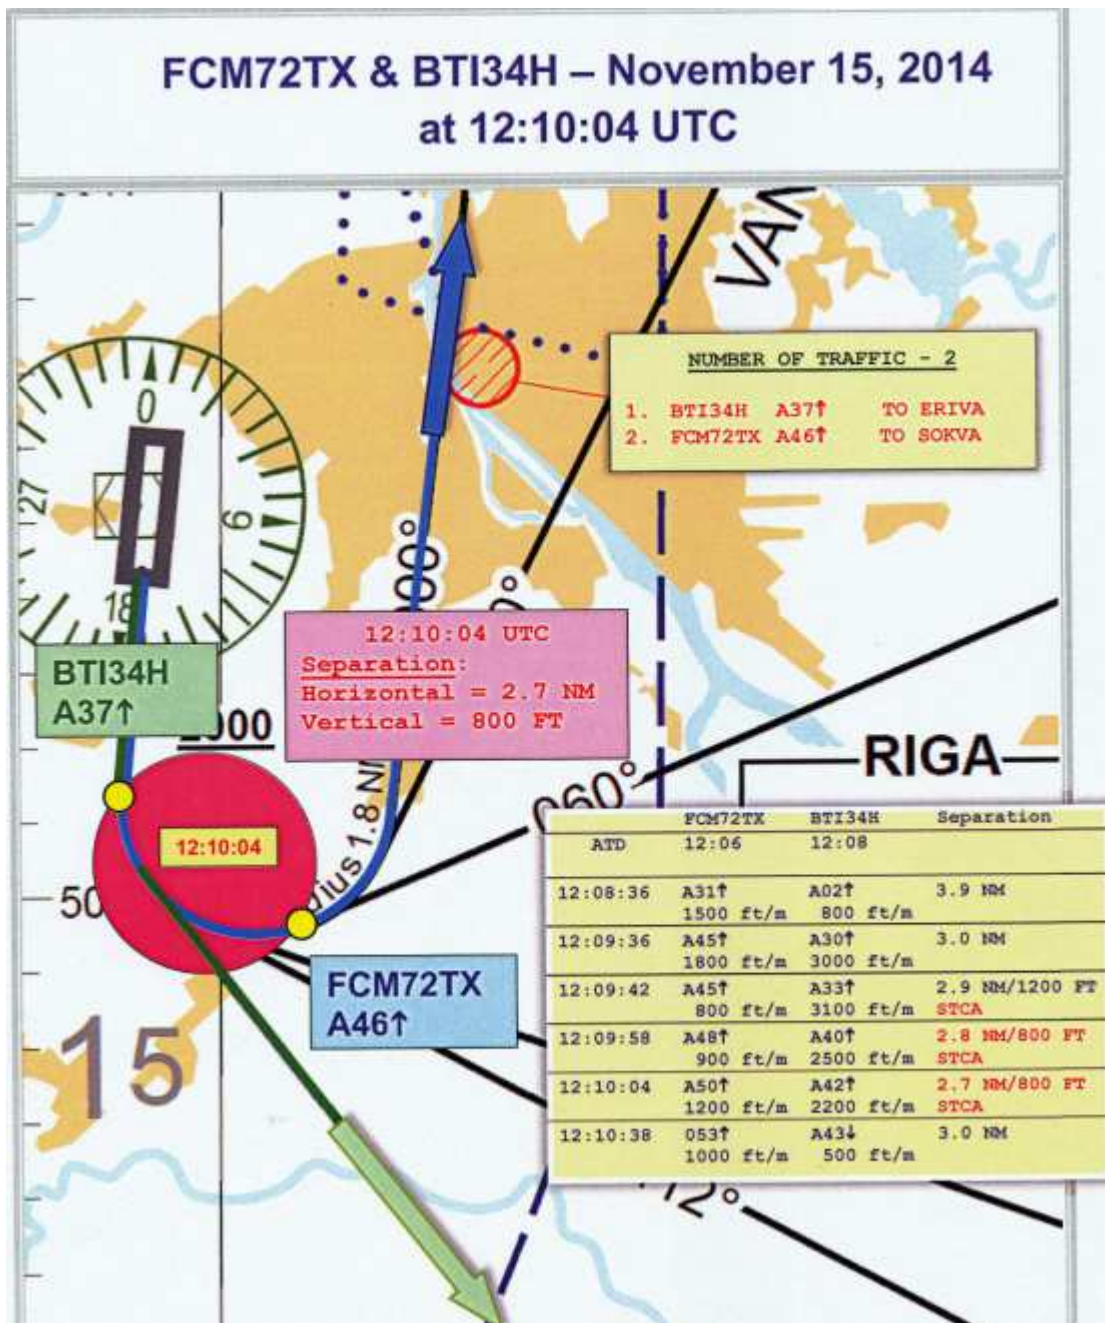
BTI-34H was at altitude **4400FT**, ground speed 156KT on true track 184 degrees. Distance between traffic **2.7NM**. Vertical interval between aircraft was **700FT**.

On time of incident there were 2 aircraft in the AoR of Riga ACC APP Controller.

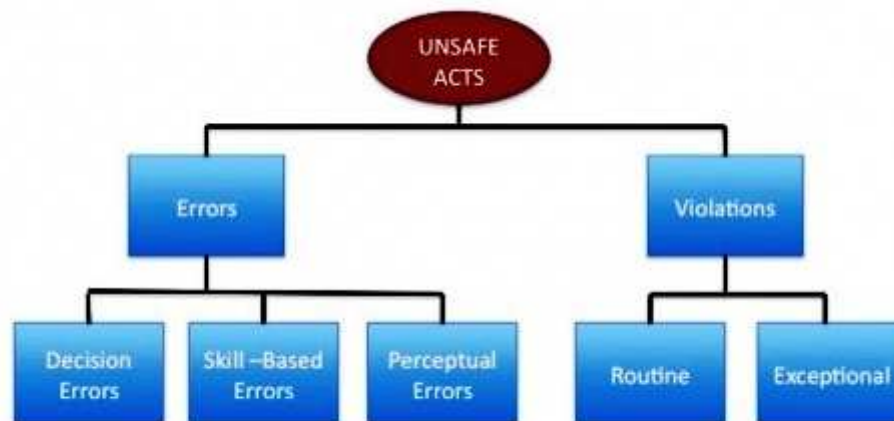
The unsafe acts can be loosely classified into two categories: errors and violations.

The APP controller- student underestimated real air space situation, failed to prioritize attention as a result allowing non gradually aircraft climbing;

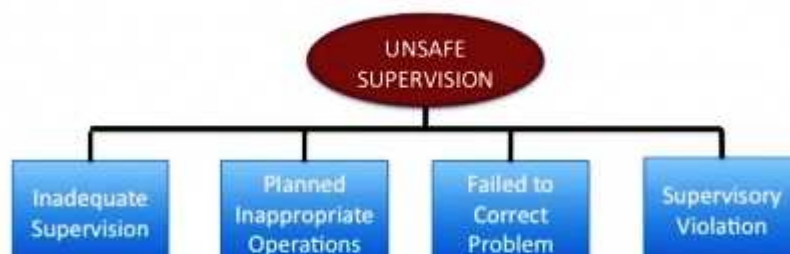
Exist four categories of unsafe supervision:

The OJTI assumed that student will stop succeeding traffic at 4000 FT for providing vertical separation but upon understanding students' mistake the instructor should have cancelled issued wrong clearance by himself. The OJTI failed to communicate /coordinate **in a timely manner**, his actions was too slow and dilatory.
