AAIS Case N°: AIFN/0021/2014

Remote Control Circuit Breaker Short Circuit

Aircraft Type: A380-861 / GP7270

Registration: A6-EDD

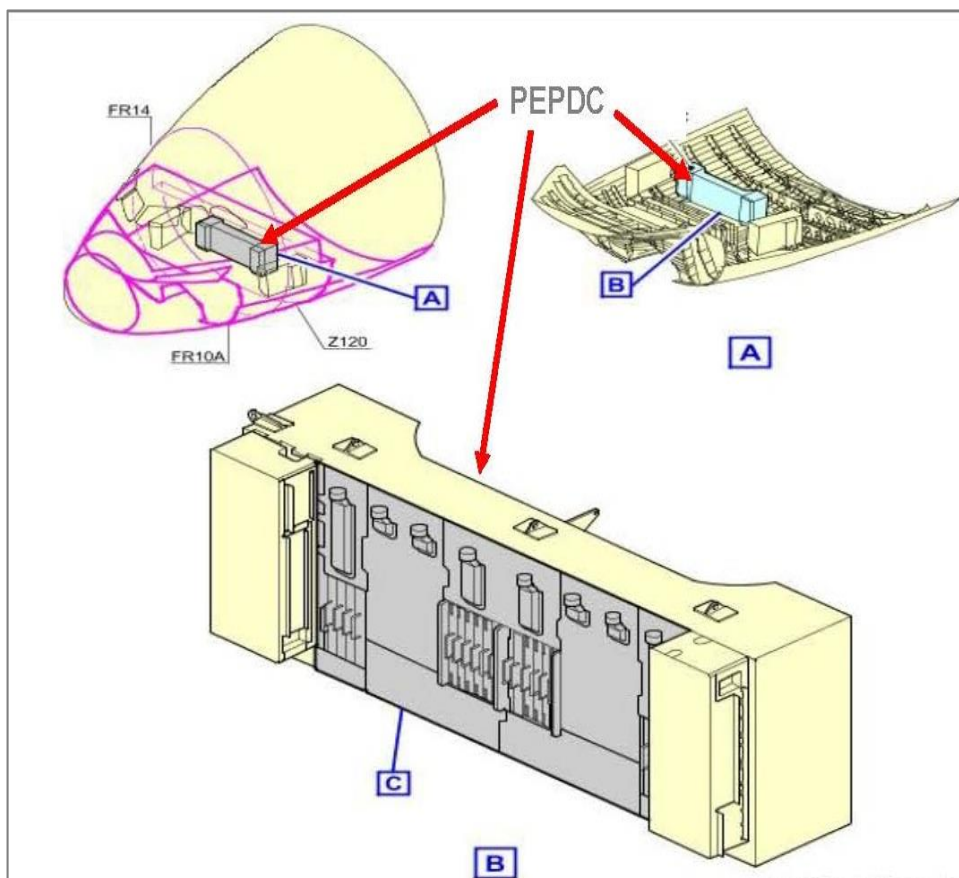
Figure 4. PEPDC Location- Main Avionics Compartment

On the Occurrence Aircraft, above the PEPDC, toilets are installed on the main deck floor and associated water and waste plumbing are circulating between the ceiling of the avionics compartment and the main deck cabin floor.

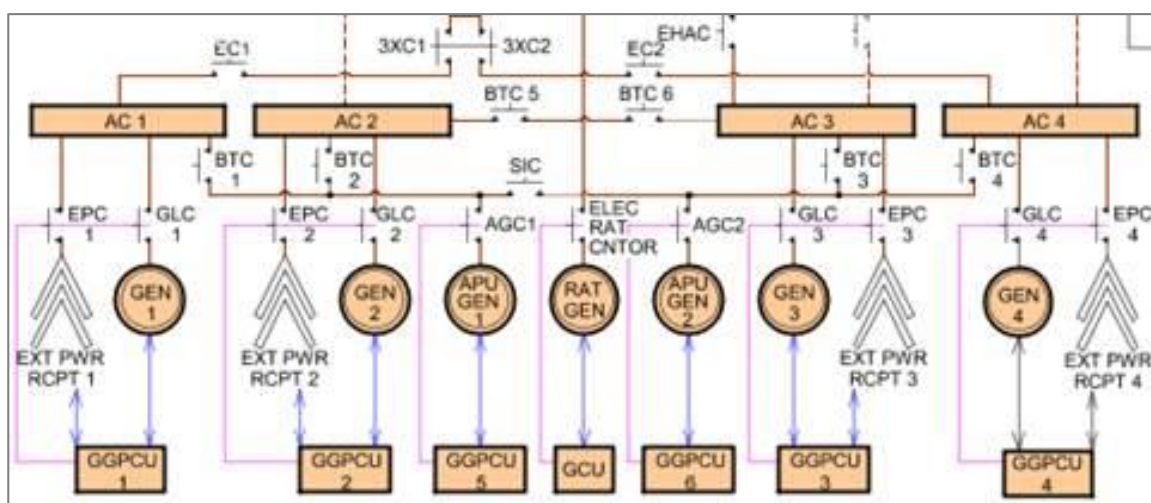
Figure 7. A380 Electrical Power Schematic

- Aircraft was electrically powered by APU GEN1 and APU GEN2 respectively supplying AC1 + AC2 and AC3 + AC4.
- External power 1 was connected but was not supplying AC1 (i.e. "AVAIL" / EPC1 open).

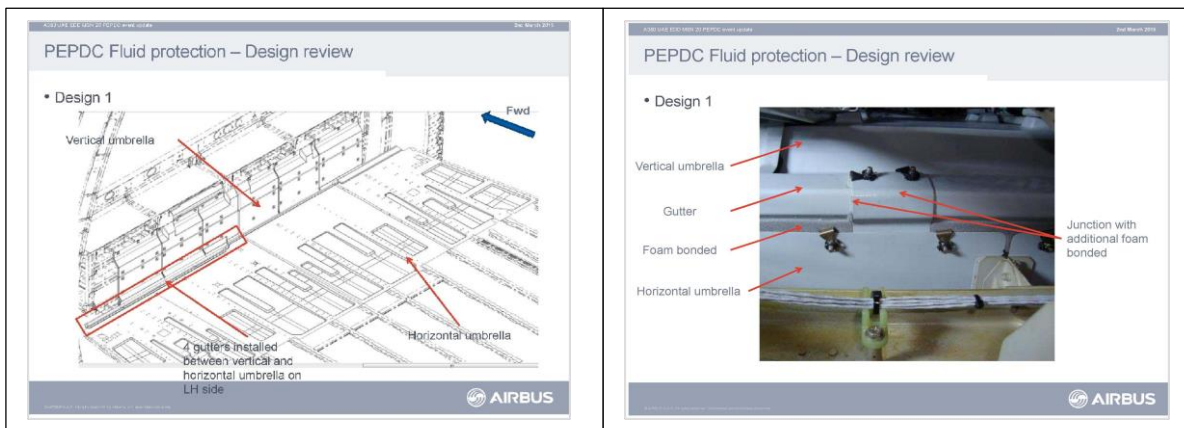
Figure 10. Design 1 Fluid Protection

- Four horizontal umbrellas at door one entrance area which are fixed on the floor structure and sealed between each member by tape.
- In design 1, waterproofness between horizontal and vertical umbrellas is ensured by a gutter equipped bonded foam.
- In design 2, waterproofness between horizontal and eight vertical umbrellas is ensured by a gutter equipped elastomer seal.
- The Occurrence Aircraft was fitted with design 1.

1. The PEPDC fluid protection was found to be deteriorated.
2. Foam was found to be debonded and missing at some locations, and in particular at the junction.
3. Fluid stains were found in areas below the umbrella, including stains on the PEPDC.

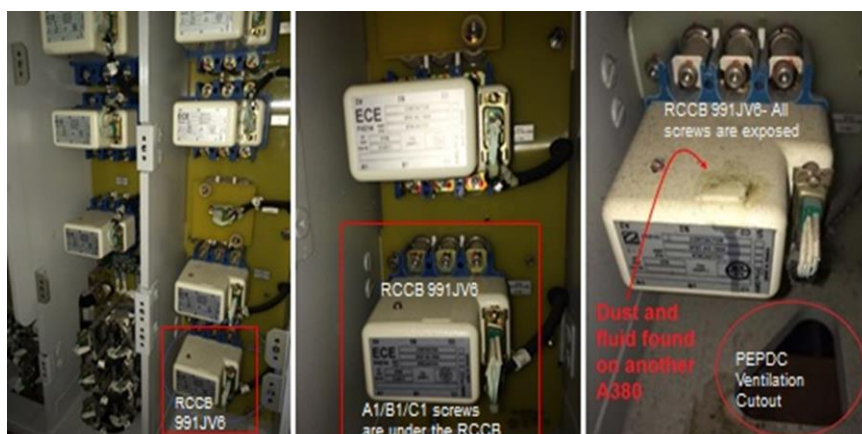
Figure 14. RCCB 991JV6 normal installation

In this installation, the six screws of the RCCB, A1/B1/C1/A2/B2/C2, are all exposed. A1/B1/C1 screws are located on the underside of the RCCB. The PEPDC ventilation blows air directly on the RCCB as the cut-out for the airflow is located next to the RCCB. The RCCB was dusty with fluid stains.

- For the six years the Aircraft was in-service, Airbus commented that RCCB 991JV6 was more prone to accumulate dust than upper contactors as it is located just above the PEPDC ventilation hole.
- Airbus mentioned that the short circuit across the RCCB was most likely generated by the mixture of dust and liquid that created an electrical arc between two phases, B1 and C1, of the RCCB as noted on figure 16.
- The Investigation could not determine the amount of dust that would have accumulated.
