<b>AIRCRAFT ACCIDENT REPORT AND EXECUTIVE SUMMARY</b>
---

Reference:	CA18/2/3/9420	
<b>Aircraft registration</b>	ZS-HBV	<b>Date of accident</b>	8 March 2015		<b>Time of accident</b>	1000Z
<b>Type of aircraft</b>	Garlick UH-1H (Helicopter)		<b>Type of operation</b>	Fire fighting		
<b>Pilot-in-command licence type</b>	Commercial		<b>Age</b>	71	<b>Licence valid</b>	Yes
<b>Pilot-in-command flying experience</b>	Total flying hours		10 970.7		Hours on type	227.6
<b>Last point of departure</b>	Newlands Forest Station, Western Cape					
<b>Next point of intended landing</b>	Cape Point National Park, Western Cape					
<b>Location of the accident site with reference to easily defined geographical points (GPS readings if possible)</b>						
Open field in the Cape Point National Park (GPS position: 34°15.771' South 018°25.101' East)						
<b>Meteorological information</b>	Surface wind: ±160°/10kt gusting 20kt, Temperature: 16°C, Visibility: + 10 km					
<b>Number of people on board</b>	1 + 0	<b>No. of people injured</b>	0	<b>No. of people killed</b>	1

<b>Probable cause</b>						
<p>The pilot was unable to regain control of the helicopter following a loss of tail rotor thrust, which was cause

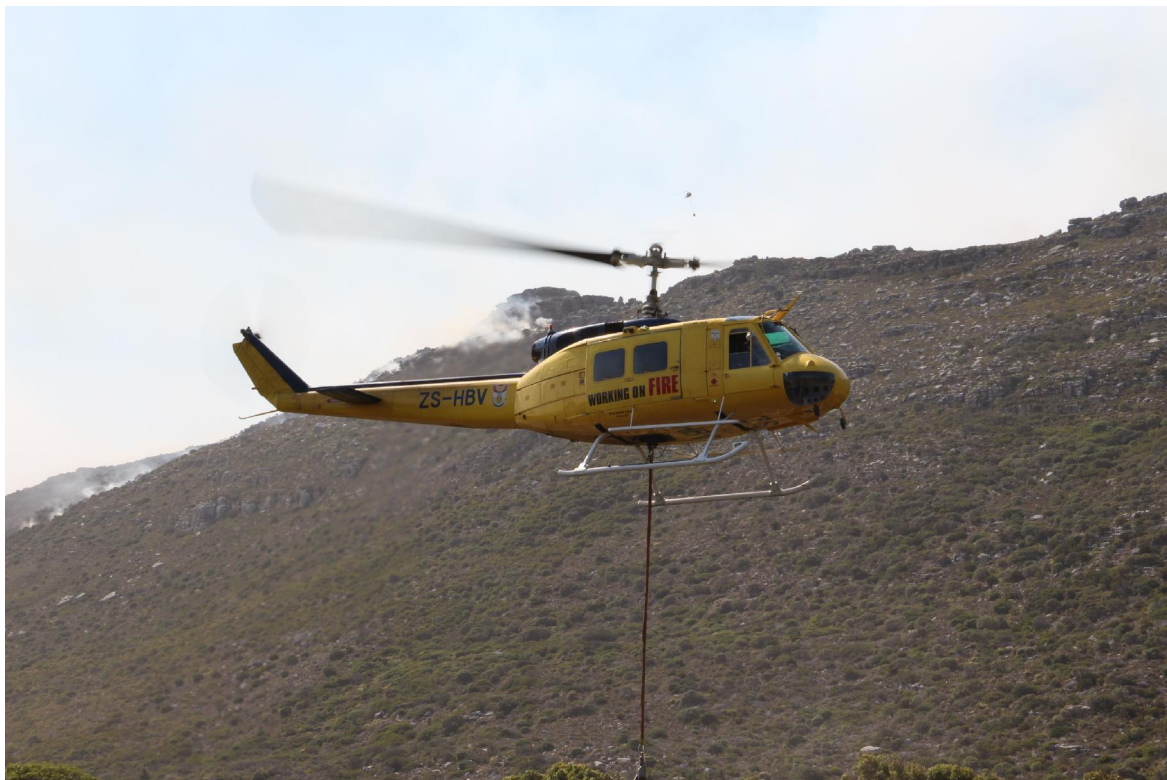
**Figure 3.** The helicopter ZS-HBV, courtesy of Dale Carter

helicopter in question was equipped with an extended height landing gear kit, which provided significant extra ground clearance for the installation of belly-mounted equipment. The skid gear can be seen in Figure 3 on page 8 of this report, which would have raised the helicopter by approximately another 70 centimetres, or just over 2 feet from the ground when parked on a level surface. Therefore, when oil needed to be added in either or one of these two gearboxes the pilot would require a very long stepladder or another means of getting to the filler caps (i.e., a proper maintenance stand). To replenish the 42° gearbox, the gearbox cowling must be removed in order to gain access to the filler cap. As the Newlands Forest Station is not a maintenance base, no maintenance stands were available that maintenance personnel or pilots could use. They had to use a long stepladder or an alternative means of reaching these two gearboxes, especially the 90° tail rotor gearbox, which on this helicopter would have been approximately 4m (13 feet) from the ground.

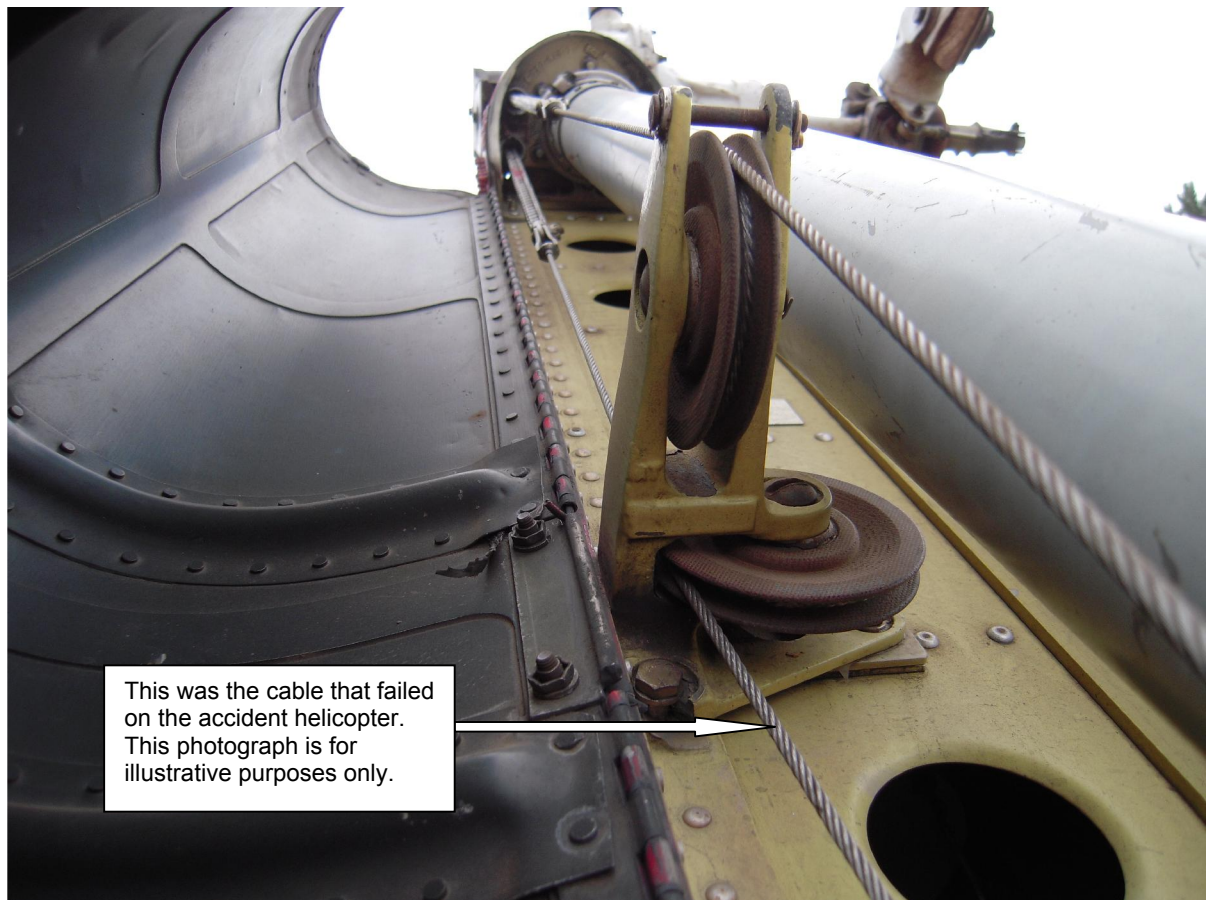
**Figure 15.** A photograph of the tail rotor control cable orientation on a serviceable helicopter (similar type)

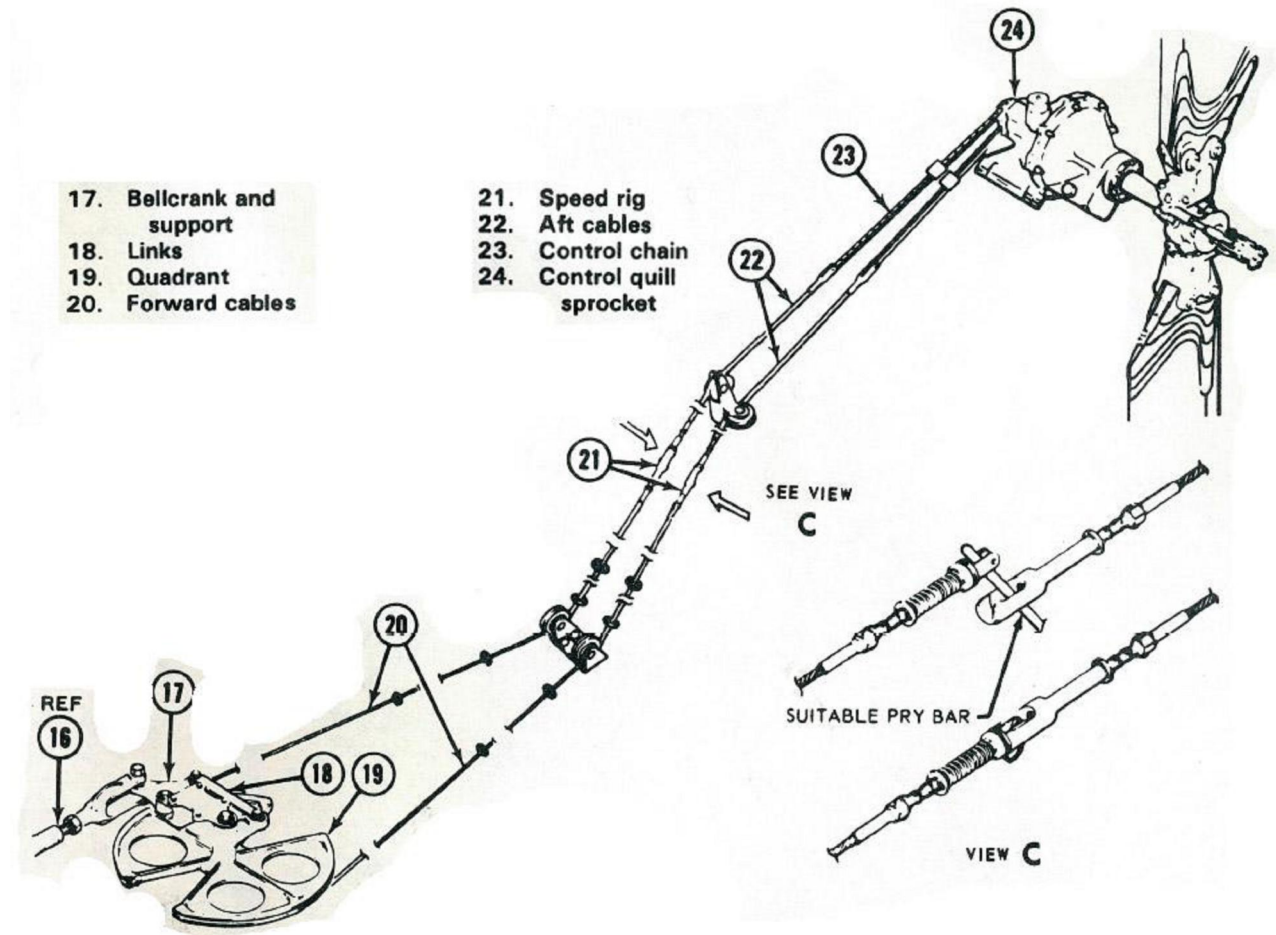
The tail rotor crosshead bearing was free to rotate by hand. See Figure 23 for the tail rotor control cable and chain rigging schematic.

**Figure 23:** Schematic of the tail rotor control cables and chain rigging with the control quill sprocket (24)

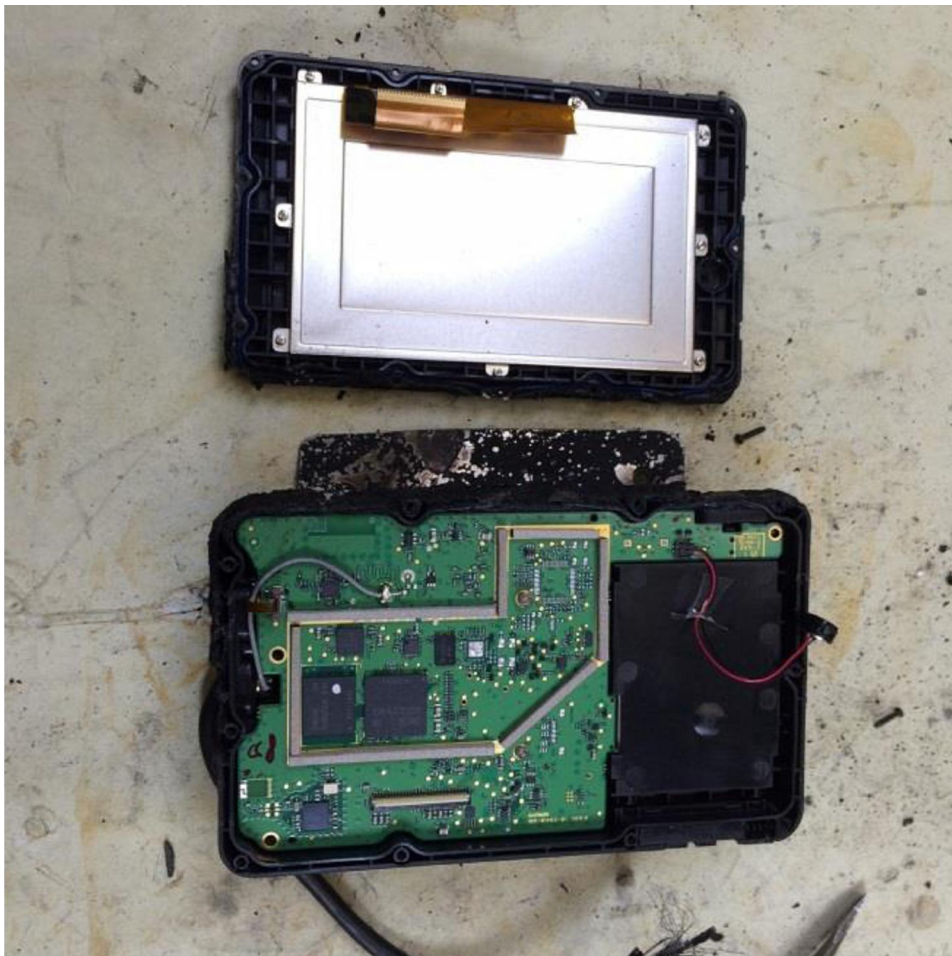
The screen of the unit was removed, which revealed that the unit's internal circuit board was in an excellent condition. The device USB port was still intact and was connected to a PC via a standard mini-USB cable. Power was applied, the PC recognized the device and waypoint and tracklog information was downloaded normally using the manufacturer's standard procedure. Additionally, the non-volatile memory (NVM) chip was identified from the main circuit board and was removed. The chip was read out in binary format and was converted using laboratory software. The results of the two downloads were compared.

**Figure 36.** The internal circuit board with the screen removed

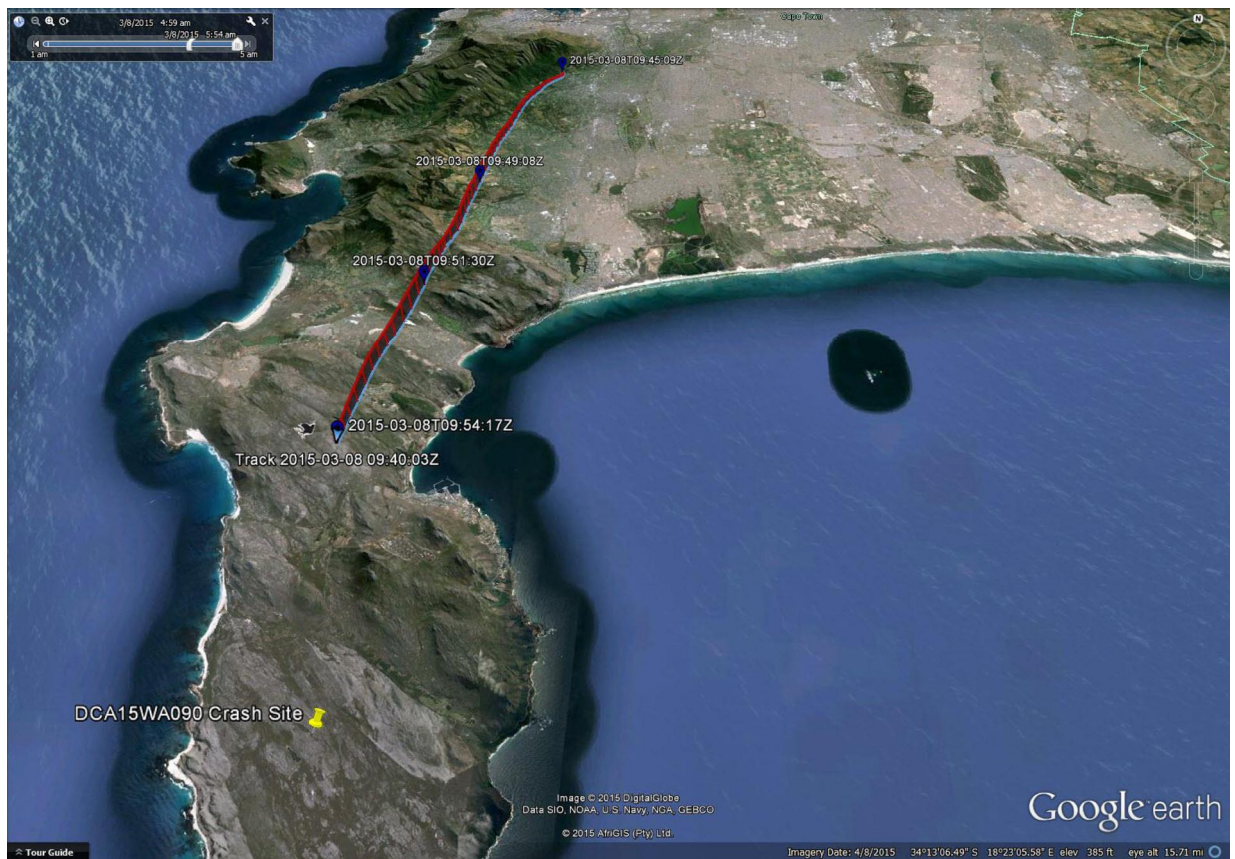
Figure 37 is a graphical overlay generated using Google Earth for the accident flight. The weather and lighting conditions in Google Earth are not necessarily the weather and lighting conditions present at the time of the recording.

The flight left the helicopter base at 09:40:09Z. The helicopter began tracking in a southerly direction and eventually settled into cruise between 2 000 and 3 000 feet and a derived groundspeed of between 80 and 110 miles per hour (mph). The data ended 0.6 nautical miles southeast of Kleinplaas Dam, showing the helicopter at a GPS altitude of 2 303 feet, on a derived track of 185° true and a derived groundspeed of 106 mph. Due to data buffering on the GPS unit, the date recording ended before the accident event. The last recorded parameter was at 09:54:17Z on 8 March 2015, which was approximately 5 nm before the crash site.

**Figure 37.** Google Earth overlay showing the entire recovered portion of the accident recording

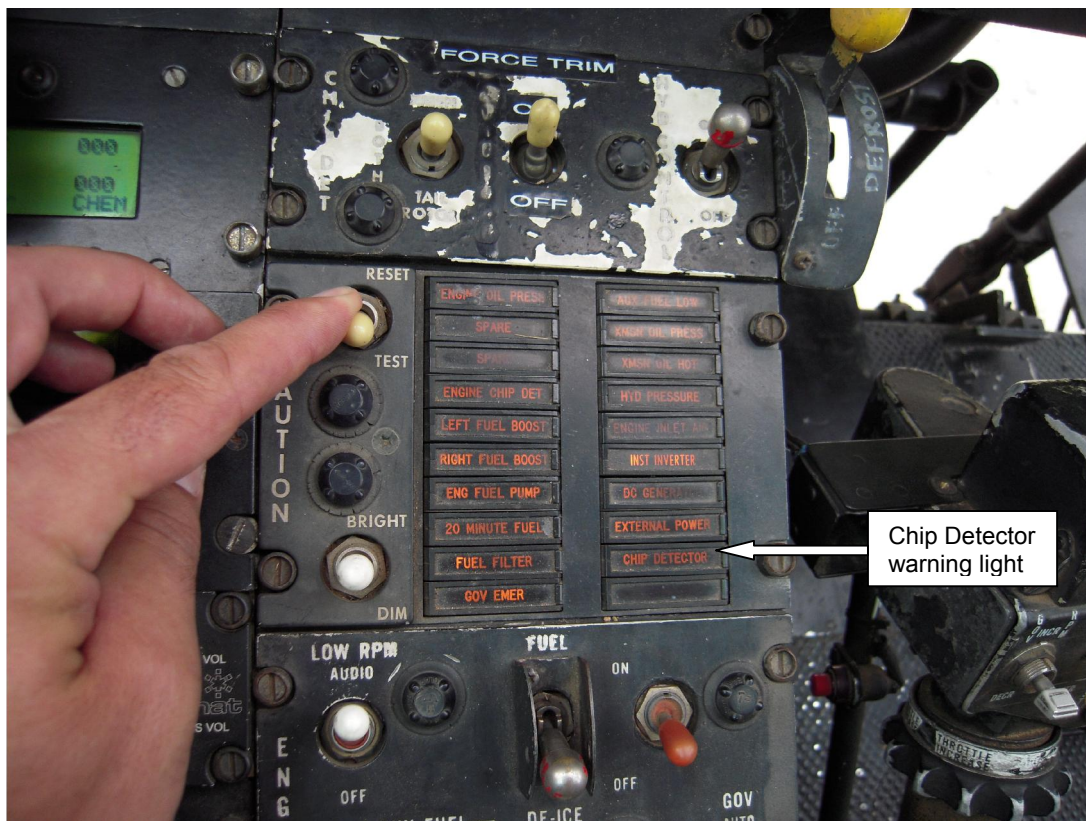
*(2) Chip Detector Switch. A CHIP DETECTOR switch (Figure 38) is installed on a pedestal mounted panel. The switch is labelled BOTH, XMSN, and TAIL ROTOR and is spring-loaded to the BOTH position. When the CHIP DETECTOR segment in the CAUTION panel lights up, position the switch to XMSN, then TAIL ROTOR to determine the trouble area. CHIP DETECTOR caution light will remain on when a contaminated component is selected. The light will go out if the non-contaminated component is selected.”*

Figure 38. The caution segments on the annunciator panel (photograph was taken in another UH-1H)

The flight appeared to progress satisfactorily until the helicopter was approaching the vicinity of the Sirkelsvlei Dam, when the pilot broadcast over the company VHF radio frequency that he had a chip detector warning light in the cockpit (this is an amber light on the annunciator panel, as can be seen in Figure 38 on page 43 of the report). When the lead pilot asked which chip warning light it was, he stated it was the tail chip light. He was then advised by the lead pilot to land on the service road, which was located to his left, in order to inspect the magnetic plugs on the 42° intermediate gearbox as well as the 90° tail rotor gearbox. He opted to proceed ahead to where the helicopter support vehicle was located, which was approximately 2 nm to the south of his location at the time. Shortly thereafter he broadcast a mayday call. After he had executed a 180° turn and observed the helicopter at approximately 800 feet AGL rotating in a clockwise direction, the lead pilot told him to close the throttle and lower the collective pitch lever. There was no further communication from the pilot flying the ill-fated helicopter. The pilot flying the second helicopter also observed the helicopter rotating in a clockwise direction and making abrupt movements. It could not be determined why the pilot did not jettison the Bambi bucket when tail rotor control was lost. It could be that he became preoccupied when the chip detector warning light came on, as he was
