AIRCRAFT ACCIDENT REPORT AND EXECUTIVE SUMMARY

Reference:	CA18/2/3/9432	
Aircraft Registration	ZS-RBS	Date of Accident	17 April 2015		Time of Accident	1230Z
Type of Aircraft	Robinson R22 Beta		Type of Operation	Commercial		
Pilot-in-command Licence Type		Commercial (H)	Age	41	Licence Valid	Yes
Pilot-in-command Flying Experience		Total Flying Hours	7825.2		Hours on Type	3998.5
Last point of departure		Grahamstown aerodrome (FAGT): Eastern Cape province				
Next point of intended landing		Private air strip in Somerset East: Eastern Cape province				
Location of the accident site with reference to easily defined geographical points (GPS readings if possible)						
On a game farm south of Somerset East at GPS Co-ordinates: S32° 54' 56", E025° 21' 31"						
Meteorological Information		Wind direction: 180° at 10kts; Visibility: 10000ft; Cloud base: 8000ft				
Number of people on board	1+1	No. of people injured	2	No. of people killed	0	
Synopsis

AIRCRAFT ACCIDENT REPORT

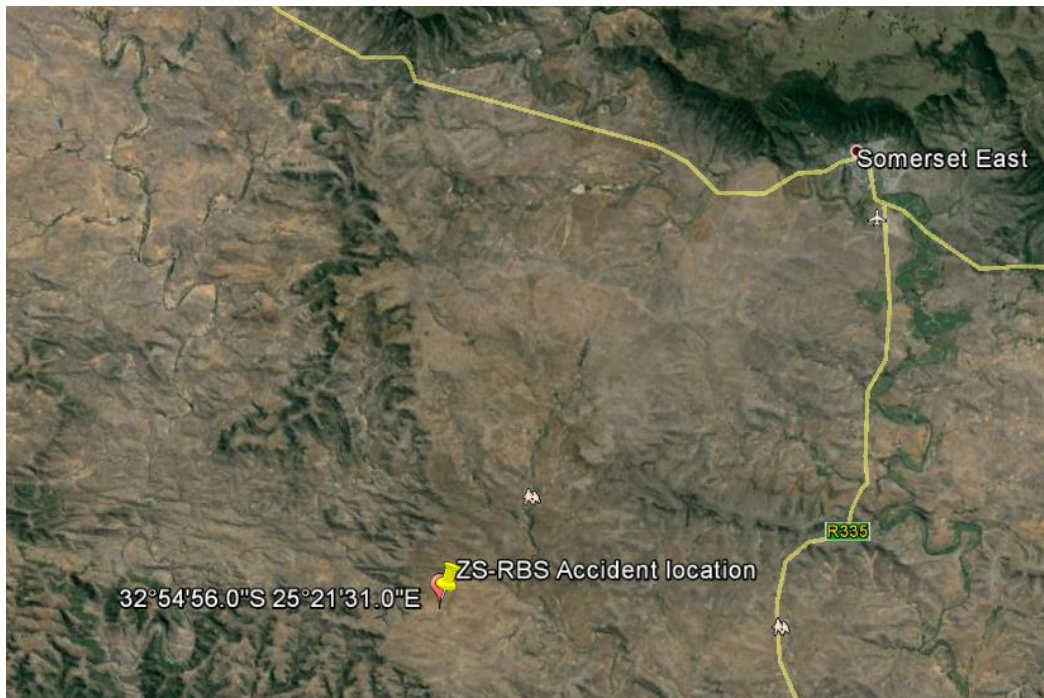
Figure 2: Google Map view of the terrain in the region of the accident site

anthills. Ground marks were made during the post-impact sequence and these were identified and accounted for to obtain information on the accident sequence. The wreckage distribution was located within a radius of approximately 20 metres.

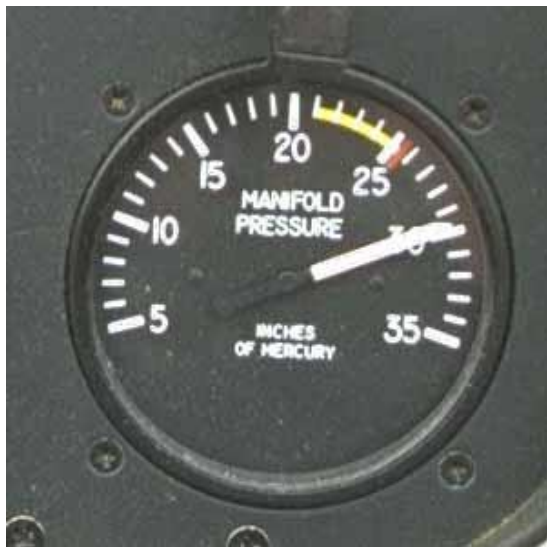
Figure 4: The manifold pressure gauge

The rightmost bottom gauge is the Manifold Pressure gauge. The pilot uses this gauge to determine the throttle setting. In the R22 the pilot calculates a maximum manifold pressure, taking into account the current temperature and pressure. By calculating this maximum and not exceeding it, the pilot derates the engine from the 160 horsepower which is actually available, to the derated maximum of 124 horsepower (continuous) or 131 horsepower (for up to 5 minutes). Derating the engine prolongs its useful life, making it more reliable than if full power were being used on a regular basis. It also means that full power is available to a higher altitude, just as if the engine were turbocharged.

1.18.1 According to the pilot's response in the CA 12-03 Pilot Questionnaire, the manifold pressure was observed to be 21 inches. Control of a helicopter during an animal darting operation calls for much co-ordination during manoeuvring. This subjects the helicopter into variable pitch changing and adjustments to power required.

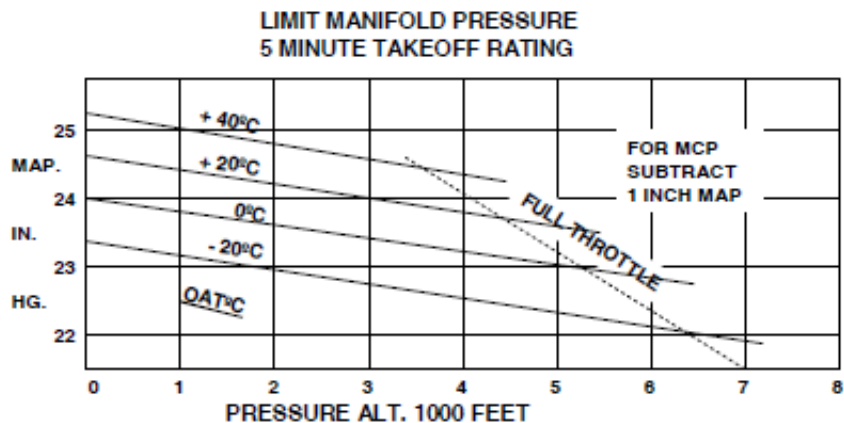
Figure 5: Manifold limitation

At standard sea level conditions, the maximum continuous manifold pressure limit is 22.4 inches for the R22 Beta. The manifold pressure limits are even less at higher altitude or lower temperatures. Operation above these limits may produce fatigue damage in rotor blades or drive system components which can result in a catastrophic in-flight failure.

Yellow arc: 21.0 to 25.2 in. Hg. Red line: 25.2 in. Hg

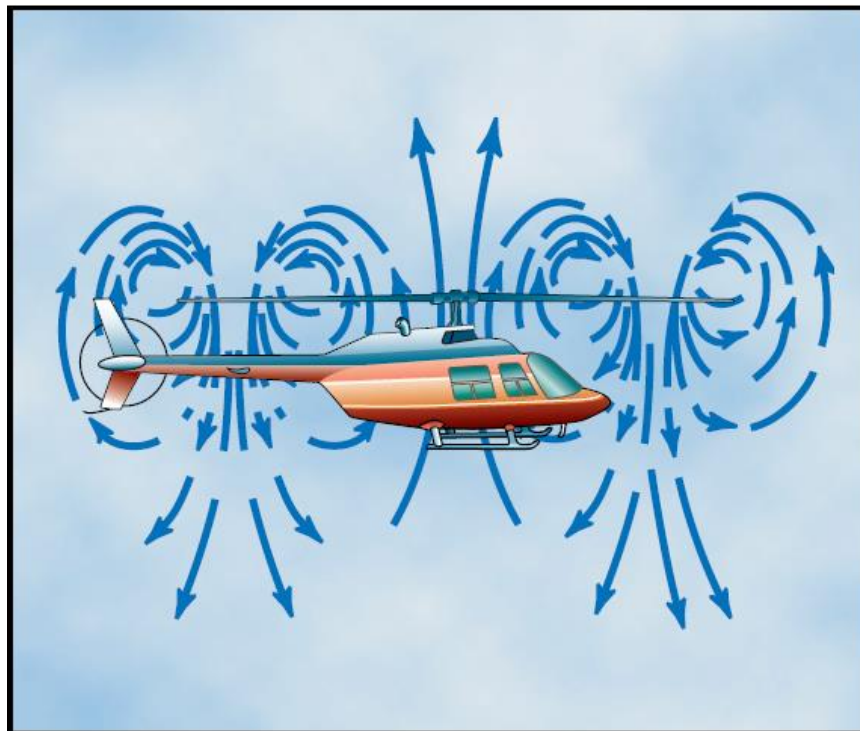
Figure 7: The vortex ring state

Probable Cause						
The helicopter entered into a vortex ring state during hover out-of-ground effect at a height of approximately 130ft above ground level and the pilot was unable to recover.						
Contributing Factor/s						
<ol style="list-style-type: none"> 1. Insufficient power available to sustain hover. 2. Induced power coordination as a result of pilot diverting his attention. 						
IARC Date				Release Date		
CA 12-12a		11 JULY 2013		Page 1 of 21

The term “vortex ring state” refers to an aerodynamic condition in which a helicopter may be in a vertical descent with the application of between 20 percent and maximum power, and little or no climb performance. The term “settling with power”

arises from the fact that the helicopter keeps settling even though full engine power is applied. In a normal out-of-ground-effect (OGE) hover, the helicopter is able to remain stationary by propelling a large mass of air down through the main rotor. Some of the air is recirculated near the tips of the blades, curling up from the bottom of the rotor system and re-joining the air entering the rotor from the top. This phenomenon is common to all air-foils and is known as tip vortices. Tip vortices generate drag and degrade air-foil efficiency.

A fully developed vortex ring state is characterised by an unstable condition in which the helicopter experiences uncommanded pitch and roll oscillations, has little or no collective authority, and achieves a descent rate that may approach 6,000 feet per minute (fpm) if allowed to develop.
