<b>AIRCRAFT ACCIDENT REPORT AND EXECUTIVE SUMMARY</b>
---

Reference:	CA18/2/3/9433	
<b>Aircraft Registration</b>	ZU-UHI	<b>Date of Accident</b>	22 April 2015		<b>Time of Accident</b>	1405Z
<b>Type of Aircraft</b>	Bell 205 – UH-1H		<b>Type of Operation</b>	Fire Fighting - Part 137		
<b>Pilot-in-command Licence Type</b>		Commercial	<b>Age</b>	39	<b>Licence Valid</b>	Yes
<b>Pilot-in-command Flying Experience</b>		Total Flying Hours	2 914		Hours on Type	1 567.4
<b>Last point of departure</b>		Tulbagh Forestry Station (Western Cape)				
<b>Next point of intended landing</b>		Bains's Kloof Pass area (Western Cape)				
<b>Location of the accident site with reference to easily defined geographical points (GPS readings if possible)</b>						
Bains's Kloof Pass area (GPS coordinates: S33°36'30.68' E019°6'29.18') and a field elevation of 2026ft						
<b>Meteorological Information</b>		Surface wind: 045 <sup>0</sup> at 12-15 kt, Visibility: CAVOK				
<b>Number of people on board</b>	1 + 1	<b>No. of people injured</b>	0	<b>No. of people killed</b>	2

**Name of Owner** : FFA Assets (Pty) Ltd  
**Name of Operator** : FFA Aviation (Pty) Ltd  
**Manufacturer** : Bell Helicopter Textron  
**Model**

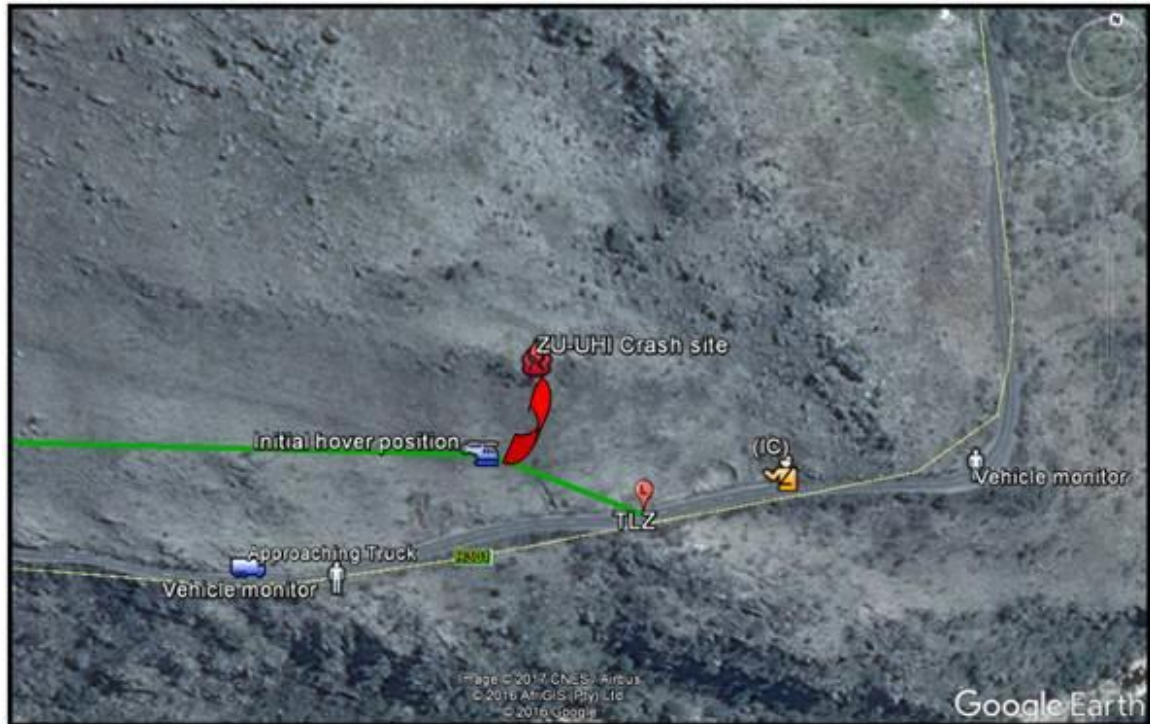
**Figure 1:** Google Earth image of the accident site

The pilot then steered the helicopter away from the road in the direction of the mountain (to the left). The IC witnessed the helicopter initially banking slightly to the right and then to the left, then colliding with terrain. He then ran towards the helicopter; as he got closer he observed fuel was leaking. Although the main rotor was separated from the helicopter, the engine was still running. The fuel ignited and a fire started. He then started using his knife to cut off the safety harness and removed the pilot from the helicopter. The fire became intense and he could not go back to remove the HSL who was seated in the rear seat.

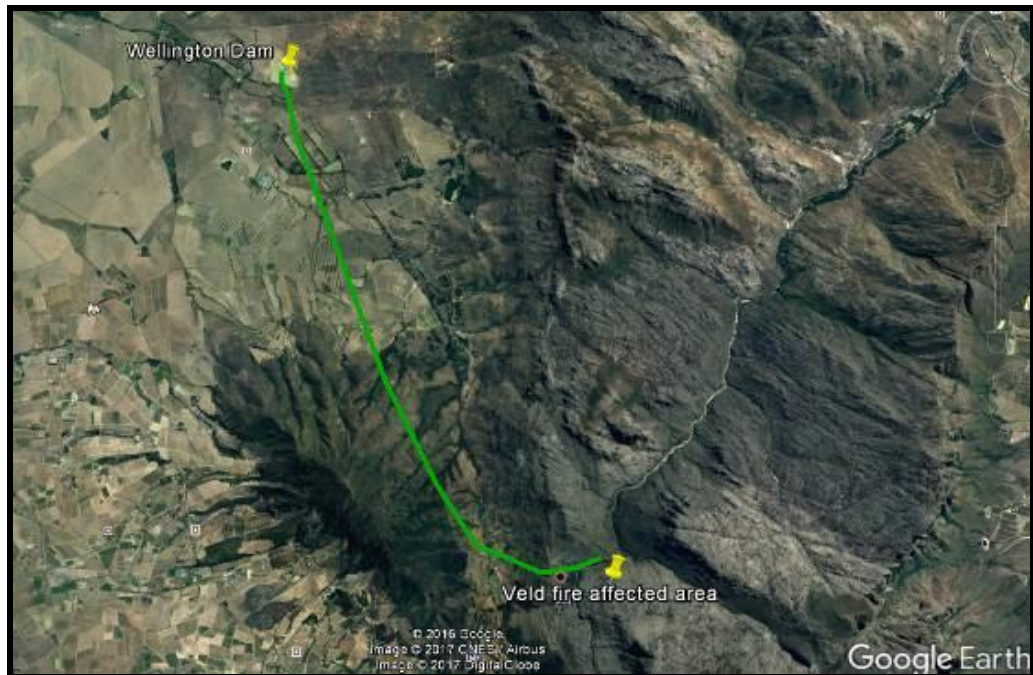
**Figure 5:** Google Earth view of the operational area

1.12.2 The helicopter was to uplift water from a farm dam approximately 10 km north-west of the fire-affected area. At the time of the accident, the helicopter (ZU-UHI) approached the temporary landing zone from the south-west and was facing north-east, hovering for landing to have the bambi bucket attached to the helicopter for

fire-fighting operations. The helicopter was then observed to turn to the right and then to the left as it pitched nose up, before its main rotor blades impacted with high-rising terrain on the left and it crashed. The distance from the temporary landing zone (on the R103 regional road) to the accident site was approximately 91 m at an incline angle of approximately 35° from the road surface. The helicopter impacted the terrain and came to rest on its port side with the tail boom severed.

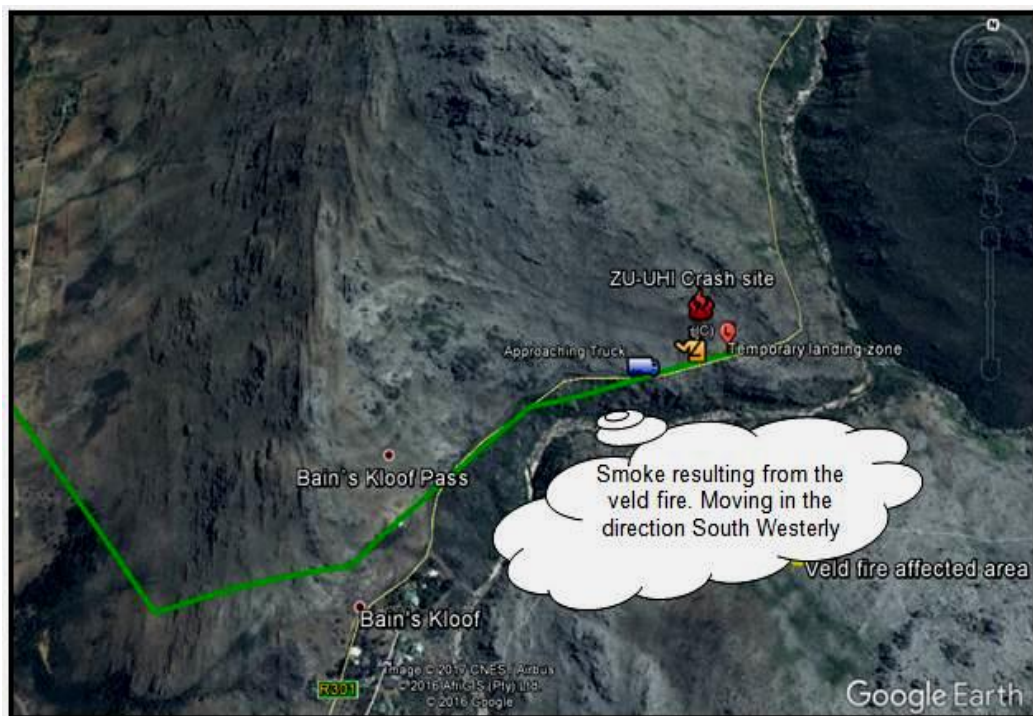
**Figure 6:** Google Earth view of the area of the veld fire around the accident site

1.12.3 All damage to the helicopter airframe structure, power plant and control surface components was attributed to the high-impact forces and fire damage (post-impact and veld fire).

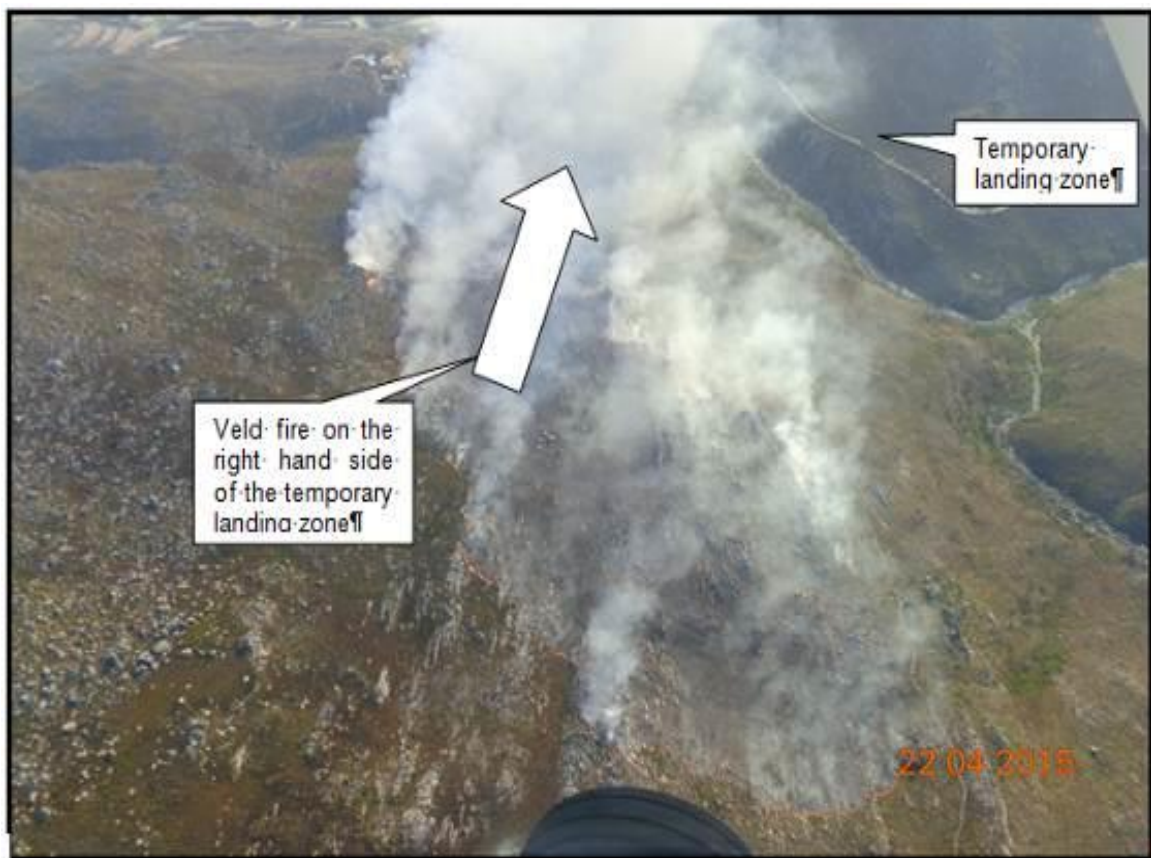
**Figure 7:** The operational site

- The accident site was confined to be the point of impact. The main rotors and tail boom had separated, and were located within a 5 m radius from the main wreck.

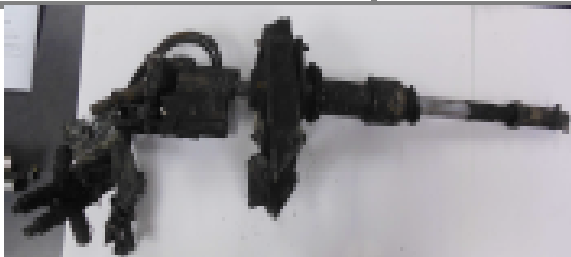
Photo 3: Supplied Hydraulic Servo (digital)

1.1. The Left Hand Cyclic Control Hydraulic Servo assembly (Photo 3) originating from a Bell UH-1H "Huey" Helicopter (Photo 1), was submitted to determine the operation status thereof on impact.

The visual inspection of the as-received Hydraulic Servo unit (Diagrams 1, 2 and 3: Red dashed squares; Photo 5) revealed a fractured attachment bracket (orange arrow) and extensive post-impact fire damages with a clear indication of the servo jack position after impact (Photo 6, red arrow).

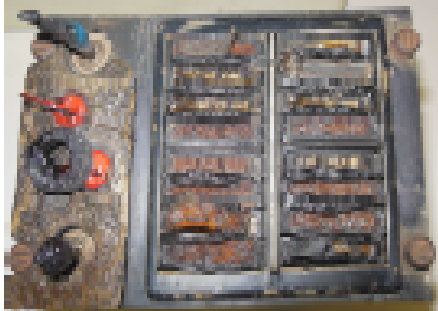
Photo 4: Supplied Warning Light Panel (digital)

1.2. The Cockpit Warning Light Panel assembly (Photo 4) originating from a Bell UH-1H "Huey" Helicopter (Photo 1), was submitted to determine the status of selected warning indicators on impact.

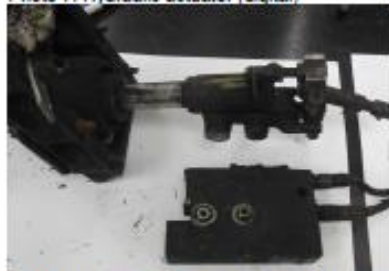
Photo 8: Hydraulic actuator - removed (digital)

The Hydraulic Actuator block (Photo 5, blue arrow; Photo 7) was removed from the Hydraulic Control Valve (Diagrams 2 and 3, blue arrows; Photo 8) for inspection. All the inlet and return ports proved to be unobstructed (Photo 9). Teardown of the actuator revealed no clear indication/s of possible blockages (Photo's 10 and 11).

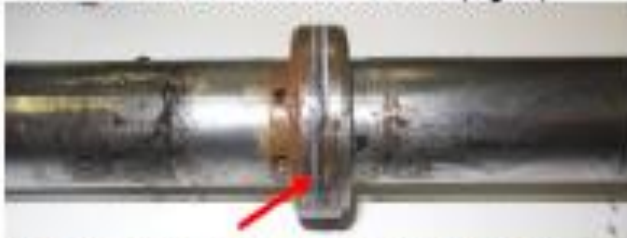
Photo 19: Feed holes – Control Tube (digital)

All three hydraulic seals (Photo 19, red arrows) proved to be in good condition with no clear indications of fractures, excessive wear or collapse.

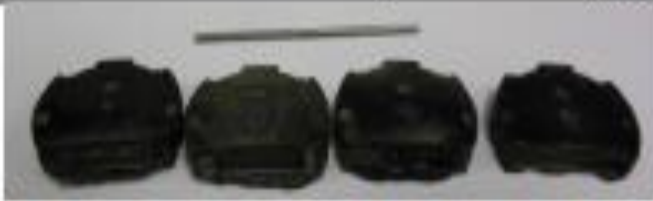
Photo 23: Selected warning light bulb holders, removed (digital)

The selected warning light bulb holders and bulbs (Photo's 23 and 24) were removed from the panel for inspection.

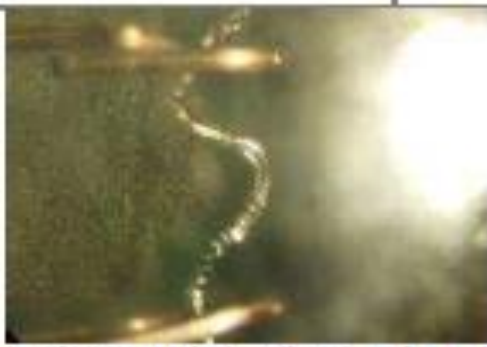
Photo 27: Master Caution - light bulb filament condition (stereo)

*The Master Caution (Photo 27) was selected as a possible reference assuming that it would be operational considering the possible influences of the impact forces on other component/s linked to the same panel prior to final impact. The XMSN OIL PRESS was selected as a*
