Air, Maritime and Railway Traffic Accident Investigation Agency

FINAL REPORT

ON ACCIDENT OF THE AIRCRAFT Lake LA-4-200, 9A-DLA

Resnik near Split, 25 June 2015

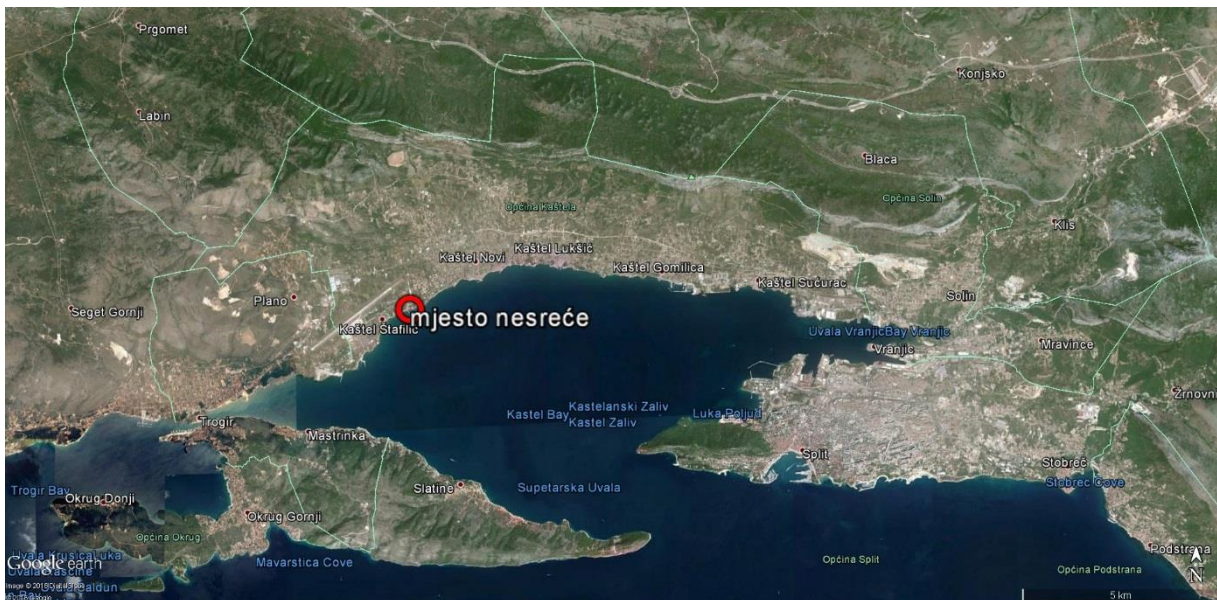
Picture 1 – flight area of 9A-DLA and the accident site (red circle)

After the engine failure, the pilot first directed the aircraft towards the airport and then towards the sea. In the final part of the access to the sea surface, the aircraft no longer had sufficient height to cross obstacles on the shore. It hit the roof of the building on the shore and crashed into the shallow sea near the coast.

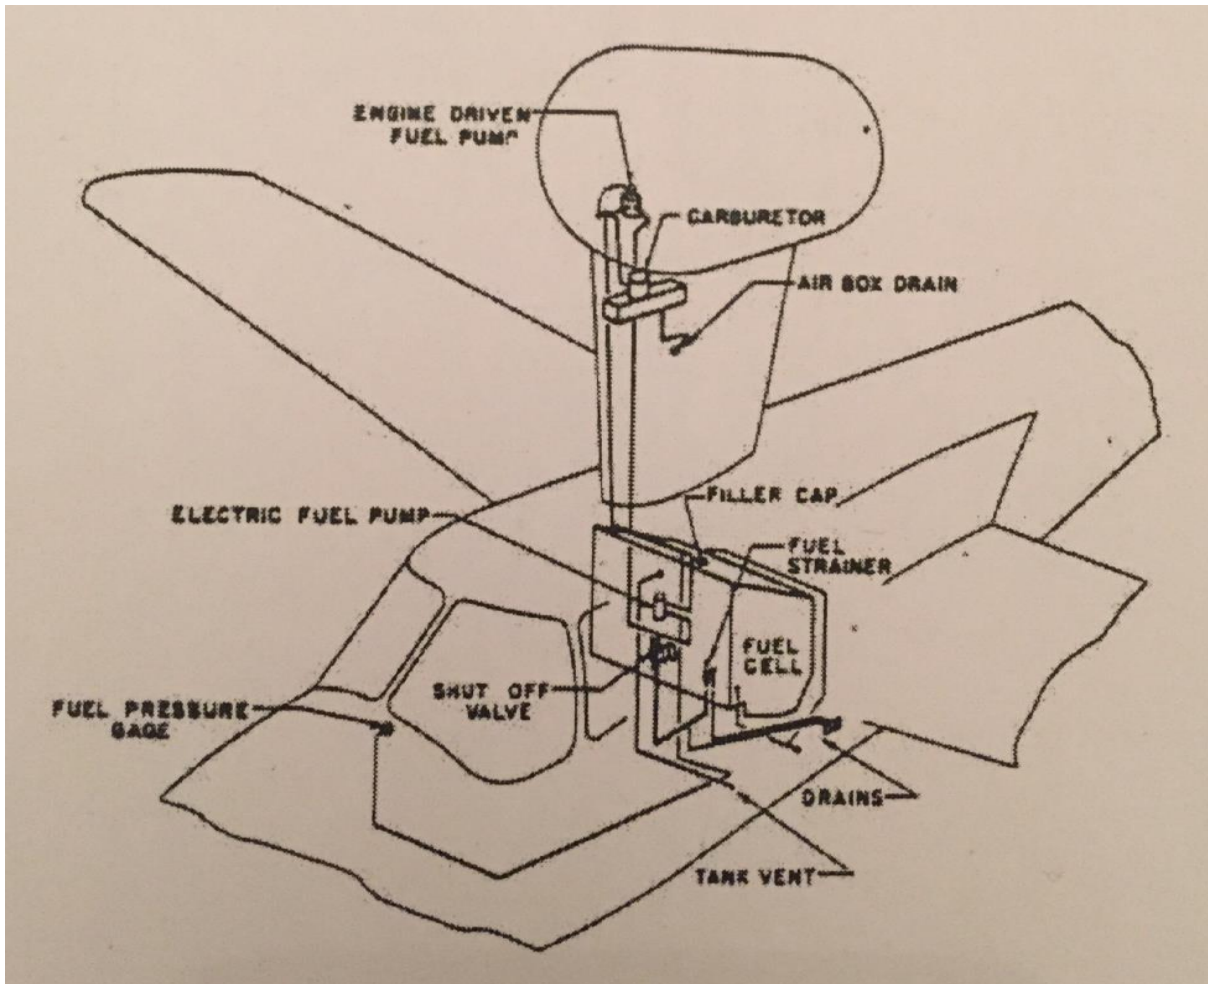
Picture 6 - Schematic presentation of the fuel system components of the aircraft Lake LA-4. Note: The system with carburettor is presented

The main fuel filter is located in the fuel line between the electric and mechanical engine driven pump somewhere around the middle of the engine pylon/carrier. Its purpose is to purify fuel that is distributed to the engine. The filter should be periodically inspected and cleaned, and also replaced at regular intervals.

<p>1.6.4. page 19 Description of fuel system</p>	<p>Picture 6 - Displays the fuel system components of the LA-4-200 aircraft with the note that the carburetor system is shown.</p>	<p>Wrong fuel system graph in the report by the AIN. The ECA aircraft LA-4-200 had the engine IO-360 A1B with a fuel injection system, which is essential data for analyzing the operation and possible causes of engine failure. The AIN is displaying an engine with a carburetor fuel system. The AIN is showing great lack of technical knowledge which is highly concerning to ECA.</p>
<p>1.6.6.1. page 20 Engine history</p>	<p>It is important to note that on 21 June 2015, when the aircraft was taxiing to the runway at Sinj Airport, the engine of the aircraft suddenly stopped working. The pilot immediately restarted the engine and flown the aircraft. When he landed at</p>	<p>This allegation has no substantial evidence, neither was this event known to ECA as the aircraft operator. AIN does not present any facts that confirm this event, and the pilots did not record this event in the aircraft technical logbook.</p>
