## *Final report RL 2016:05e*

**Accident at Malmö Sturup Airport on 27 June 2015 involving aircraft SE-GIC of model Piper-PA34-200T, Seneca II, operated by South Sweden School of Aeronautics AB.**

File no. L-61/15

2016-09-02

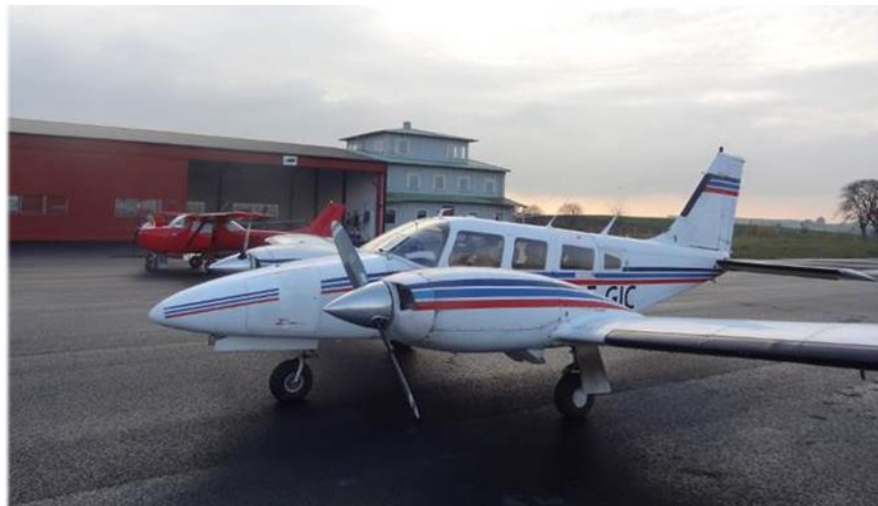
Figure 1. The aircraft in question SE-GIC. Photo: Märten Mårtensson.

The aircraft came down hard on the runway and then slid just over 200 metres before coming to a final stop. Upon impact – which has been assessed to be largely horizontal – all three landing gears broke, and the aircraft sustained substantial damage to wings, engines and fuselage. No fuel leakage arose during the crash.

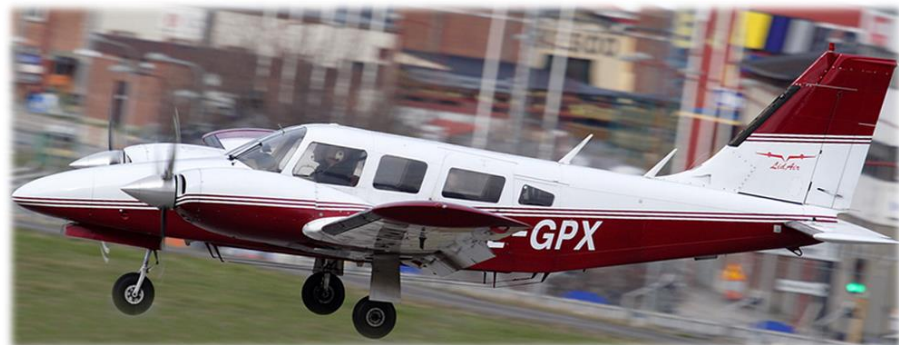
In order to recreate the sequence of events and to evaluate the aircraft's characteristics, SHK carried out a reference flight on 15 December 2015. The flight was performed with a PA34-200T, Seneca II, SE-GPX, i.e., the same model as the aircraft involved in the accident in question, see Figure 5.

Figure 5. SE-GPX, the aircraft used in the reference flight. Photo: Roger Andreasson.
