AIRCRAFT ACCIDENT REPORT AND EXECUTIVE SUMMARY

Reference:	CA18/2/3/9462	
Aircraft Registration	ZU-RHO	Date of Accident	8 August 2015		Time of Accident	0519Z
Type of Aircraft	RAF 2000 GTX SE F1– Gyroplane		Type of Operation		Private Operation – Part 94	
Pilot-in-command Licence Type		National Pilot Licence (NPL)	Age	45	Licence Valid	Yes
Pilot-in-command Flying Experience		Total Flying Hours	125.0		Hours on Type	125.0
Last point of departure		Avontuur Airfield, Eden District, Western Cape				
Next point of intended landing		Graaff-Reinet Airfield, Cacadu District, Eastern Cape				
Location of the accident site with reference to easily defined geographical points (GPS readings if possible)						
Runway 06, Avontuur Airfield						
Meteorological Information		Wind: NNE/2kt; Temperature: 8°C; Dew point: Unknown; Clouds: Nil; Visibility: Good.				
Number of people on board	1 + 1	No. of people injured	2	No. of people killed	0	
Synopsis						
<p>During take off from Avontuur, The pilot reported that he felt a vibration and he was unable to control the aircraft. After climbing to a height of approximately 3.2m above ground level, the aircraft sank without warning and struck the ground, sust

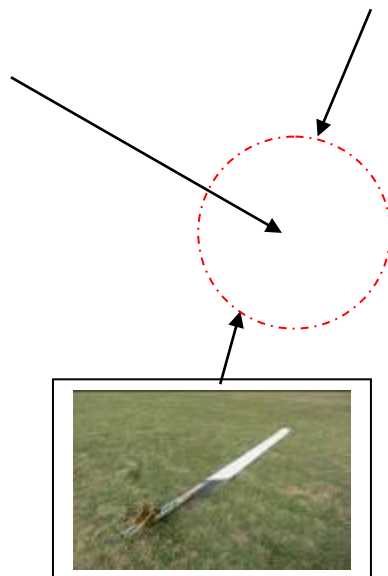
- (vi) The main wreckage, consisting of the airframe and engine (both intact), was found 363m from the runway threshold on a heading of 063° true (north-easterly) at the coordinates 33°43'27.24"S 23°9'25.91"E. The aircraft had rolled over during the ground impact sequence. The wreckage was found lying on its left side. During the roll-over, severe damage was caused to the engine cradle metal structure, including the landing gear struts.

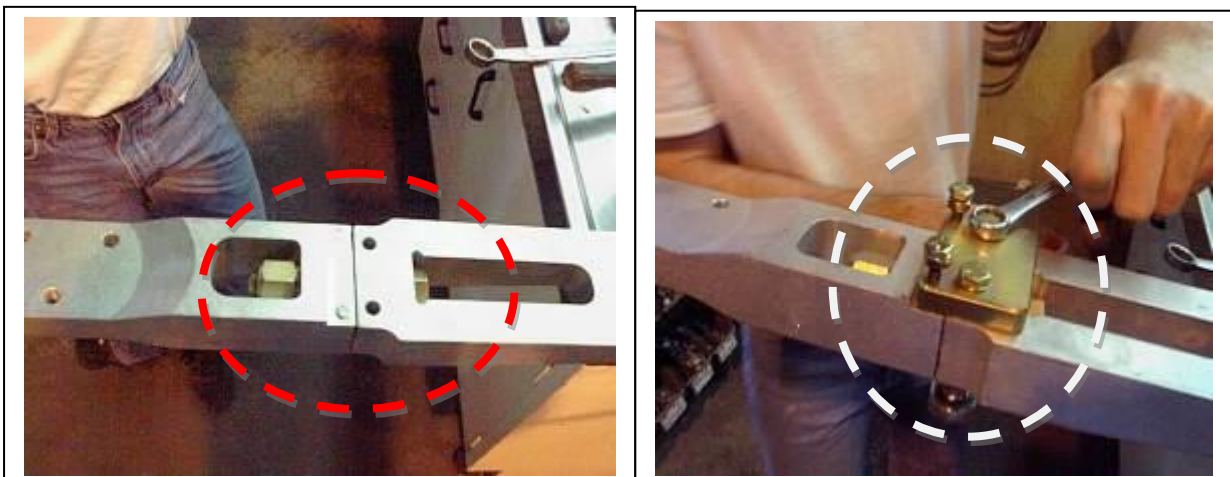
Figure 14; Hub bar winglets assembly

- (i) *“A bolt p/n AN12-34A should be inserted through the large 3/4” hole at the end of hub bar from the inside so the threads are extending away from the hub.*
- (ii) *Insert a winglet onto the extending bolt, then install a 3/4-inch machined washer and secure with an AN365-1216 nut. With the blade pitch buttons facing upward, align the machined surface of the winglet to be parallel with the top surface of the hub bar. Tighten nut all the way up threads until snug.*
- (iii) *Select two AN5-23A bolts, four AN960-516 washers and two 5/16-inch lock nuts. Position the plate onto the top of the hub bar at the end and align the holes in the plate with the holes in the hub bar. Insert a washer onto each bolt and insert bolts through the pitch adjustment plate (from the top) and through the hub bar. Insert a washer and nut onto each bolt. Torque to 150in-lbs.”*

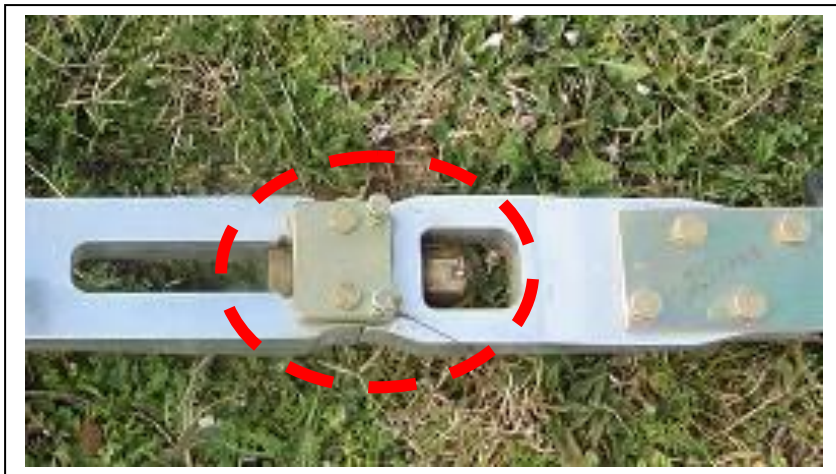
Figure 15 Hub bar winglets

1.16.8.1 Following mathematical calculations, it was determined that the centrifugal loading on the bolt was $F \text{ (lb)} = 11\,470,9 \text{ lb.}$ and the stress load was $S \text{ (psi)} = 5,735 \text{ psi.}$ Hence RAFSA decided to exchange the bolt AN12 with AN12-34A rated at 50 000 psi to further increase the safety factor to the expected load of $F \text{ (lbs.)} = 11\,470,9 \text{ lbs.}$ The new AN12-34A bolt radius under the head was twice as large as that of the old AN12 bolt. A washer with a proper bevel cut to accommodate the radius was also installed. RAF's expectation was that the new AN12-34A bolt would increase its strength by 25%. Also, the hub bar and winglets were machined to eliminate the straight cuts on the top and bottom using the process of contour machining.

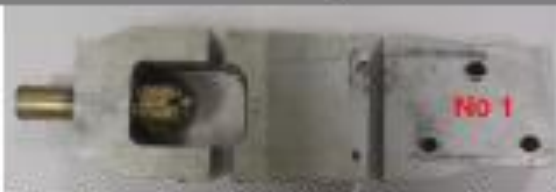
Photo 5: Sectioned No MR Blade attachment bracket (digital)

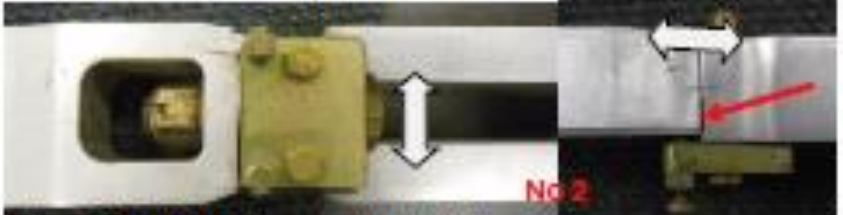
Photo 9: No MR blade assembly (digital)

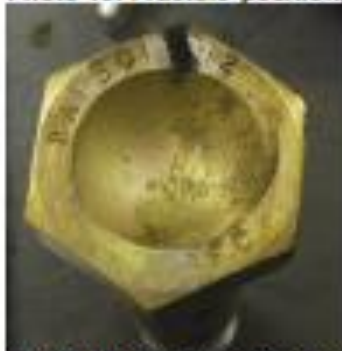
Photo 16: Specification stamp, No 2 bolt (digital)
