AIRCRAFT ACCIDENT REPORT AND EXECUTIVE SUMMARY

Reference:	CA18/2/3/9461	
Aircraft registration	ZS-WVV	Date of accident	08 August 2015		Time of accident	±1135Z
Type of aircraft	Challenger II (Aeroplane)		Type of operation	Part 94		
Pilot-in-command licence type	National Pilot		Age	66	Licence valid	Yes
Pilot-in-command flying experience	Total flying hours		68.5		Hours on type	62.5
Last point of departure	Morningstar aerodrome in Cape Town: Western Cape province					
Next point of intended landing	Morningstar aerodrome in Cape Town: Western Cape province					
Location of the accident site with reference to easily defined geographical points (GPS readings if possible)						
Onto the field at Blouberg farm, Cape Town at GPS co-ordinates determined to be S33° 43.´ 49" E018° 30.´ 13" at an elevation of 338 feet AMSL.						
Meteorological information	Temperature: 17°C, Dew-point: 11°C, Wind direction: 160, Wind speed: 6 knots, Scattered clouds at 2 000ft AGL, Barometric pressure: Q1021hPa.

Probable cause						
Incapacitation of pilot.						
SRP date				Release date

Registration Marks : ZS-WVV

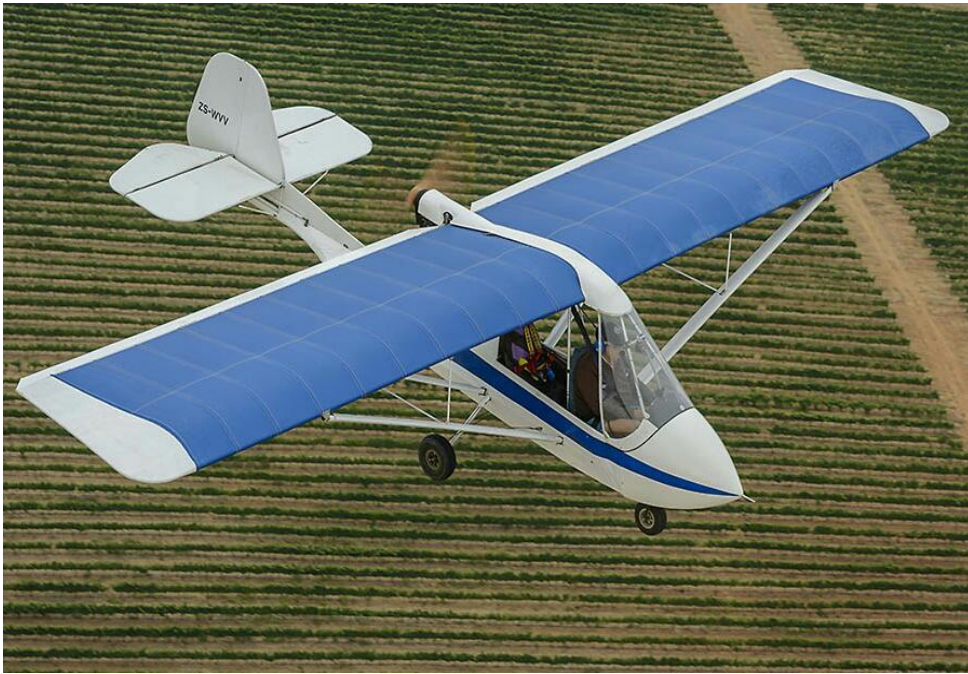
Figure 3: The accident aircraft

- 1.6.1 The Challenger II is a high wing, tricycle gear microlite with a frame structure built from aluminium alloy tubing fastened with bolts and rivets and covered with Dacron fabric. It is powered by a 50 horse power twin cylinder two stroke Rotax 503 engine that drives a wooden fixed pitch propeller. The engine is mounted in pusher configuration. The aircraft has the capacity to soar with its engine switched off.
