AIRCRAFT ACCIDENT REPORT AND EXECUTIVE SUMMARY

Reference:	CA18/2/3/9463
Aircraft Registration	V5-NRS	Date of Accident	16 August 2015	Time of Accident	0429Z
Type of Aircraft	Cessna 441 (Aeroplane)		Type of Operation	Commercial (Medical Rescue, Part 138)	
Pilot-in-command Licence Type	Commercial (Namibia)	Age	53	Licence Valid	Yes
Pilot-in-command Flying Experience	Total Flying Hours	6353.0	Hours on Type	1357.9	
Last point of departure	Oranjemund Airport (FYOG) Namibia				
Next point of intended landing	Cape Town International Airport (FACT) Western Cape				
Location of the accident site with reference to easily defined geographical points (GPS readings if possible)					
On the farm Maastrecht, approximately 8 nm to the North of FACT. (GPS position S 33°50'56.3" E 018°34'57.5") elevation 468ft AMSL.					
Meteorological Information	Wind: 160°M/15 Knots; Visibility: 6000m; Temperature: 11°C; Dew point: 11°C; Cloud cover: Broken; Cloud base: 500ft.

Probable Cause					
The aircraft collided with terrain during instrument meteorological flight conditions while on the VOR approach for Runway 19 at FACT.					
SRP Date	12 September 2017	Release Date	20 September 2017

Name of Owner : Namibi

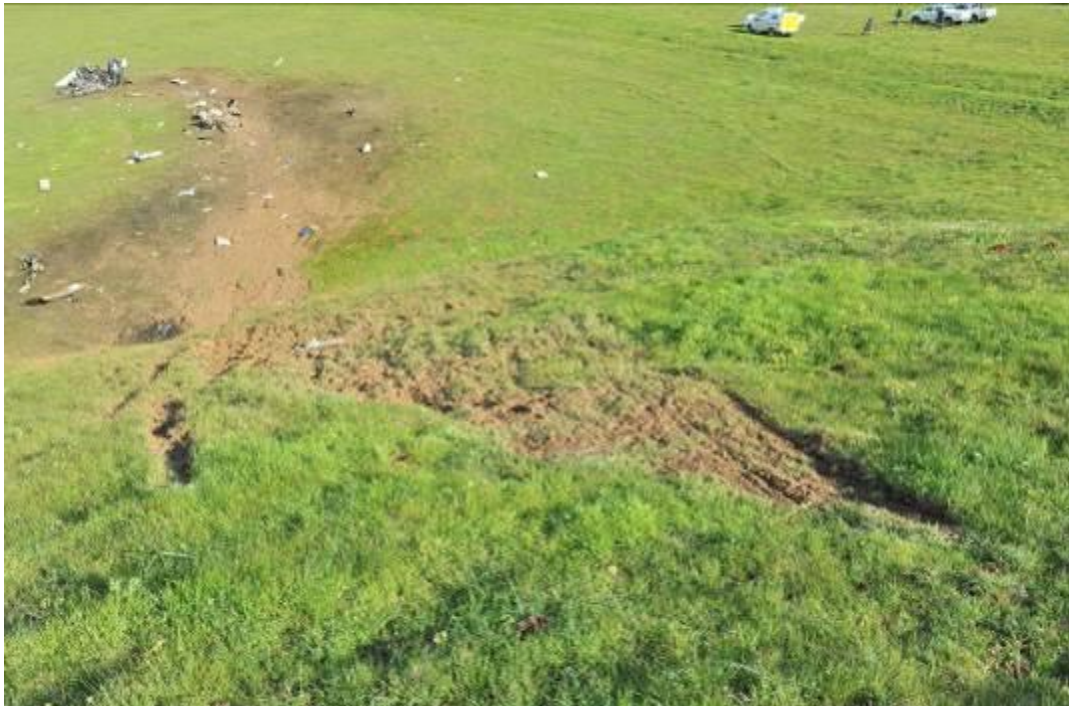
Figure 2: No damage caused to the environment.

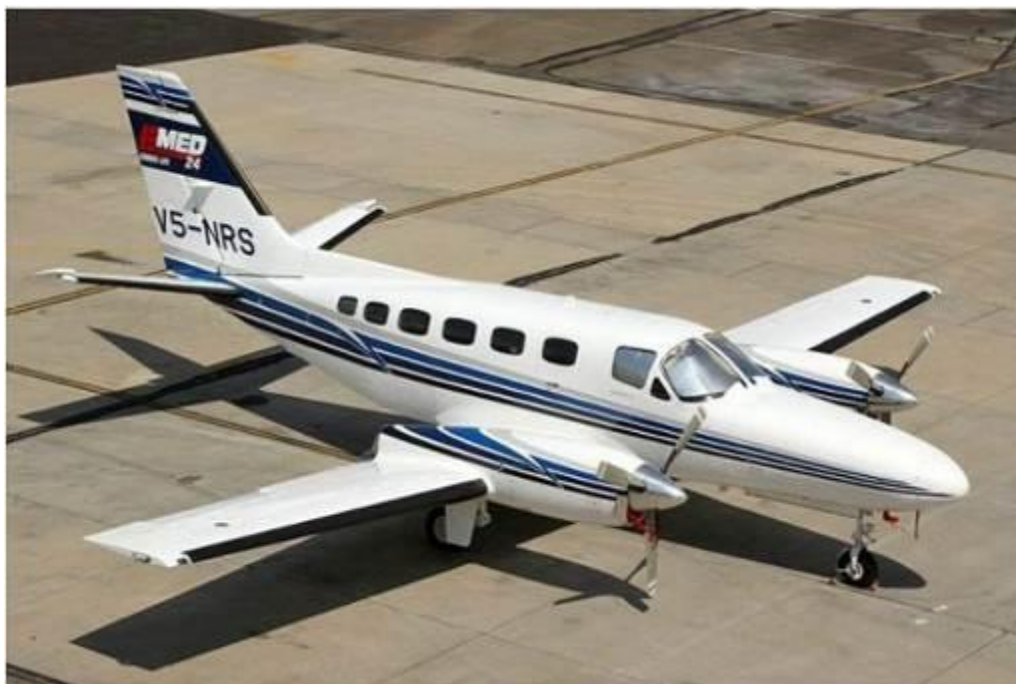
Figure 3: Picture of the accident aircraft

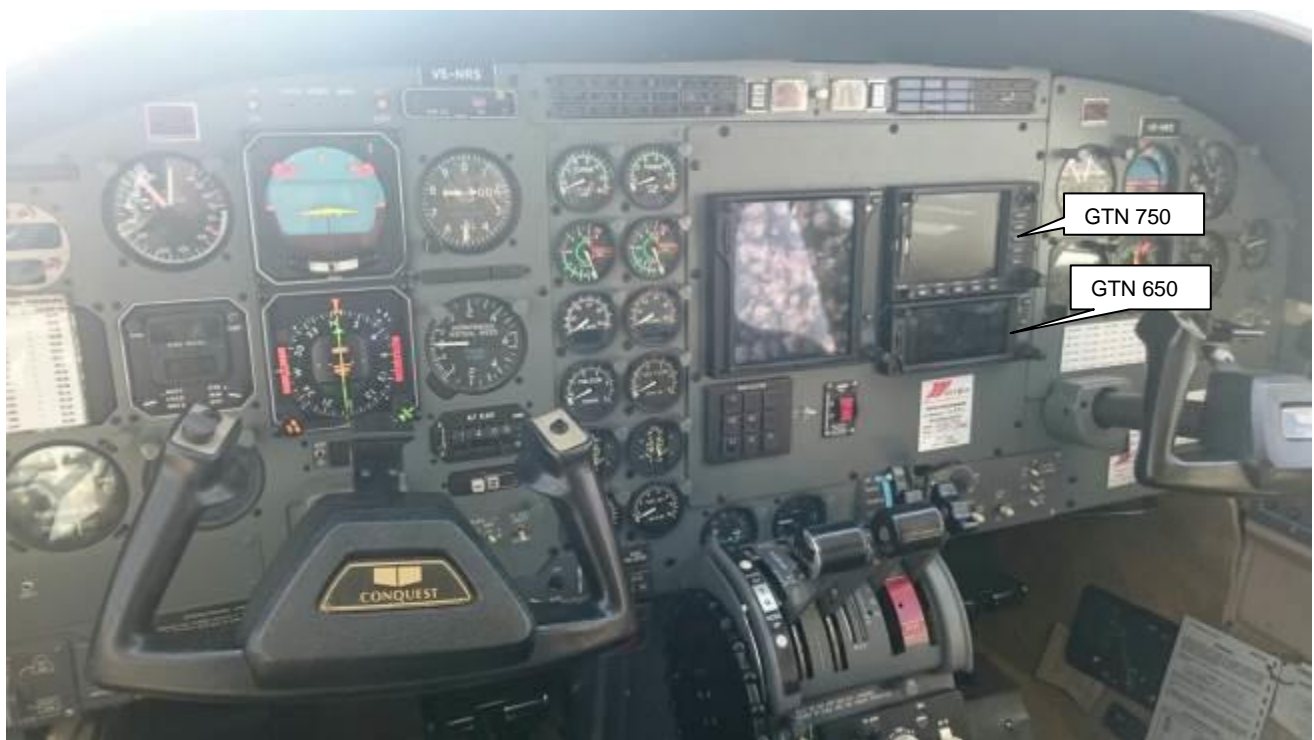
Figure 5: Installation of the GTN 750 and GTN 650 GPS in the accident aircraft

2.6.2 The aircraft was fitted with a Garmin GTN 750 touch screen and Garmin GTN 650 GPS. The only experience the co-pilot had on these two instruments was when she was introduced to them by the CFI during her test of 1.2 hours on the aircraft. Her experience was limited to what the instructor could introduce her to within the 1.2 hours during which she was doing her test with him. No system-specific training was done with her before or after the conversion flight. Both these instruments were situated on the co-pilot side of the cockpit. These two instruments with their advanced technology played a vital role during the crucial moments at the end of the flight. With the limited training the co-pilot had on these systems, it was possible that these instruments could cause confusion to the co-pilot, rather than assisting her, due to her limited knowledge of the operation of the systems.

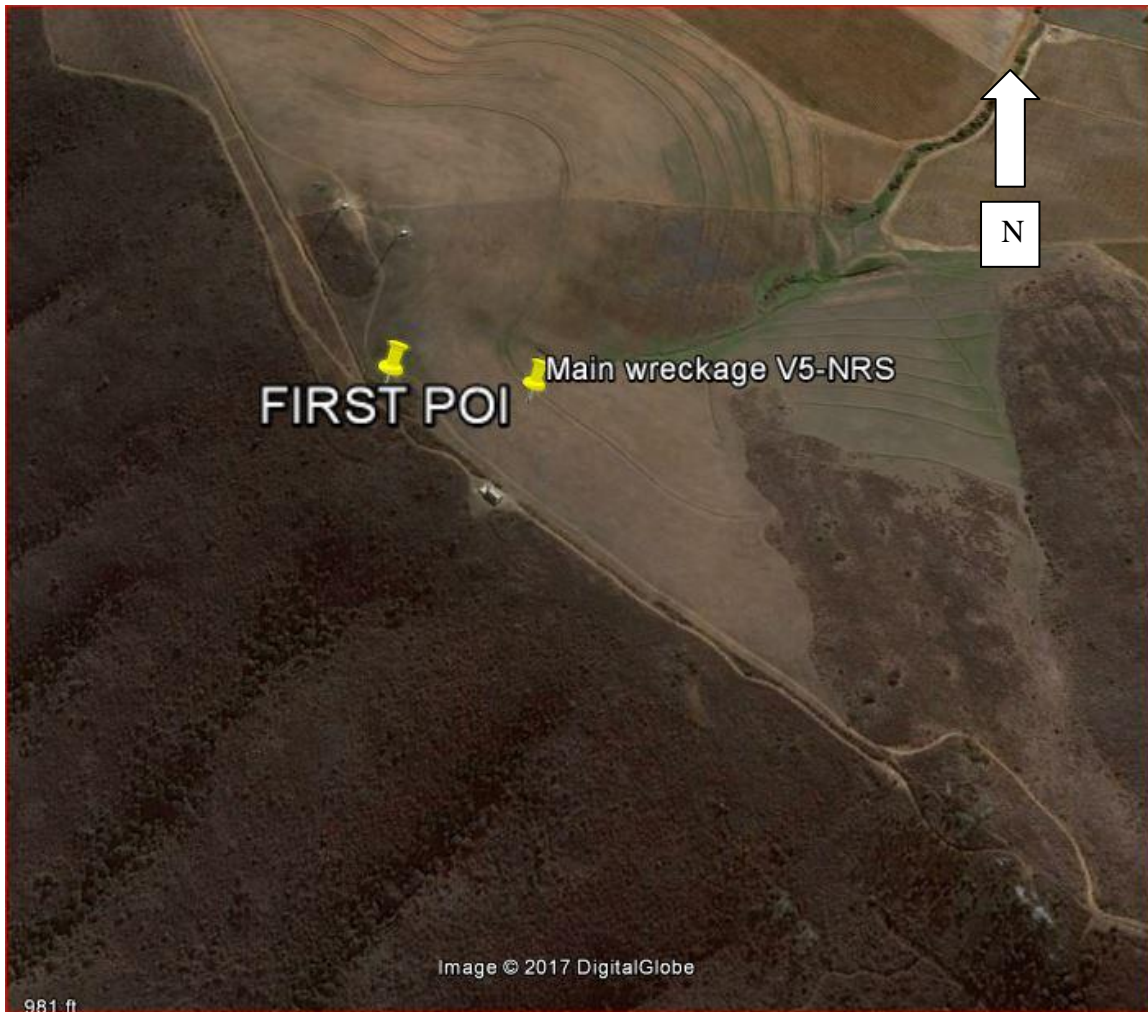
1.10.4 The accident happened in close proximity 8 NM North of Cape Town International Aerodrome.

Figure 8: The accident site is 8 NM to the North of Cape Town International Airport

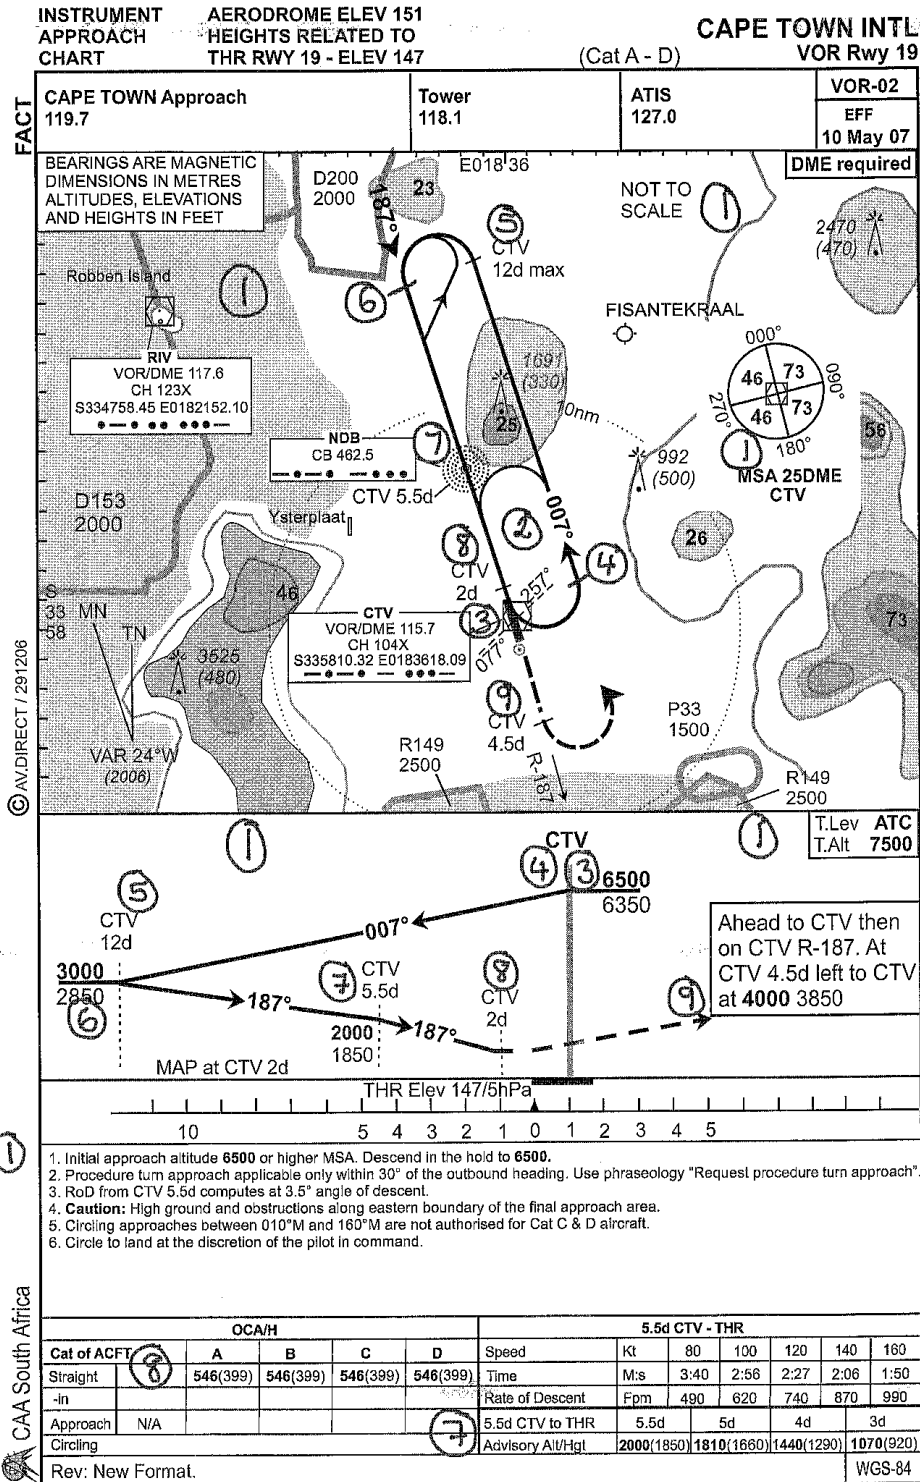
Figure 10: Cape Town VOR RWY 19 with reference points

- Once established on heading 007°M or abeam VOR CTV, whichever comes later, the aircraft is required to descend to 3000ft ALT on a heading of 007°M to a maximum distance of 12 DME CTV. (Calculated Descent Gradient: ±4.8%). (See Point 5 in Figure 10.)

- At 12 DME CTV the aircraft is required to maintain 3000ft ALT and execute a left turn onto CTV R007 (inbound) to arrive established on, or within 5° of, CTV R007 at 3000ft ALT by 12 DME CTV. (See Point 6 on Figure 10.)

- At 12DME CTV on, or within 5° of, CTV R007° (Inbound) the aircraft is required to descend in order to reach 5.5DME CTV (FAF) (Final Approach Fix) at 2000ft ALT. (See Point 7 on Figure 10.)

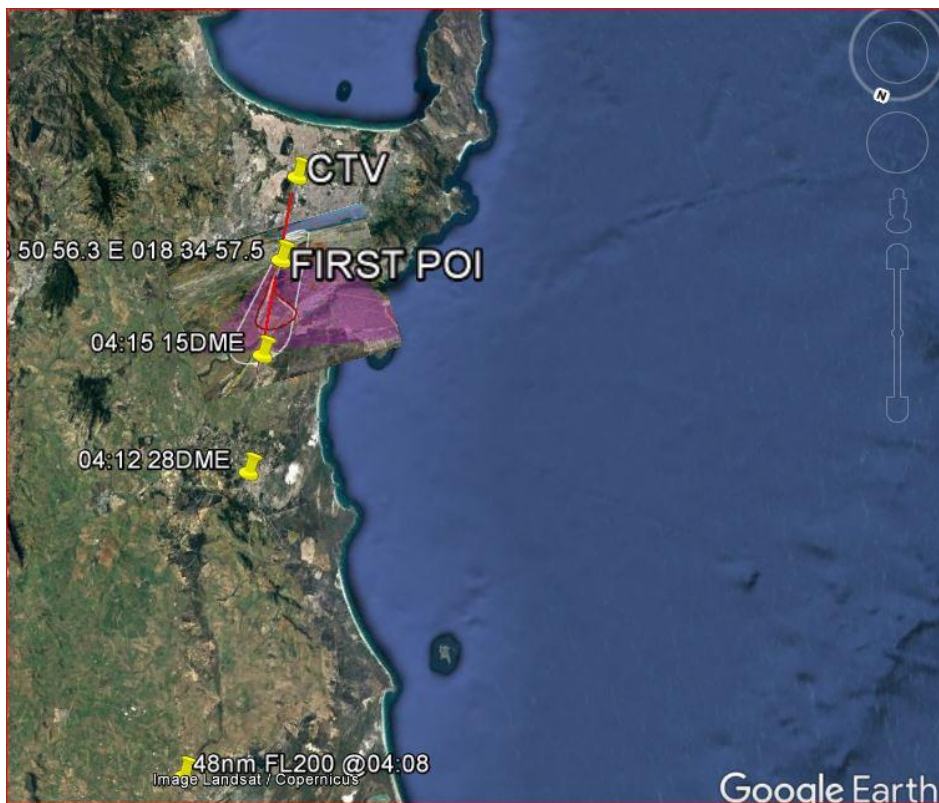
Figure 12: Different points along the route before starting the approach
