AIRCRAFT ACCIDENT REPORT AND EXECUTIVE SUMMARY

Reference:	CA18/2/3/9492	
Aircraft Registration	ZS-MRM	Date of Accident	16 October 2015		Time of Accident	Unknown	
Type of Aircraft	Beech Bonanza F33A		Type of Operation		Private (Part 91)		
Pilot-in-command Licence Type		Commercial Pilot	Age	22	Licence Valid	Yes	
Pilot-in-command Flying Experience		Total Flying Hours	unknown		Hours on Type	unknown	
Last point of departure		Wonderboom Aerodrome (FAWB), Gauteng Province					
Next point of intended landing		Wonderboom Aerodrome (FAWB), Gauteng Province					
Location of the accident site with reference to easily defined geographical points (GPS readings if possible)							
Motlatse Canyon Provincial Nature Reserve in an area called Erasmushoek close to Bourkes Luck Potholes, Graskop, Mpumalanga (S24° 40.267 E030° 54.720 at 5207 feet elevation)							
Meteorological Information		Temperature: 12.2 °C; Dew point: 11.8; Wind 255°-264 ° /04 kt; Visibility: Reduced; Cloud cover: broken clouds.

AIRCRAFT ACCIDENT REPORT

Name of Owner : Intrax Investments 108 (PTY) LTD
Name of Operator : Private
Manufacturer : Beech Aircraft Corporation
Model : Beech Bonanza F33A
Nationality : South African
Reg

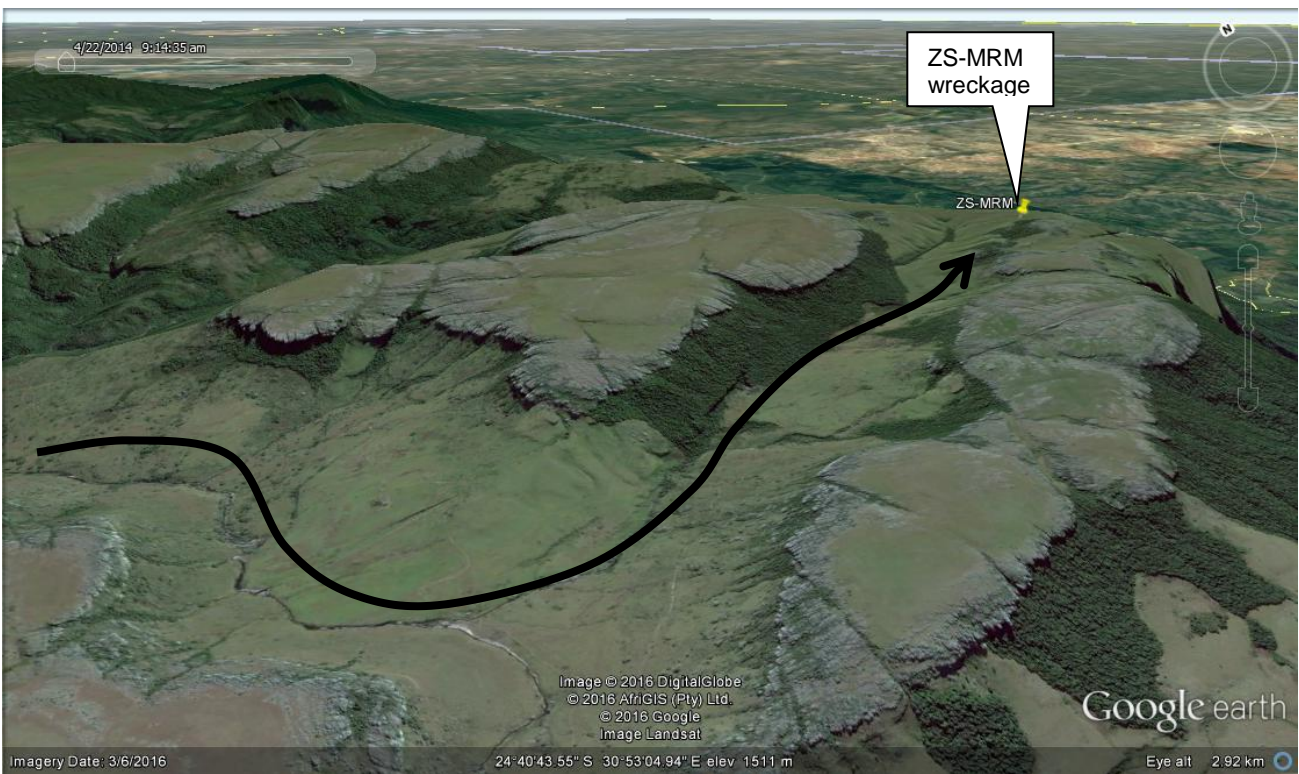
Figure 2: Google Earth view of accident site and canyon route

- 1.1 The wreckage of ZS-MRM was found to have crashed onto mountains in the Motlatse Canyon Provincial Nature Reserve in the Erasmushoek area close to Bourkes Luck Potholes, Graskop, Mpumalanga. The pilot sustained fatal injuries during the accident.
