SHORT REPORT AND EXECUTIVE SUMMARY

Reference:	CA18/3/2/1140	
Aircraft registration	ZU-MJM	Date of incident	7 November 2015		Time of incident	0907Z
Type of aircraft	Jabiru J430 (Micro-light aircraft)		Type of operation		Private (Part 94)	
Pilot-in-command licence type		Private	Age	54	Licence valid	Yes
Pilot-in-command flying experience		Total flying hours	895.3		Hours on type	472.8
Last point of departure		Richards Bay Aerodrome (FARB), KwaZulu-Natal Province				
Next point of intended landing		Richards Bay Aerodrome (FARB), KwaZulu-Natal Province				
Location of the incident site with reference to easily defined geographical points (GPS readings if possible)						
Beach near Richards Bay Harbour (GPS position; 28°49'44.30" South 032°04'04.20" East), elevation 2 feet						
Meteorological information		Surface wind: 240°/10 knots, Temperature: 27°C, Visibility: +10km, CAVOK				
Number of people on board		1 + 1	No. of people injured	0	No. of people killed	0

AIRCRAFT SERIOUS INCIDENT REPORT

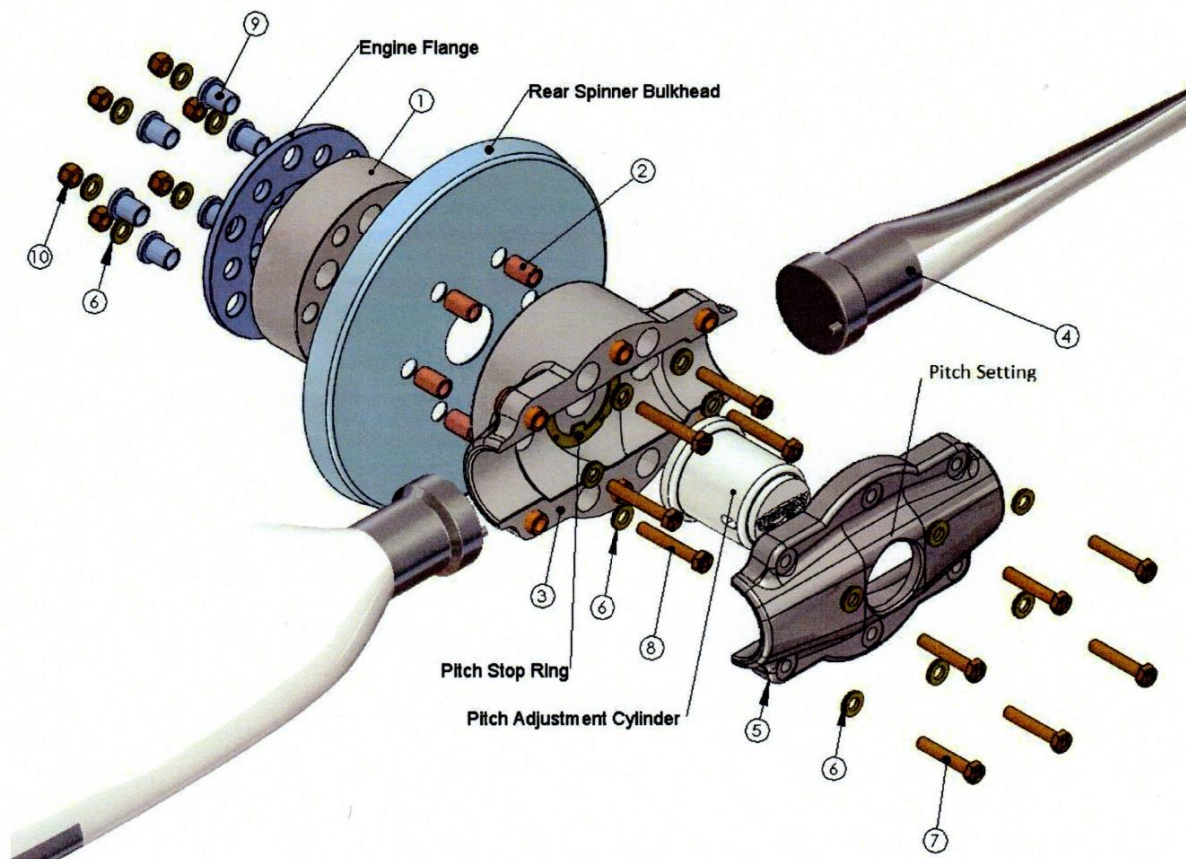
FIGURE 1. JABIRU PROPELLER ASSEMBLY

- 2.2.1 Inflight separation of the propeller and the cause could not be established.

- 3.1 It is recommended to the Director of Civil Aviation that all Jabiru aircraft fitted with the same type of propeller be made aware of this incident and that a maintenance advisory notice (MAN) be issued to prevent a re-occurrence.
- 3.2 Safety Message: A potentially serious accident was avoided by the pilot's adherence to emergency procedures and maintaining control of the aircraft after an in-flight engine stoppage.
