AIRCRAFT ACCIDENT REPORT AND EXECUTIVE SUMMARY

Reference:	CA18/2/3/9510	
Aircraft Registration	ZU-RON	Date of Accident	30 December 2015		Time of Accident	0430Z
Type of Aircraft	Aeroprakt		Type of Operation	Private (Part 94)		
Pilot-in-command Licence Type		National Pilot	Age	53	Licence Valid	Yes
Pilot-in-command Flying Experience		Total Flying Hours	877.68		Hours on Type	540
Last point of departure		Vygeboom Dam private airstrip-Mpumalanga Province				
Next point of intended landing		Vygeboom Dam private airstrip-Mpumalanga Province				
Location of the accident site with reference to easily defined geographical points (GPS readings if possible)						
On water channel next to a dam in an area with GPS reading as: (S 25°52'39.57", E 030°37'13.66")						
Meteorological Information		Wind direction: 010°; Wind speed: 01kt; Visibility: 10km; Air temperature: 18°C; Dew point: 15°C; Cloud cover: Sct; Cloud base: 1500ft AGL				
Number of people on board	1+1	No. of people injured	2	No. of people killed	0

Name of Owner : Gemdam Trust
Name of Operator : Gemdam Trust
Manufacturer : Aeroprakt
Model : A-22
Nationality : South African
Registration Marks : ZU-RON
Place : Vygeboom Dam, Mpumalanga

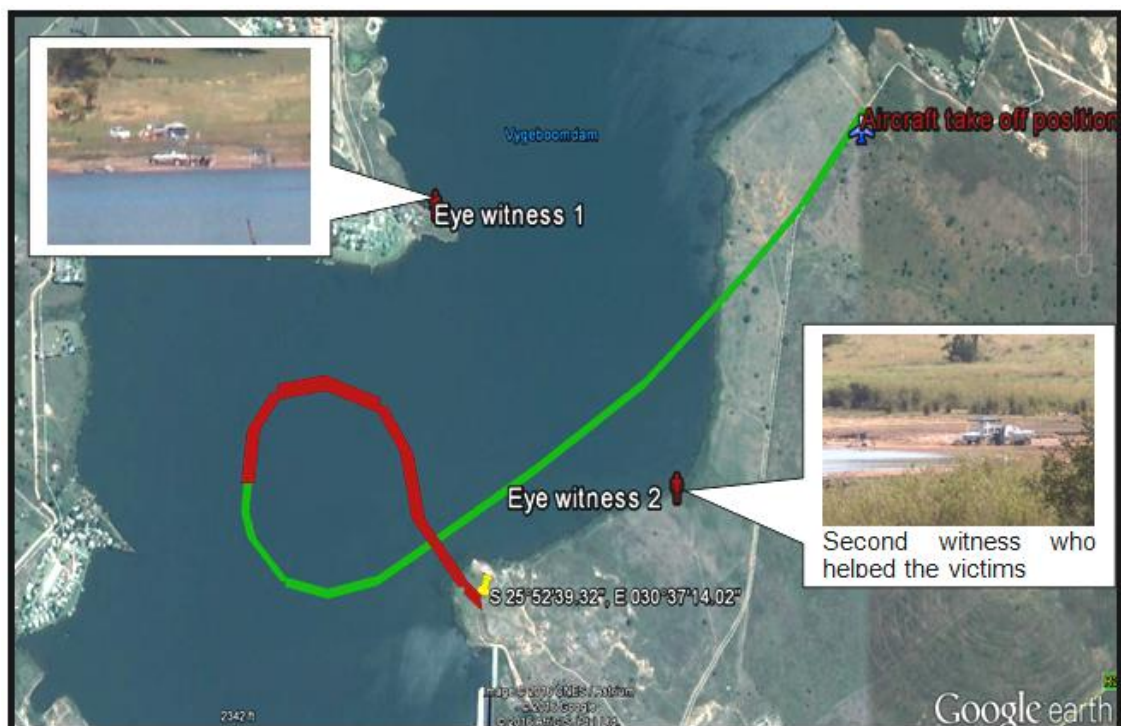
off from a place in the north east of the dam at approximately 1 nautical mile and made a right turn over the dam. During a turn the aircraft was then witnessed flying towards the eastern side losing height drastically. The aircraft crashed into the water canal on the eastern side of the dam after making contact with the ground approximately 46 meters before.

Figure 1: Shows the google view of the accident site

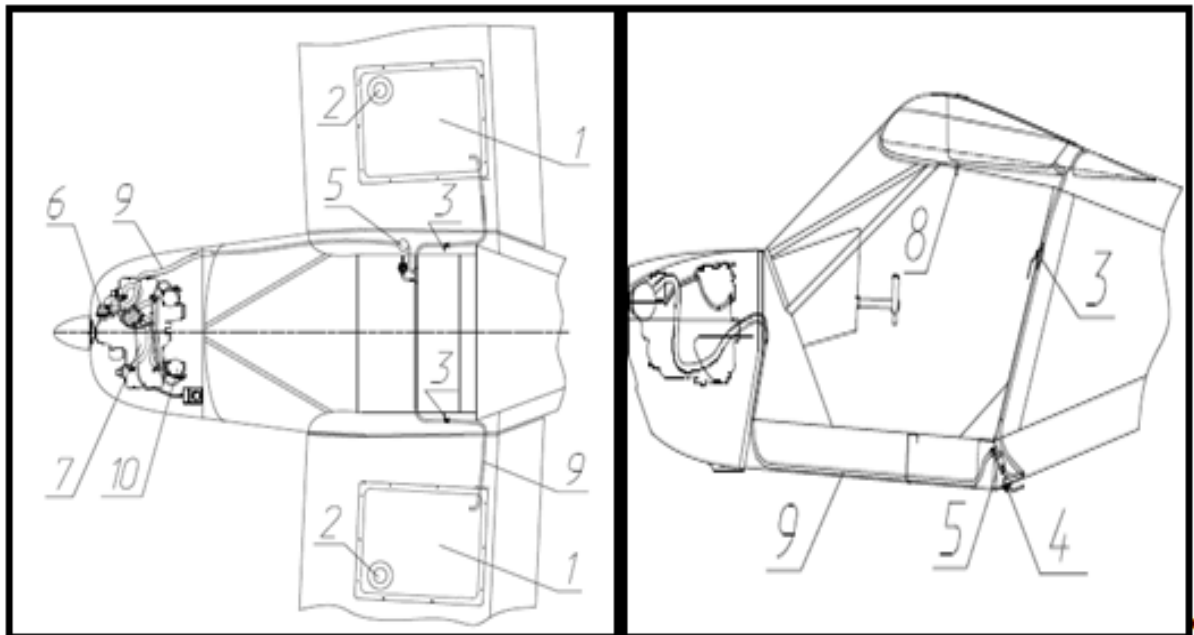
Figure 3: Shows the aircraft type fuel system schematic

(Fig.3) includes two wing fuel tanks 1 (each of 45litres or 11.9 US gal capacity) with filler inlets 2 and fuel lines 9 connecting the tanks to each other and to the engine fuel pump 6 (that is feeding fuel to the engine carburetors 10) via two fuel valves 3 and fuel filter 5. Fuel can be drained from the tanks using the drain valve 4. The fuel tanks are connected with the atmosphere via the vent lines 8.
