AIRCRAFT ACCIDENT REPORT AND EXECUTIVE SUMMARY

Reference:	CA18/2/3/9511	
Aircraft Registration	ZS-RZL	Date of Accident	02 January 2016		Time of Accident	0835Z
Type of Aircraft	Eurocopter EC-130 B4 (Helicopter)		Type of Operation		Part 91	
Pilot-in-command Licence Type	Private pilot licence	Age	65	Licence Valid	Yes	
Pilot-in-command Flying Experience	Total Flying Hours	858.7		Hours on Type	747.4	
Last point of departure	Private property Loch Vaal: Free State province					
Next point of intended landing	Private property Loch Vaal: Free State province					
Location of the accident site with reference to easily defined geographical points (GPS readings if possible)						
On a maize field in Parys at GPS co-ordinates determined to be S26° 55" 00 .3' E27° 23" 05.3' at an elevation of approximately 4 650 ft above mean sea level (AMSL).						
Meteorological Information	Temperature- 30°C: Visibility- 10 km: Wind direction-SW @05 knots: Cloud base-±8000 ft: Cloud cover-Scattered cumulus.

AIRCRAFT ACCIDENT REPORT

Name of Owner/Operator : Beltimar (Pty) Ltd
Manufacturer : Eurocopter Helicopters
Model : EC-130 B4
Nationality : South African
Registration Marks : ZS-RZL
Place : On a maize fiel

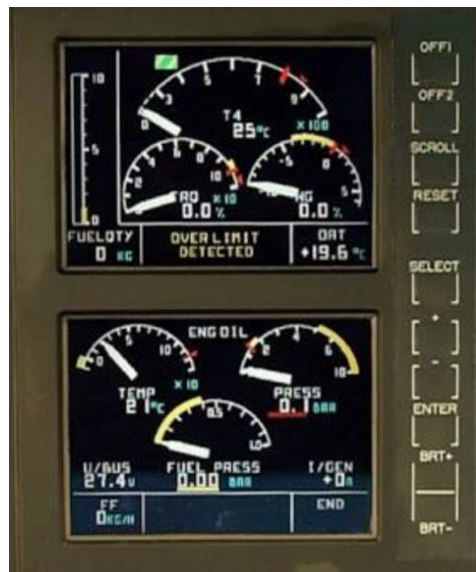
Figure 5: VEMD computer unit installed on the helicopter

1.11.1 The helicopter was equipped with vehicle and engine multifunction display (VEMD) computer unit that registers exceedances and system faults. Attached below is a VEMD picture.
