DUTCH
SAFETY BOARD

Misaligned take-off from Runway 24, Amsterdam Airport Schiphol

The Hague, November 2018

Identification number:	2016004
Classification:	Serious incident
Date, time of occurrence:	18 January 2016, 17.25 hours ¹
Location of occurrence:	Amsterdam Airport Schiphol
Registration:	EC-JBD
Aircraft type:	Embraer EMB-120ER
Aircraft category:	Commercial – fixed wing
Type of flight:	Scheduled cargo flight
Phase of operation:	Take-off
Damage to aircraft:	Severe damage to the right-hand propeller, multiple fuselage skin puncture marks and damage to nose wheel
Flight crew:	Two
Passengers:	None
Injuries:	None
Other damage:	Runway edge lights
Light conditions:	Night-time

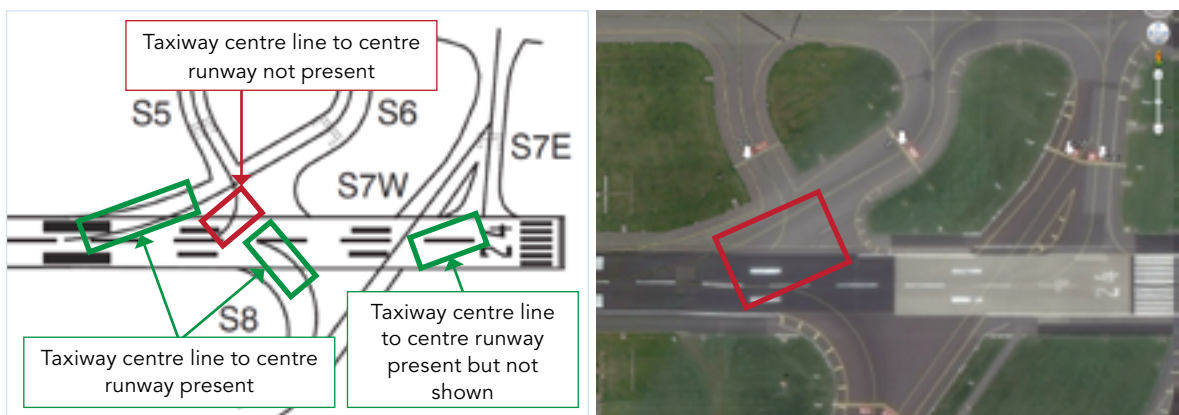
Figure 5: Taxiway B and Runway 24 with Exit S5 - S8 and taxiway centre line marking (reference). (Photo: Google Earth)

In the Integrated Aeronautical Information Package (AIP) for Amsterdam Airport Schiphol, a situation chart is published for runway 06/24. While conducting the investigation, it was found that the situation as depicted on the chart did not correspond with the actual layout of Amsterdam Airport Schiphol. Figure 5 (left) indicates that the taxiway centre line should be continuous and leading towards the runway centre line. However, from Figure 5 (right) it becomes evident that in reality the taxiway centre line is interrupted at the runway side line marking. On 26 April 2016 the investigation team of the DSB informed Air Traffic Control the Netherlands (LVNL) of the discrepancies between the published charts and actual taxiway centre line markings on Runway 24. In response, the relevant maps were updated to be correctly presented in the latest AIP publication.

As can be seen from Figure 5, a centre line marking leading from taxiway S6 to the centre line of Runway 24 is present. In contrast to S6, S5 does not have a centre line marking leading to the centre line of Runway 24. The centre line marking that is present on S5 is discontinued at the right-hand edge line of Runway 24.
