# 飛航安全調查委員會

## 航空器飛航事故 調查報告

中華航空公司 CI025 班機

報告編號：ASC-AOR-17-06-001

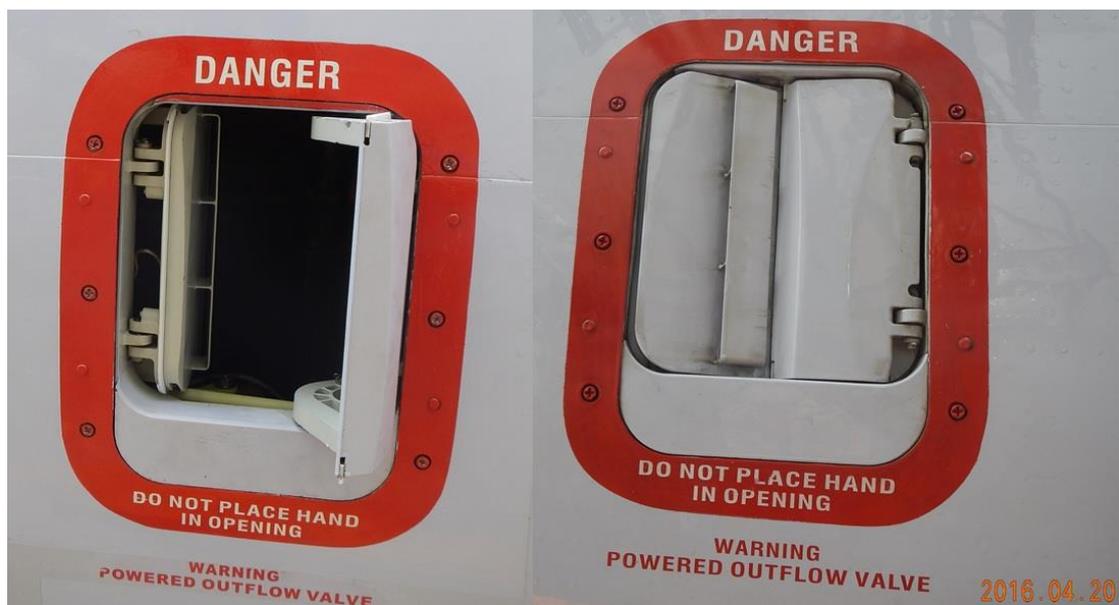
圖 1.6-3 OFV 閥門打開（左）關閉（右）位置圖

1. 航機艙壓系統外流閥齒輪插銷斷裂，使外流閥門無法控制，導致航機艙壓異常返降關島。

OFV 包含 2 具自動控制馬達、1 具手動控制馬達、齒輪連動裝置以及閥門等，在「AUTO」模式時，主控之 CPC 控制訊號驅動自動控制馬達，帶動齒輪組及連桿以控制 OFV 閥門之開合（如圖 1.6-3），OFV 閥門之位置訊號亦回傳至 2 具 CPC；在「MAN」模式時，OFV 閥門開合直接由駕駛員操作 CPCM 之 OPEN/CLOSE 撥動開關控制手動馬達作動，閥門開口大小顯示於 CPCM 之 VALVE 儀表上。
