**FINAL REPORT OF SERIOUS INCIDENT OF MYANMAR NATIONAL
AIRLINES EMBRAER-190 (Reg: XY-AGQ) AND
MANNYADANARPON AIRLINES ATR-72-212A (Reg: XY-AJP) AT DAWEI
DOMESTIC AIRPORT ON JUNE, the 25th, 2016**

SYNOPSIS

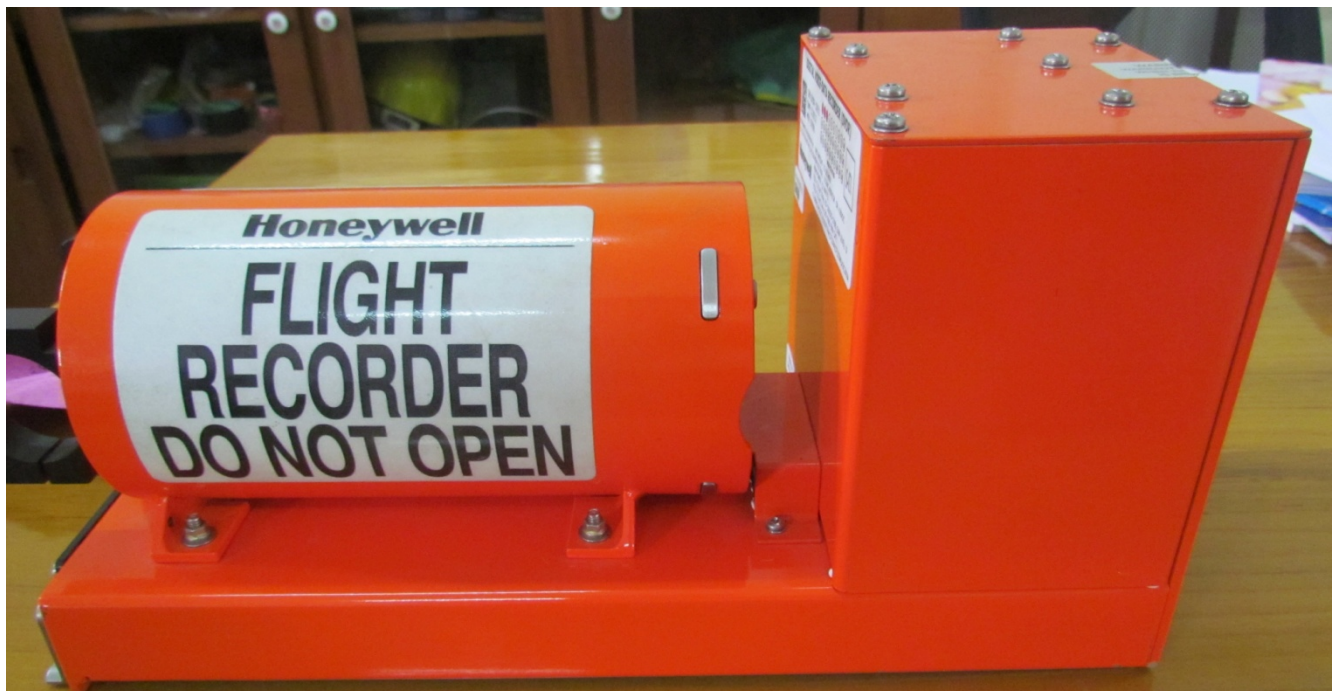
Figure:10 Digital Voice Data Recorder (DVDR)

The data downloaded from the DVDR was of good quality and comprised flight data parameters and cockpit voice information recorded during the occurrence.

No aircraft system defect or anomaly was observed in the recorded flight data parameters.

There was no damage observed to the flight recorders. The interface pins for both recorders were checked and they appeared to be in good condition.
