Aircraft Accident Investigation Board (AAIB)

Incident Investigation Final Report

State File Number: 950524EPTTA
Type of Occurrence: Serious Incident
Date of Occurrence: August 13, 2016
Place of Occurrence: Tehran Mehrabad Airport
Aircraft Type: A320
Registration: EP-TTA
Operator: Atrak Airlines

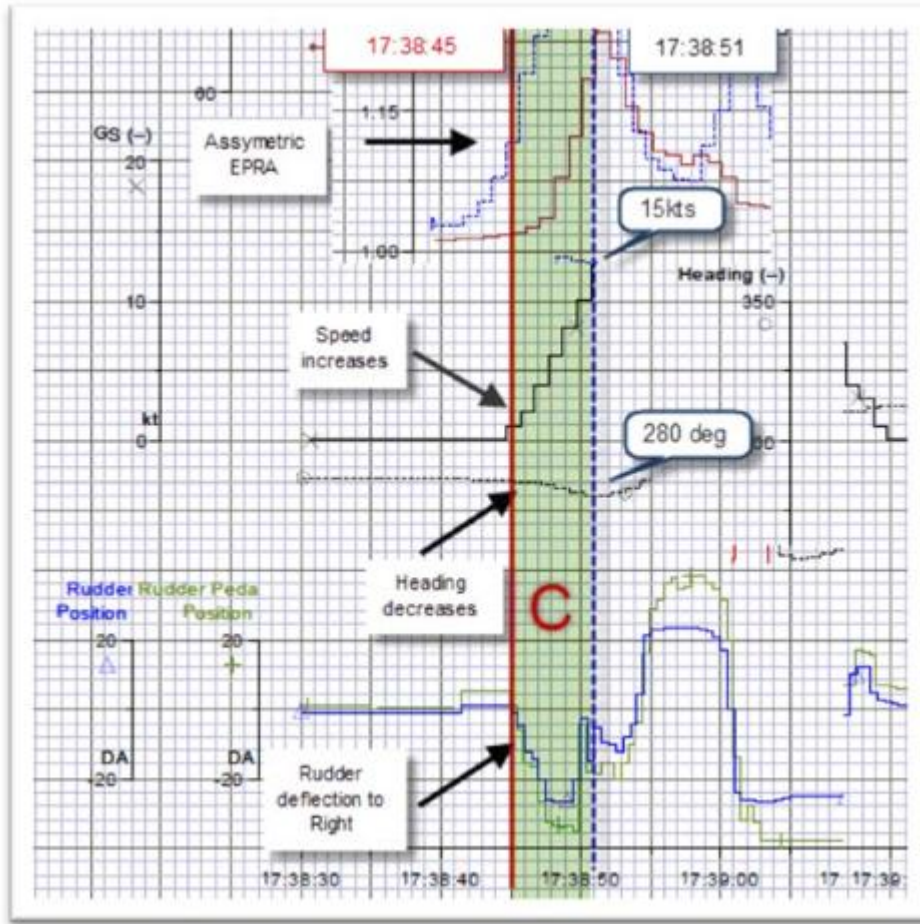
Ground speed started to increase and heading started to decrease. A right rudder pedal input was applied, reaching -34.7° within 3s; rudder deflected to the right at 26.0° max

- EPRA1 was at 1.03 while EPRA2 was at 1.24
- N2A1 was at 78.0% while N2A2 was at 91.3%

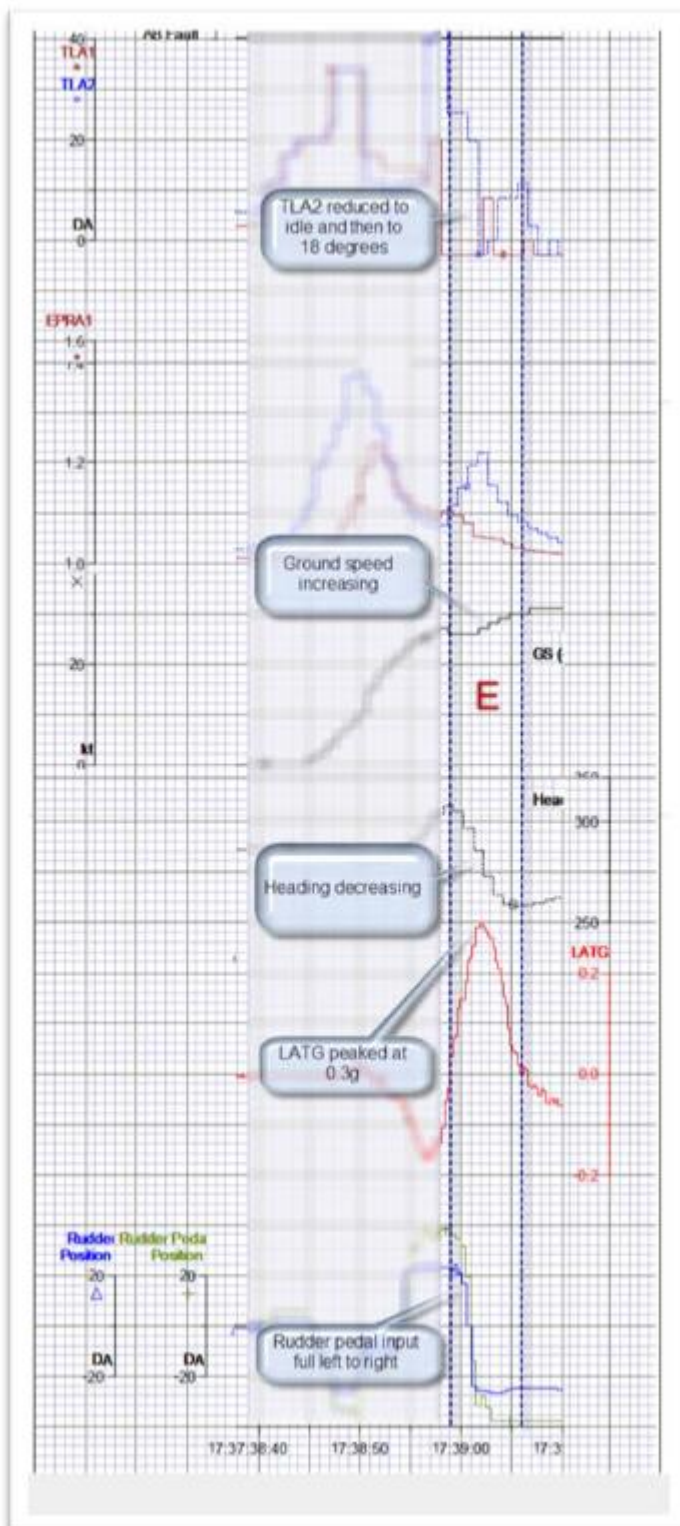
When the rudder pedal input to the right was reduced, the aircraft veered to the right.

17:38:54 UTC: At 22kt (GS) increasing, while A/C was turning to the right, a left rudder pedal order was applied up to +38.9°.

17:38:56 UTC: At 26kt (GS), TLA2 was pushed up to 42.2° (close to TOGA notch) and TLA1 was pulled to IDLE notch. LATG reached a minimum of 0.17G then started to increase.

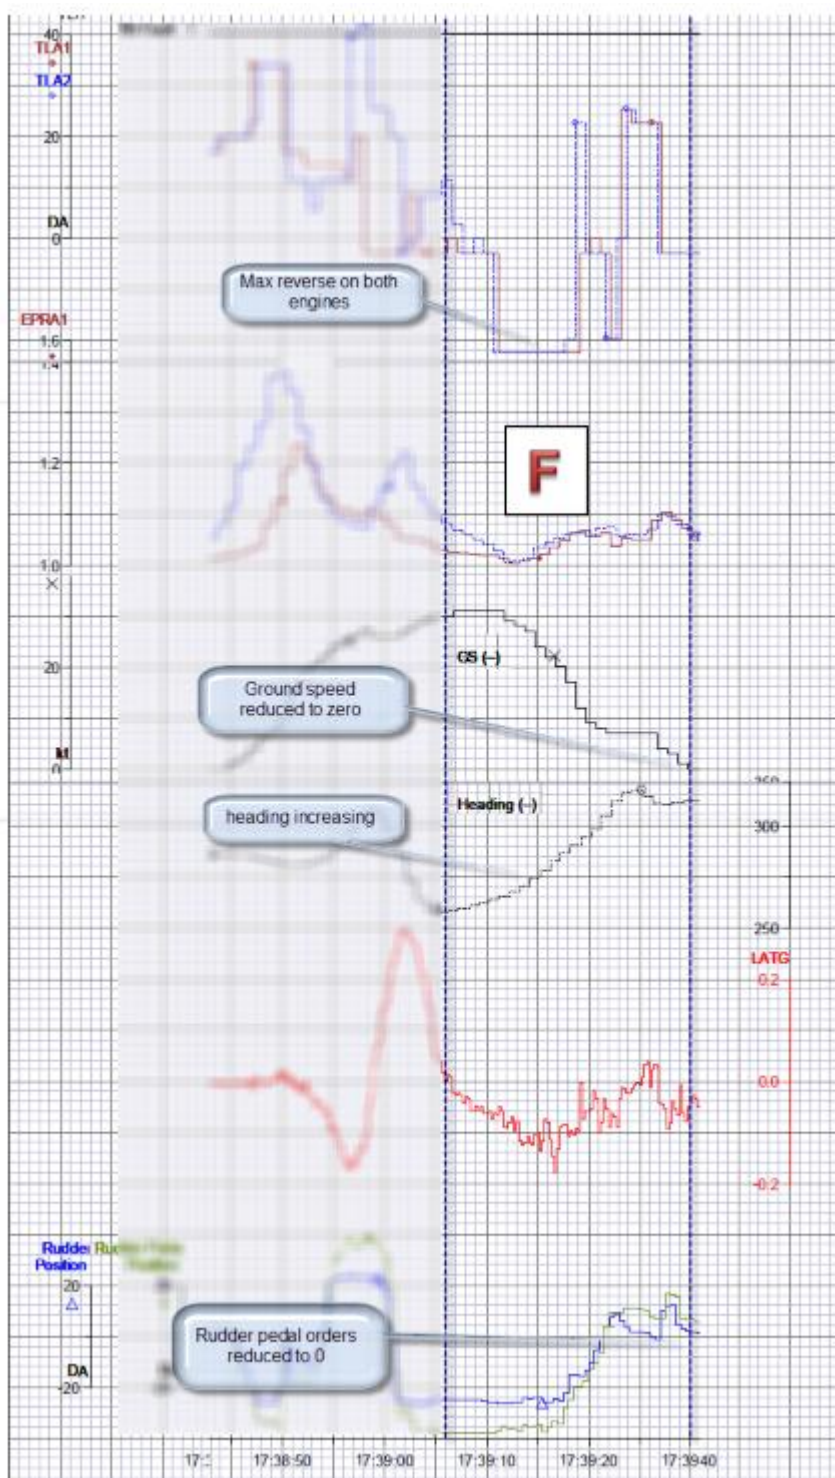
F. TRAJECTORY – PHASE 4

17:39:06 UTC: At 30kt (GS), heading reached a minimum of 258.4° then started to increase again; LOC reduced to \sim as at $+20\mu\text{A}$ (left side of the runway).

17:39:10 UTC: At a maximum of 31kt (GS), both thrust levers were pulled on MAX REV notch

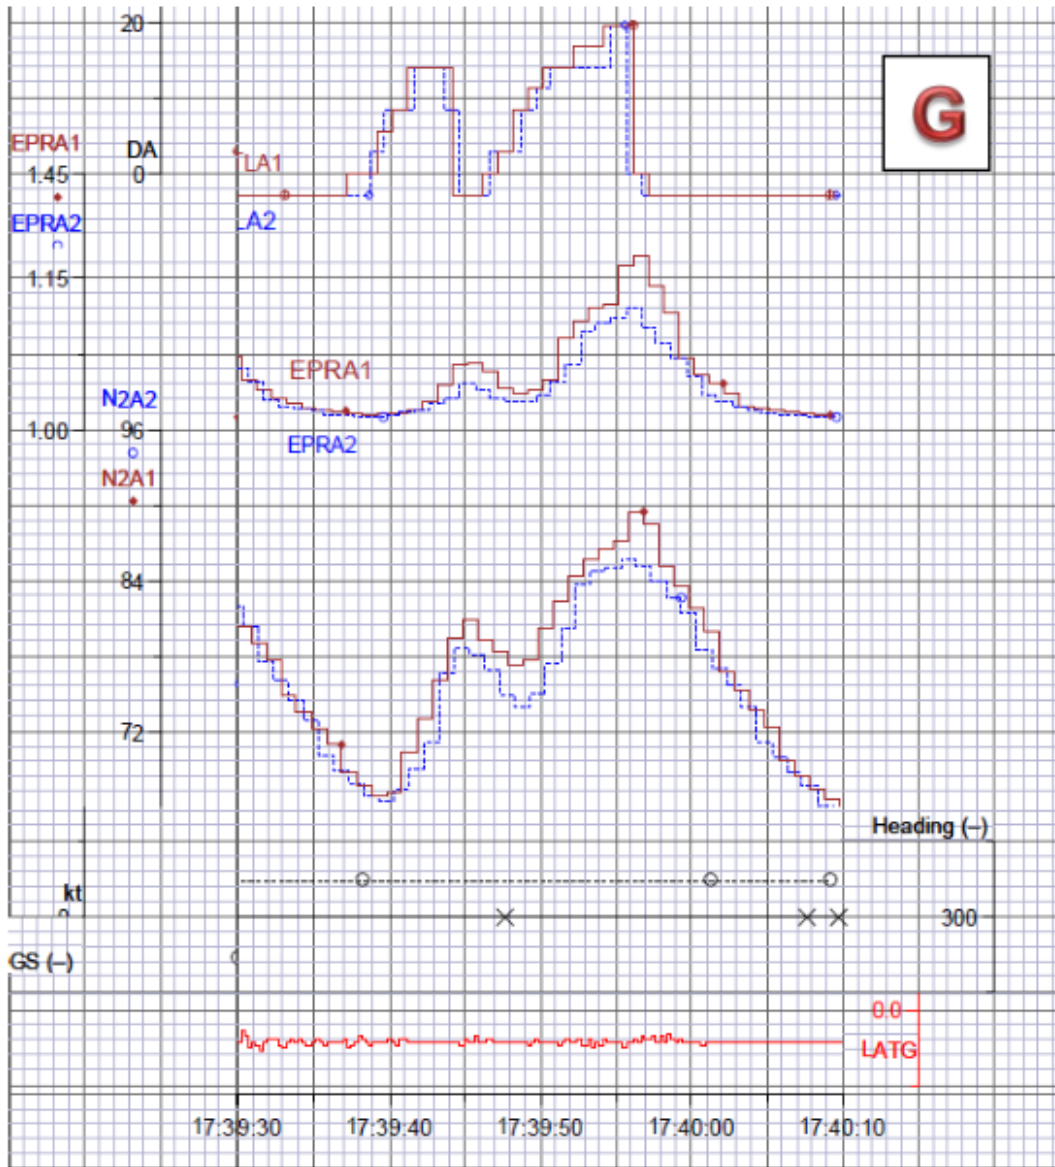
Following the aircraft coming to a standstill off the runway edge, 2 thrust applications are made, with TLAs advanced to 14° first and then to 20°, with EPRA1 reaching 1.16. There was no movement in aircraft speed which remained at zero, and the heading remained static.

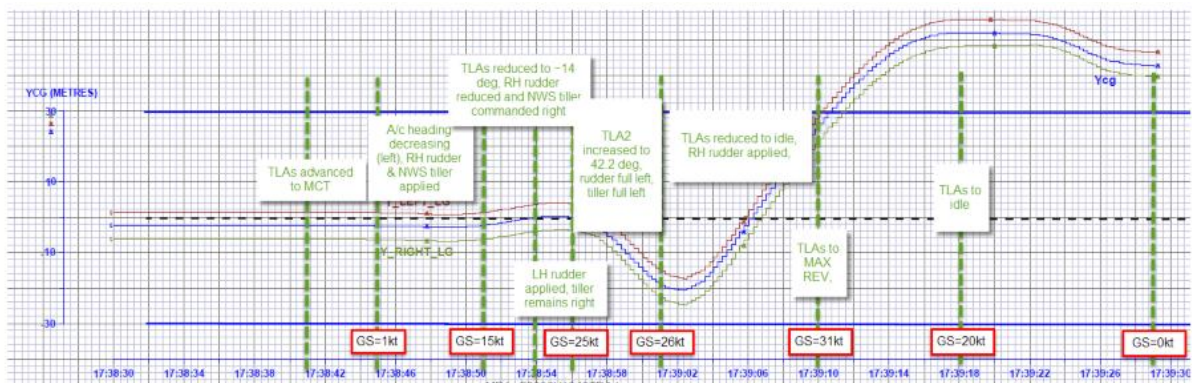
Aircraft Trajectory vs Time.

- That the actual trajectory is only possible with the use of the NW tiller deflection of the nose-wheel steering is commanded, firstly to the left and then to the right.
