DUTCH
SAFETY BOARD

Cabin crew injured during flight as a result of turbulence

The Hague, June 2018

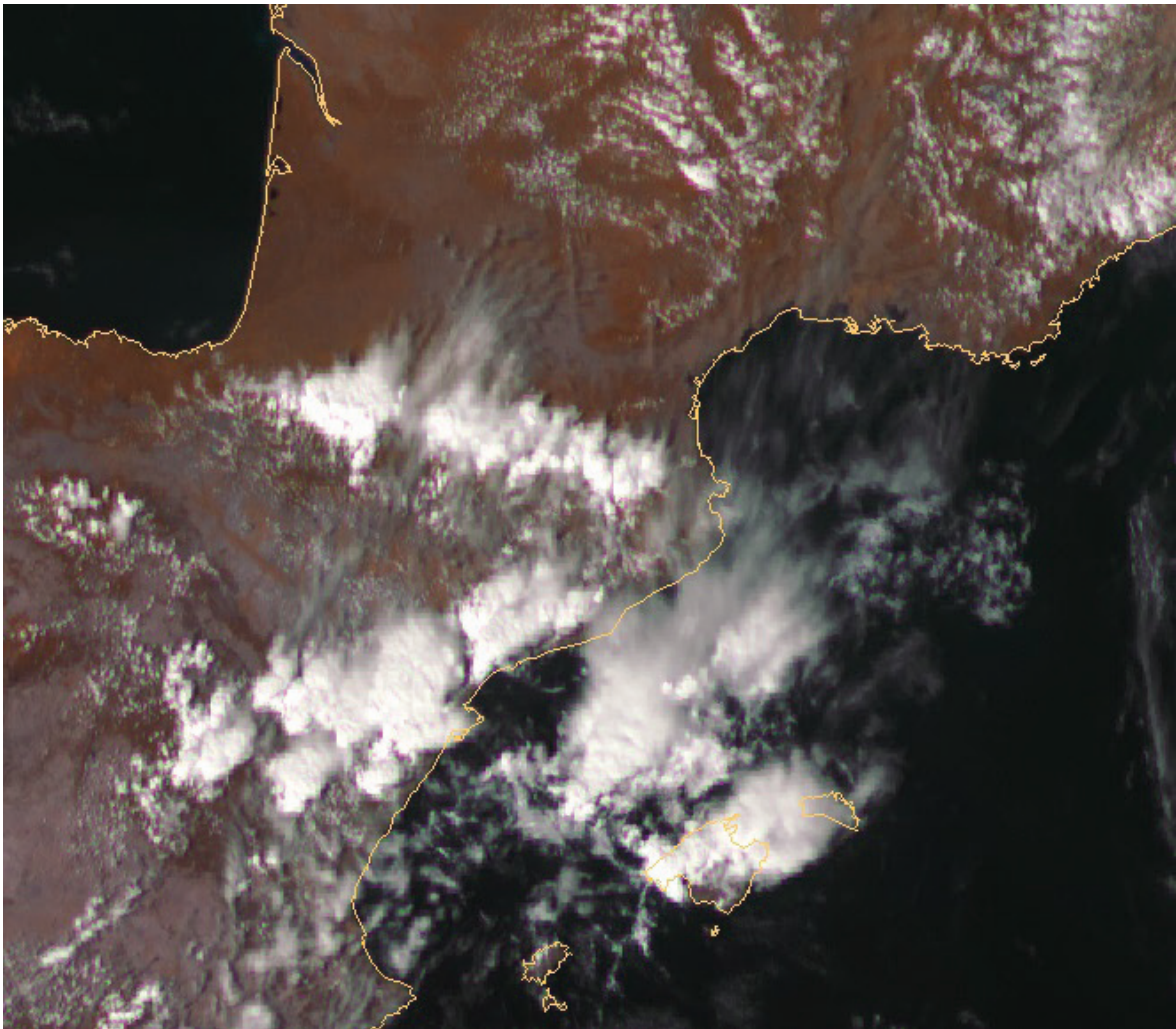
Figure 1: Satellite image of the overall situation on 13.15u. (Source: KNMI)

In medium and high levels of the atmosphere, a large low-pressure area was moving from the Atlantic across the Iberian peninsula from west to east. It had several vortices, one in the general vicinity of Cuenca, with a cold anomaly at medium levels of about -16°C , and a trailing wind of about 50 kts pushing the vortex toward the southeast. In these conditions, the area of highest storm activity spread out over much of the eastern peninsula and the Balearic Islands. On the surface, there was a high-pressure area from central Europe to Catalonia, favoring low-level winds from the east throughout the Mediterranean coast and contributing to instability in the area. There were active storms over parts of the Iberian System (see figure 1).

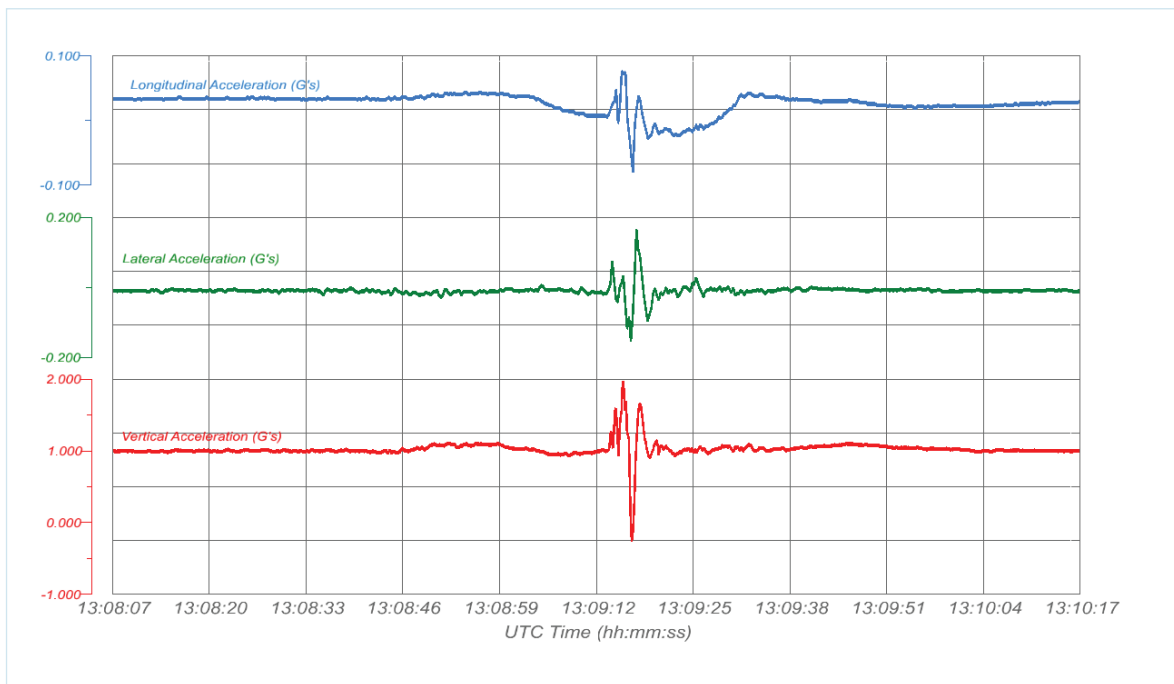
Accelerations

According to the FDR data, a series of large peaks in vertical acceleration were observed between 13.09:14 and 13.09:23. Initially, at 13.09:14, vertical acceleration¹⁶ shortly increased to 1.26g¹⁷. One second later, a vertical acceleration of 1.59g was measured. The largest magnitude peak in vertical acceleration was observed at 13:09:16, with a value of approximately 1.97g. Finally, after momentarily experiencing an upward acceleration (-0.2g at 13:09:17), another large magnitude peak in vertical acceleration with a value of 1.66g was observed at 13.09:18.

During the series of large magnitude peaks in vertical acceleration, a number of peaks were also observed in longitudinal¹⁸ and, more significantly, in lateral¹⁹ acceleration. The lateral acceleration showed recorded values ranging between -0.15g and 0.16g, with the latter peak occurring simultaneously with the 1.66g measurement in vertical direction.
