AIRCRAFT ACCIDENT REPORT AND EXECUTIVE SUMMARY

Reference:	CA18/2/3/9574	
Aircraft Registration	ZS-FAI	Date of Accident	13 October 2016		Time of Accident	1010Z
Type of Aircraft	Piper PA-28-235		Type of Operation	Private Part 91		
Pilot-in-command Licence Type	Private Pilot (PPL)		Age	67	Licence Valid	Yes
Pilot-in-command Flying Experience	Total Flying Hours	619.0		Hours on Type	619.0	
Last point of departure	Manzengwenya Airfield KwaZulu-Natal (KZN) Province					
Next point of intended landing	Brakpan-Benoni (FABB) Gauteng Province					
Location of the accident site with reference to easily defined geographical points (GPS readings if possible)						
Jozini in KwaZulu-Natal at GPS coordinates : S27° 18'.32' & E032° 15.55' at 203 feet AMSL						
Meteorological Information	Surface Wind: Calm; Clouds: SCT018 BKN018; Cloud base:1800ft AGL; Precipitation: Drizzling.					
Number of people on board	1 + 1	No. of people injured	0	No. of people killed	2

AIRCRAFT ACCIDENT REPORT

Name of Owner : Trade A Plane CC
Name of Operator : Private
Manufacturer : Piper Aircraft Corporation
Model : PA-28-235
Nationality : Germany
Registration Marks : ZS-FAI
Place : Jozini in Kwa-Zulu-Natal at GPS S27°

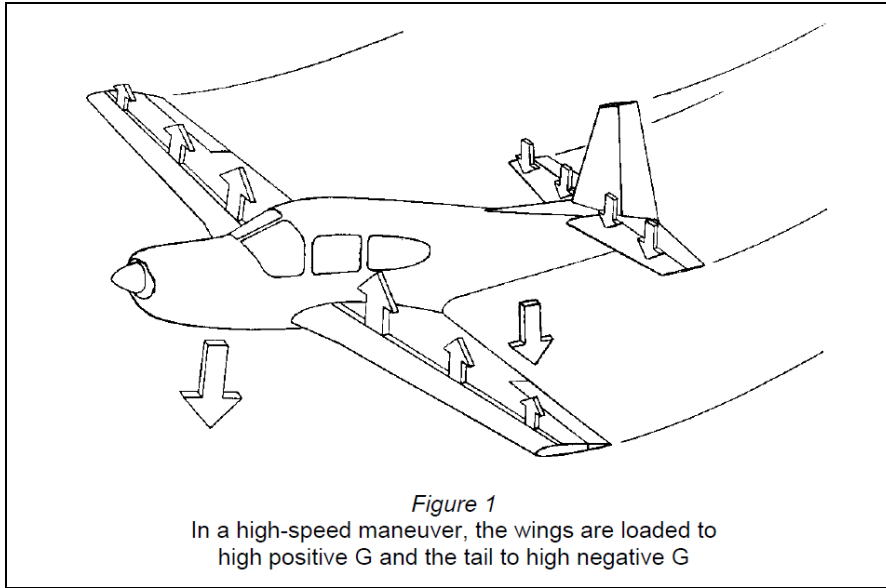
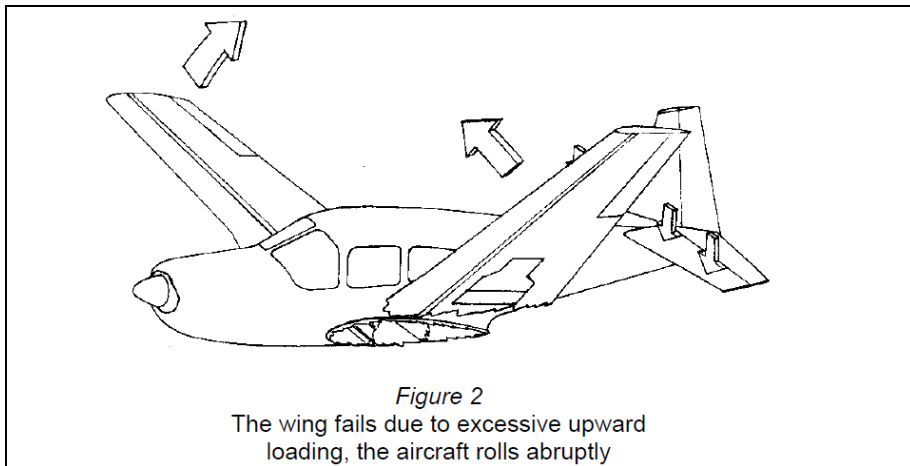
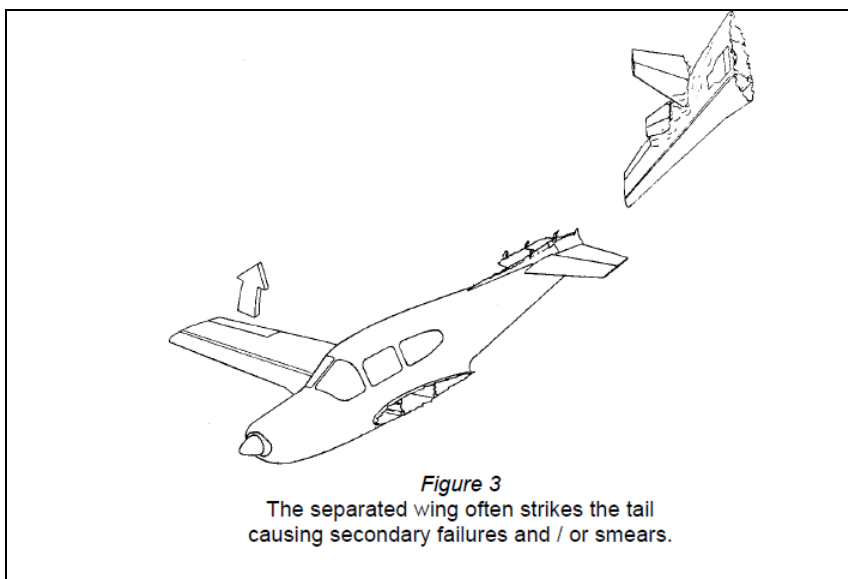
When the wing fails first due to upward static overload the separated wing will bend up and back over the fuselage. At the same time the unbalanced lift from the opposite wing causes rapid roll acceleration with the side of the aircraft missing its wing rotating downward. In some instances, the roll rate is rapid enough to cause a torsional failure in the empennage. The separated wing often impacts the tail surfaces causing matching impact marks and smears between the broken off wing and the leading edges of the tail. The impact with the tail may be severe enough to cause secondary failures in the tail structures.

Wing first characteristics

If the wing fails in flight, it will most often bend upward and break off with characteristic instantaneous overload signatures. The rapid rolling may then cause the broken off wing piece to strike the tail leaving mutual indentations and smears. The tail may also then fail as a secondary effect.

- 2.8 The main wreckage with the right wing and engine still attached, impacted the ground in a nose down attitude. The left wing failed first and was located 584.03m from the main wreckage. The vertical stabilizer was located 412.78m from the main wreckage. The horizontal stabilizer and part of the tail section were located 445.77m from the main wreckage. The wreckage distribution is indicative of an inflight break-up.
- 2.9 The investigation revealed that the pilot entered IMC conditions and subsequently became disorientated, putting the aircraft in an unusual attitude. In an attempt to correct the attitude he overstressed the aircraft structure which led to an inflight break up.
- 2.10 The pilot and passenger sustained fatal injuries and the aircraft was destroyed.
