| <b>SHORT REPORT AND EXECUTIVE SUMMARY</b> |

| | | | | Reference: | CA18/2/3/1150 | |
| <b>Aircraft Registration</b> | ZS-KEW | <b>Date of Accident</b> | 23 November 2016 | | <b>Time of Accident</b> | 07:10Z |
| <b>Type of Aircraft</b> | GRUMMAN G-164B | | <b>Type of Operation</b> | | Commercial Training Part 137 | |

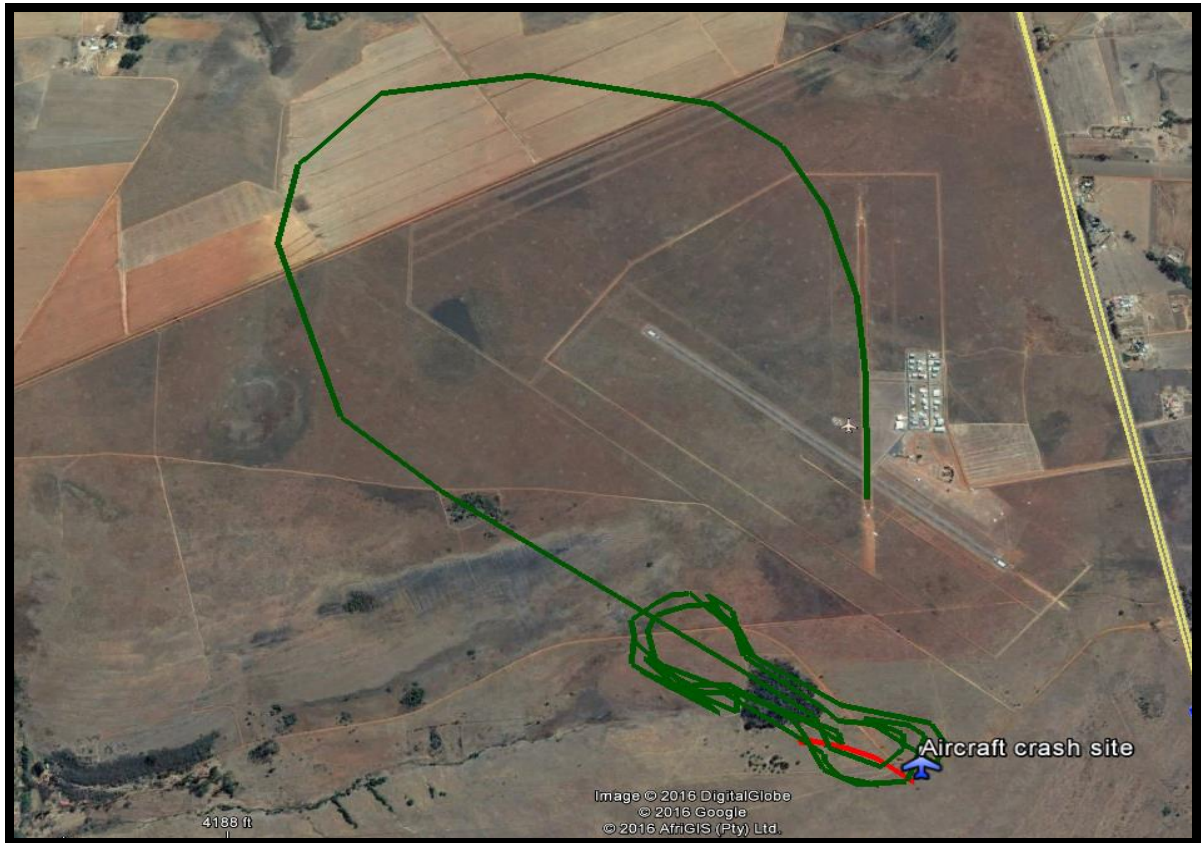
Figure 1: Google view of the accident site

- 1.1.2 The pilot attempted to recover the aircraft speed by adding power and dropping the nose. He then noticed that collision was inevitable when he noticed a tree in front of him. He then took evasive actions however the aircraft's right wing tip collided a tree top causing the aircraft to crash. The aircraft came to stop approximately 58 meters facing the direction it came north-westerly and the pilot was not injured during the accident sequence.
- 1.1.3 The accident occurred during daylight meteorological conditions in an open area 0.62 nautical miles outside Middleburg airfield in the direction 171.8 from the threshold of Runway 20, with GPS co-ordinates: S 25°41'52.55", E 029°26'36.32" and a field elevation of 4910ft.
